SOUTHERN AND NORTHERN JUNCTION RAILWAY

Abutments for Parramatta River Bridge

Drawing No 15

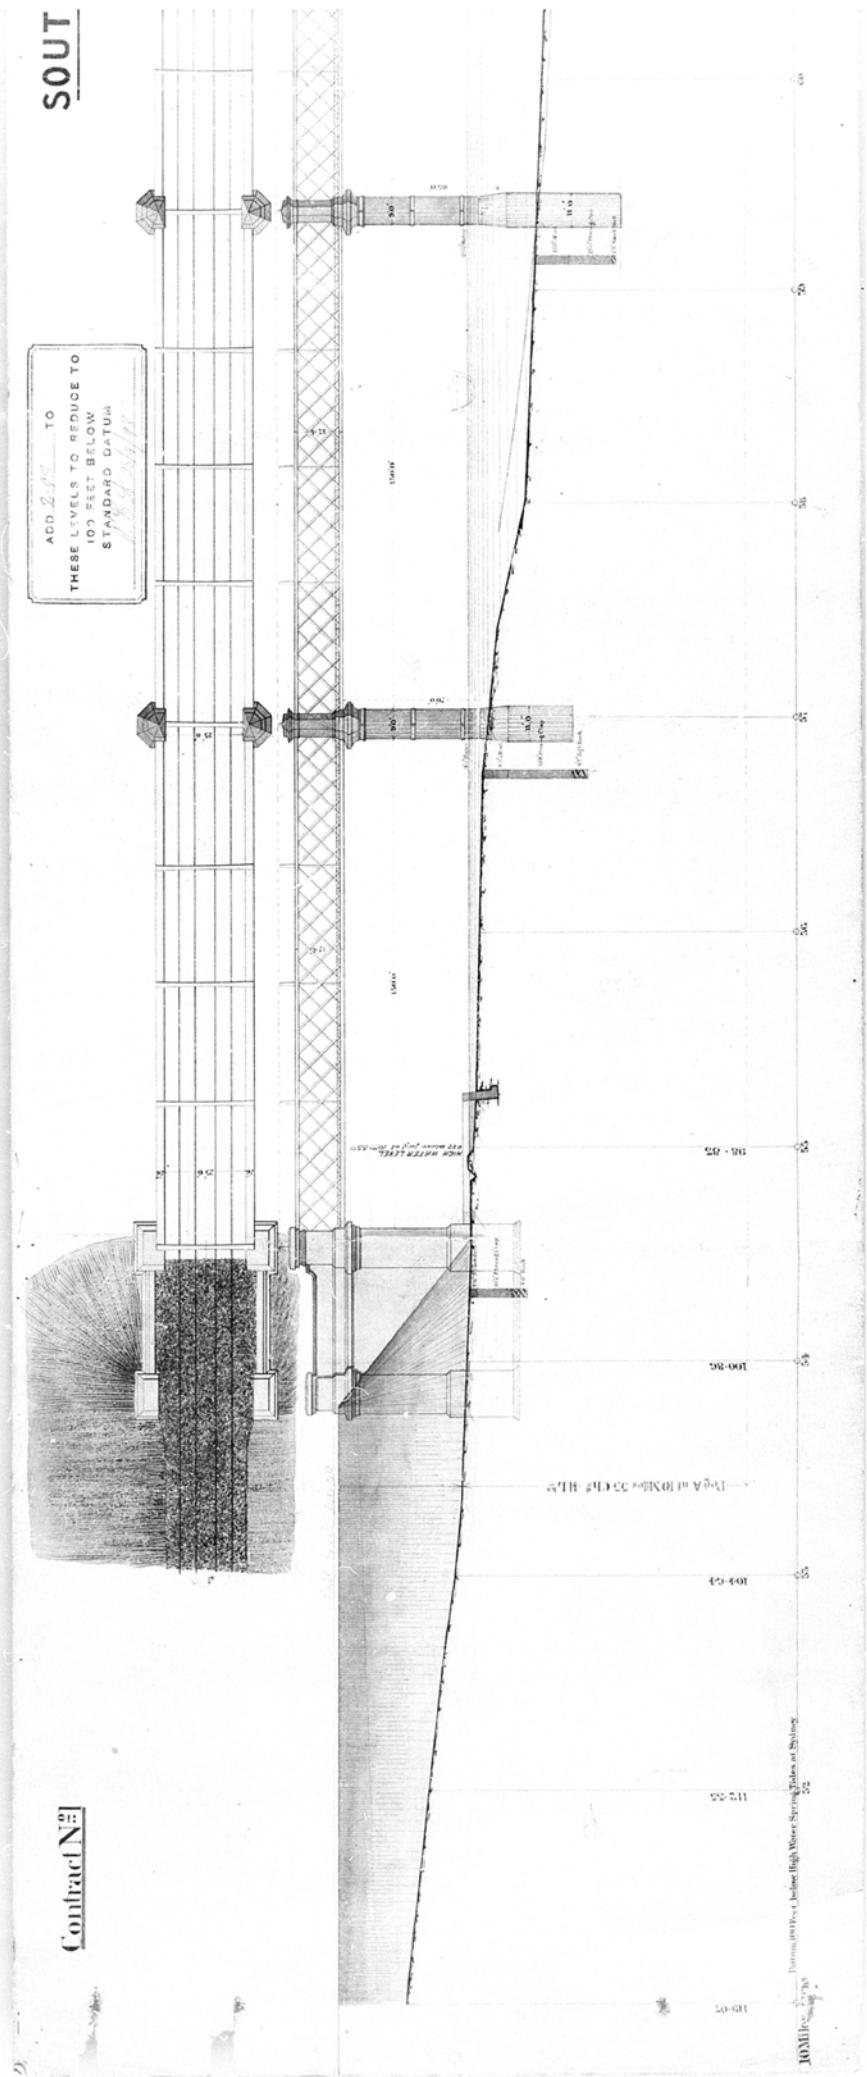
Image 1. The original plans of the bridge. Note the Amos brothers signature at the right hand end. The span is shown as 150 feet clear between the piers.

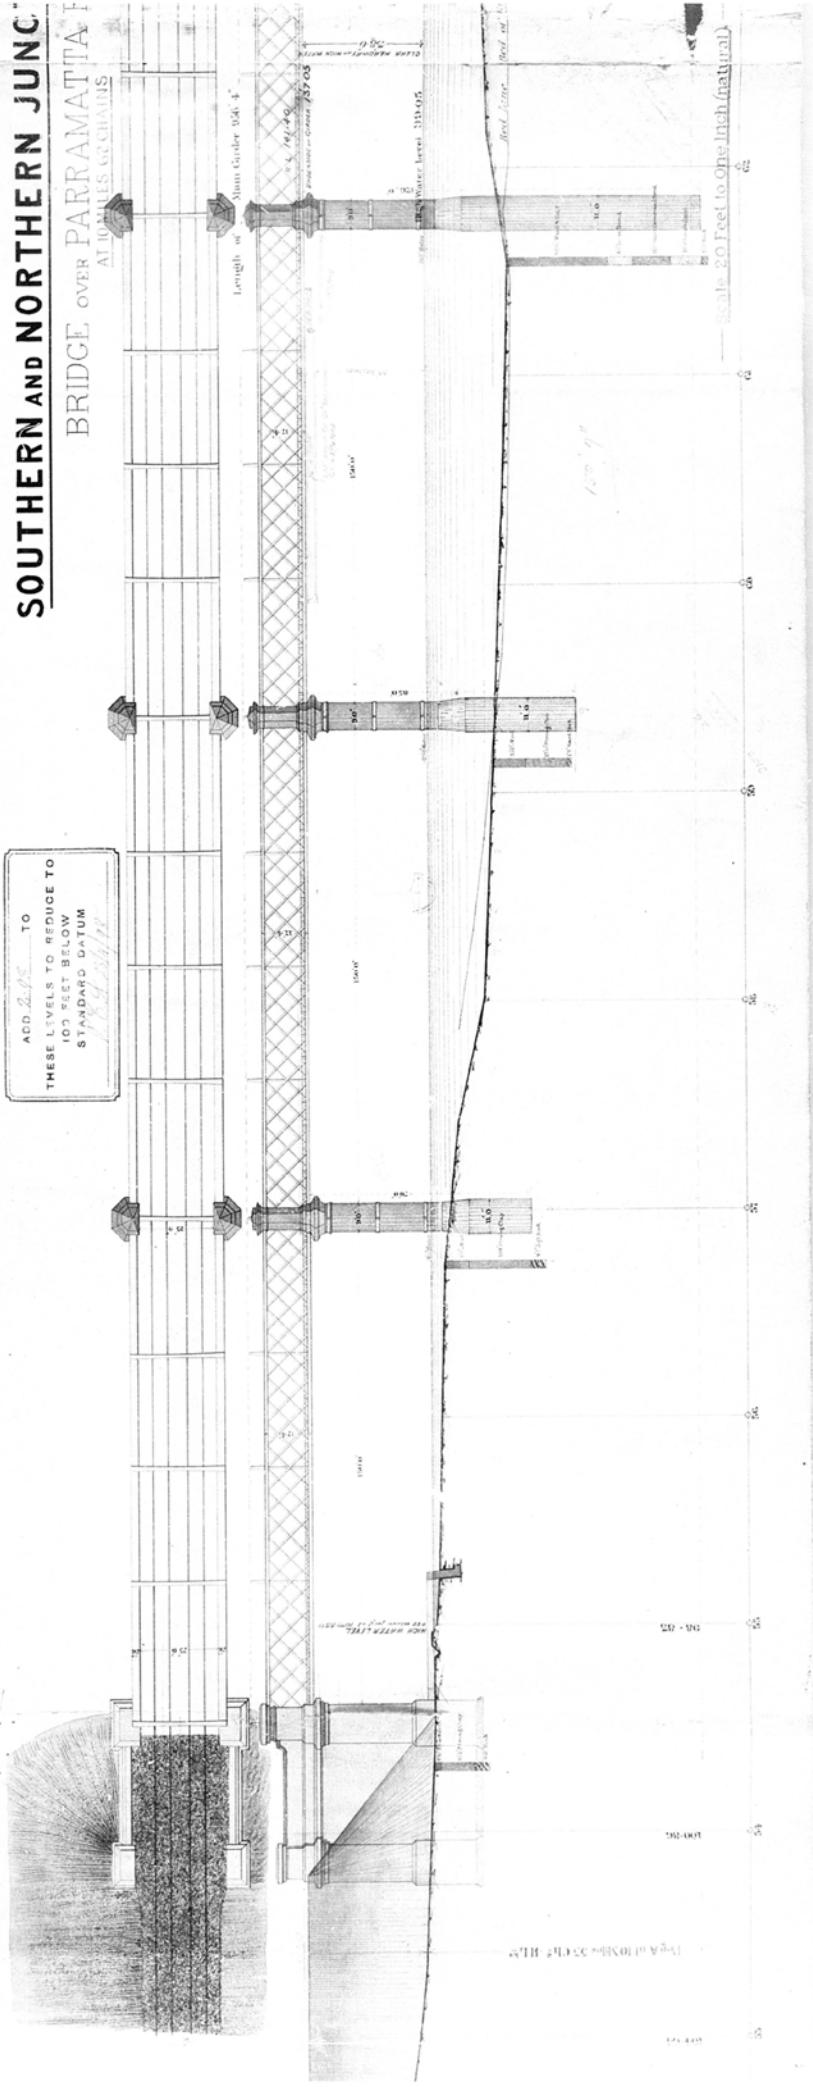
Images 2. The original plans of the bridge. Note the Amos brothers signature at the right hand end. The span is shown as 150 feet clear between the piers.

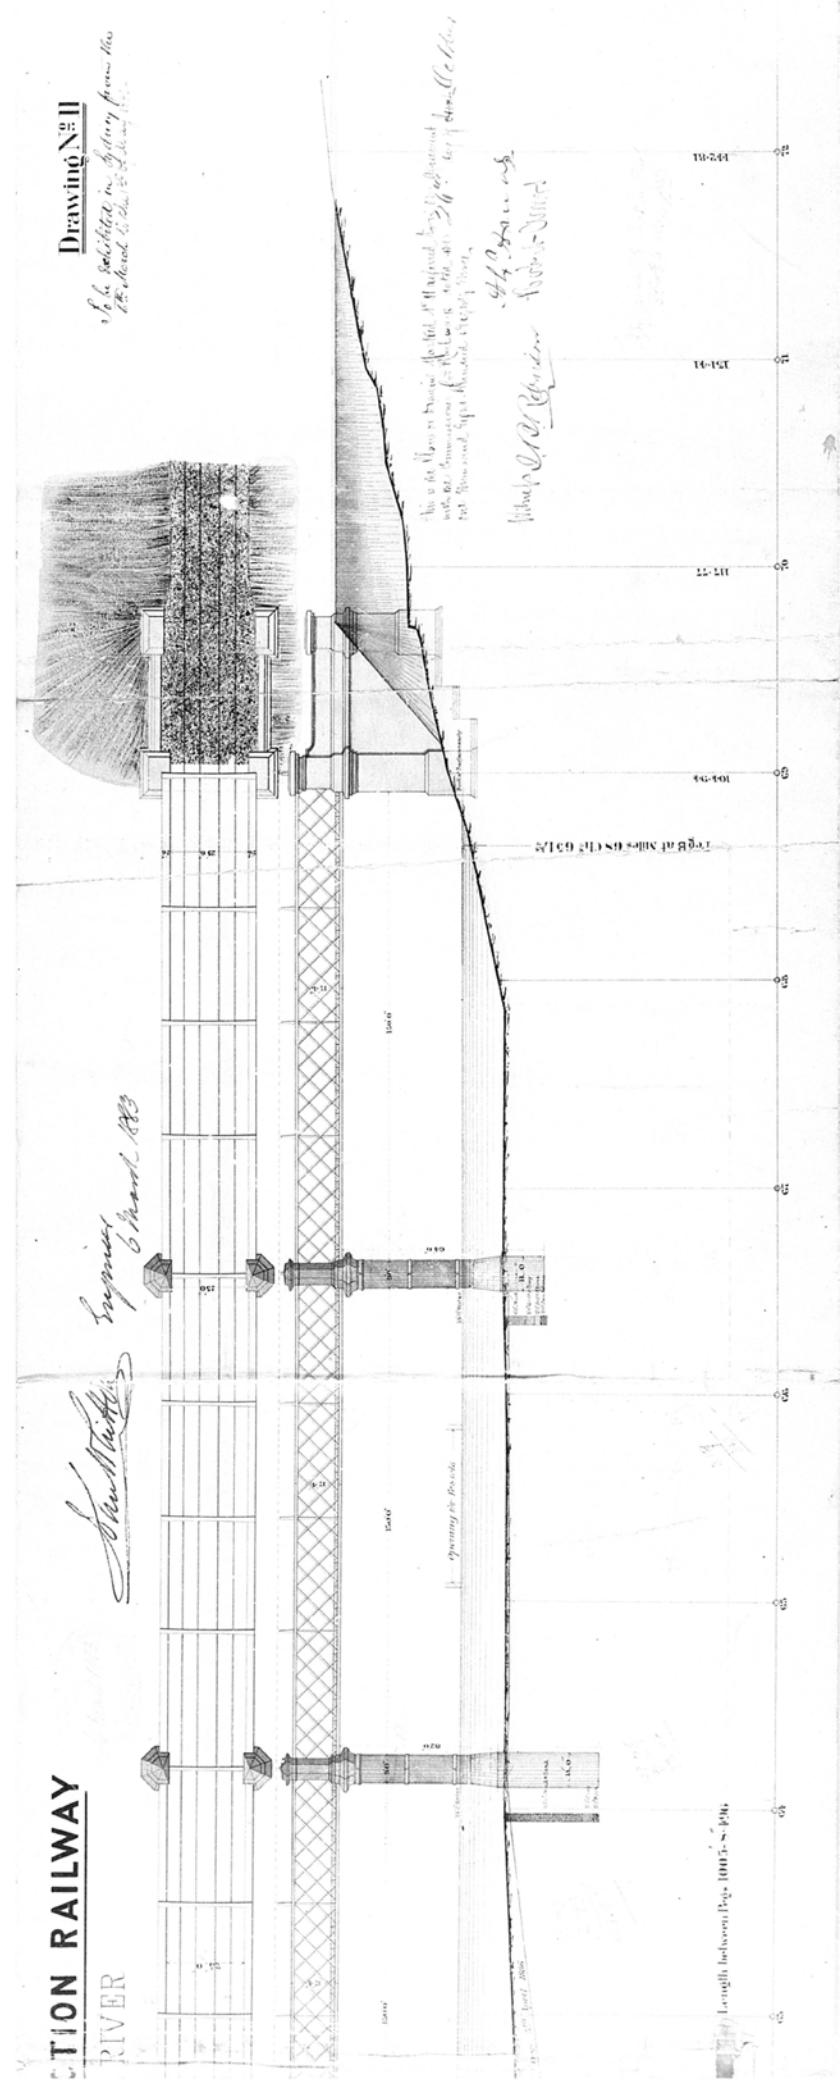
Images 3. The original plans of the bridge. Note the Amos brothers signature at the right hand end. The span is shown as 150 feet clear between the piers.

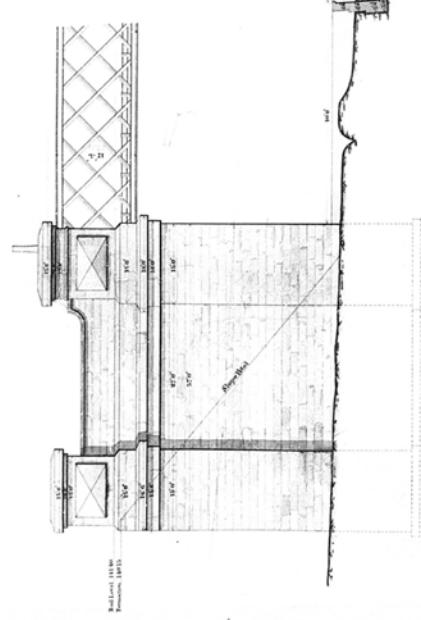
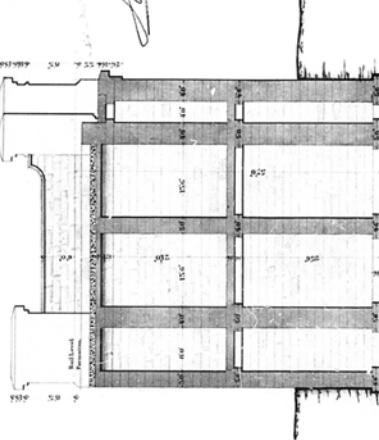
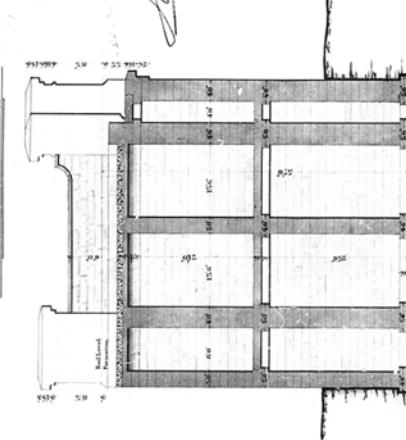
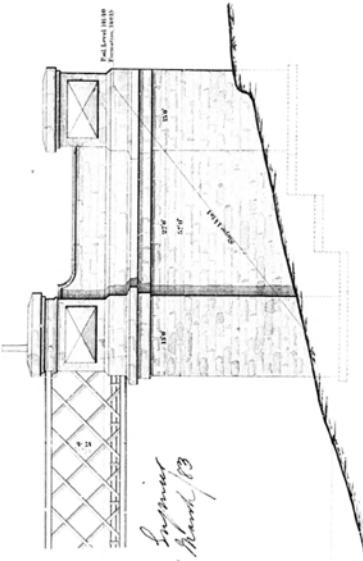
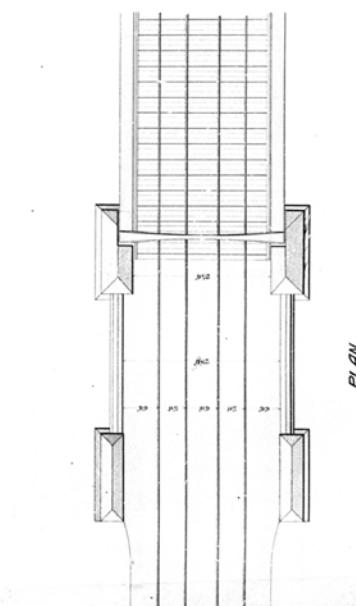
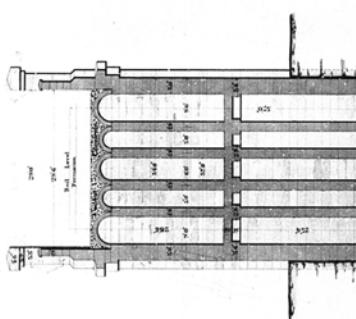
Image 4. Details of the internal structure of the sandstone abutments.

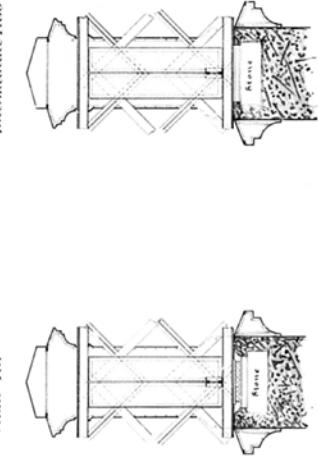
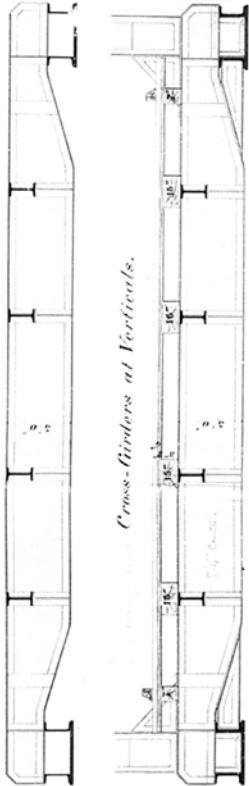
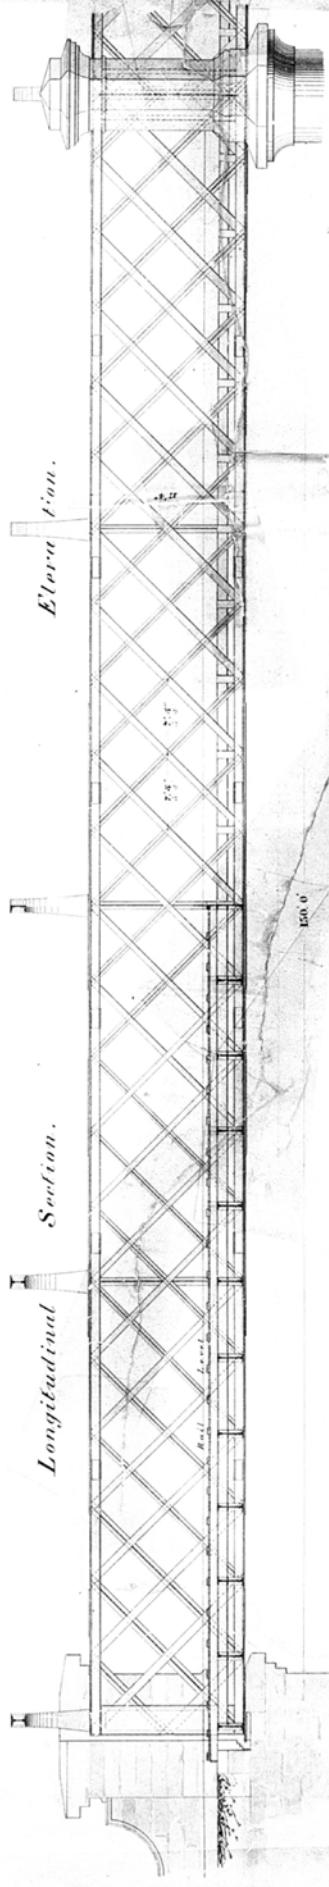
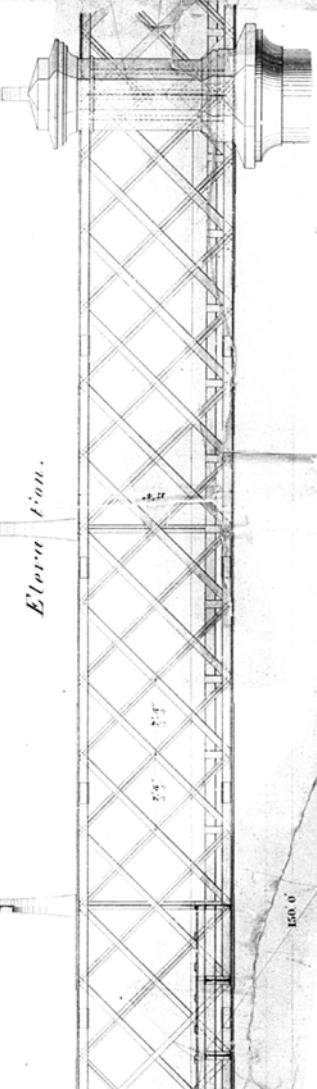
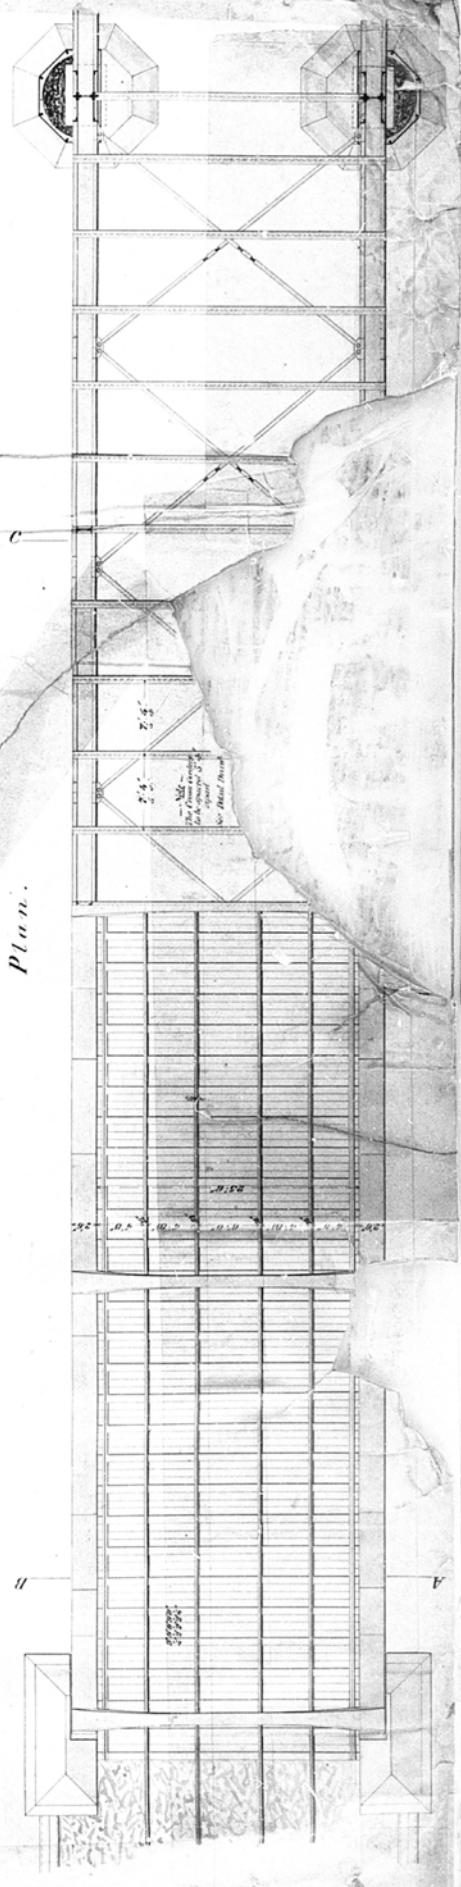
Image 5. Details of the deck structure.

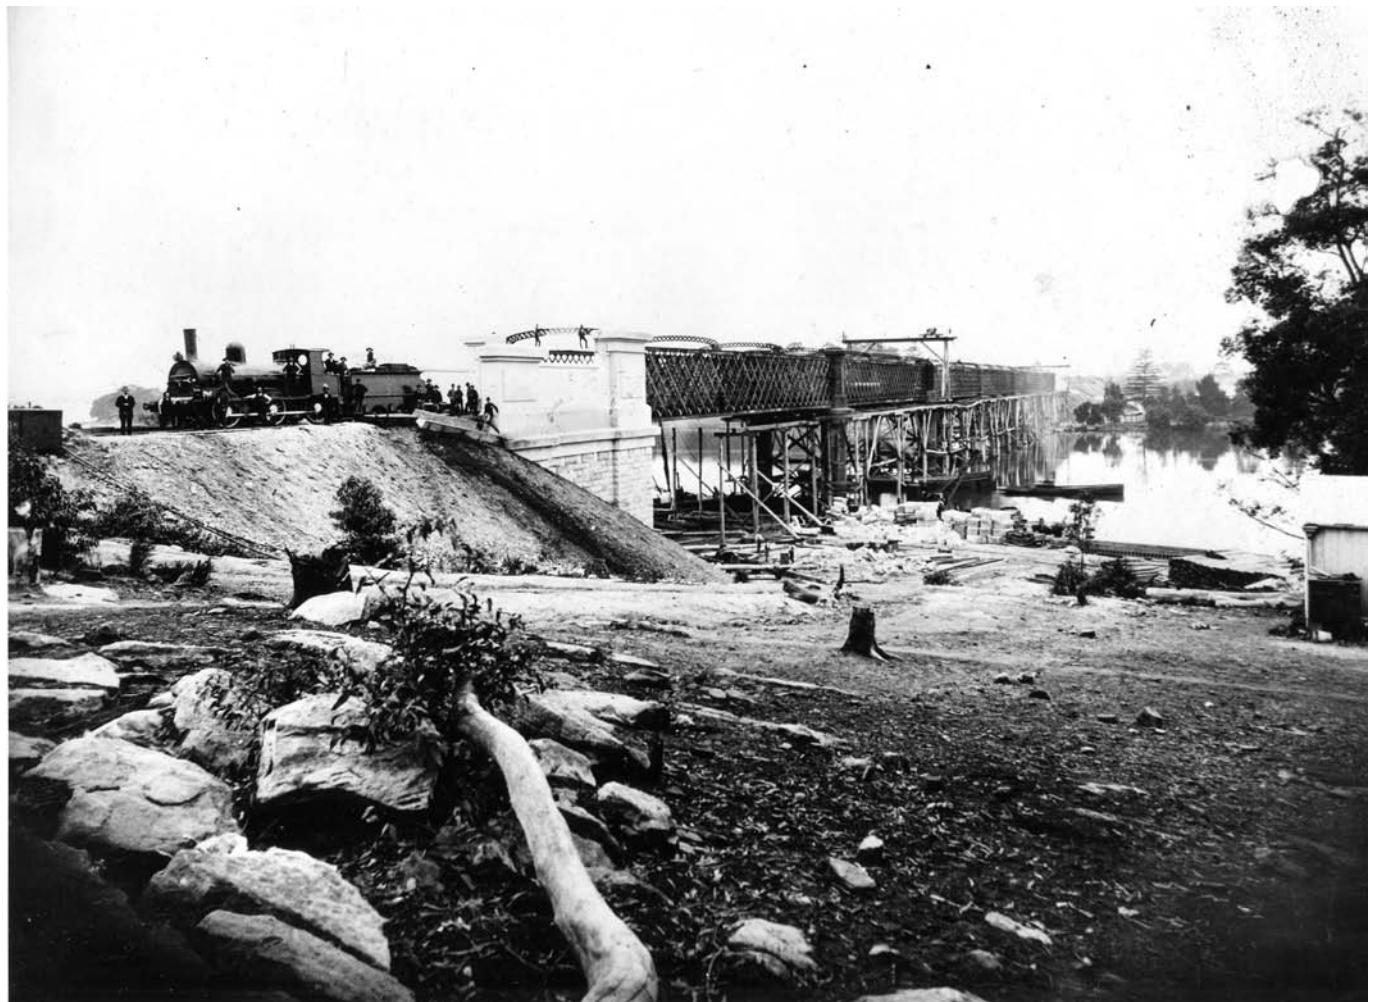
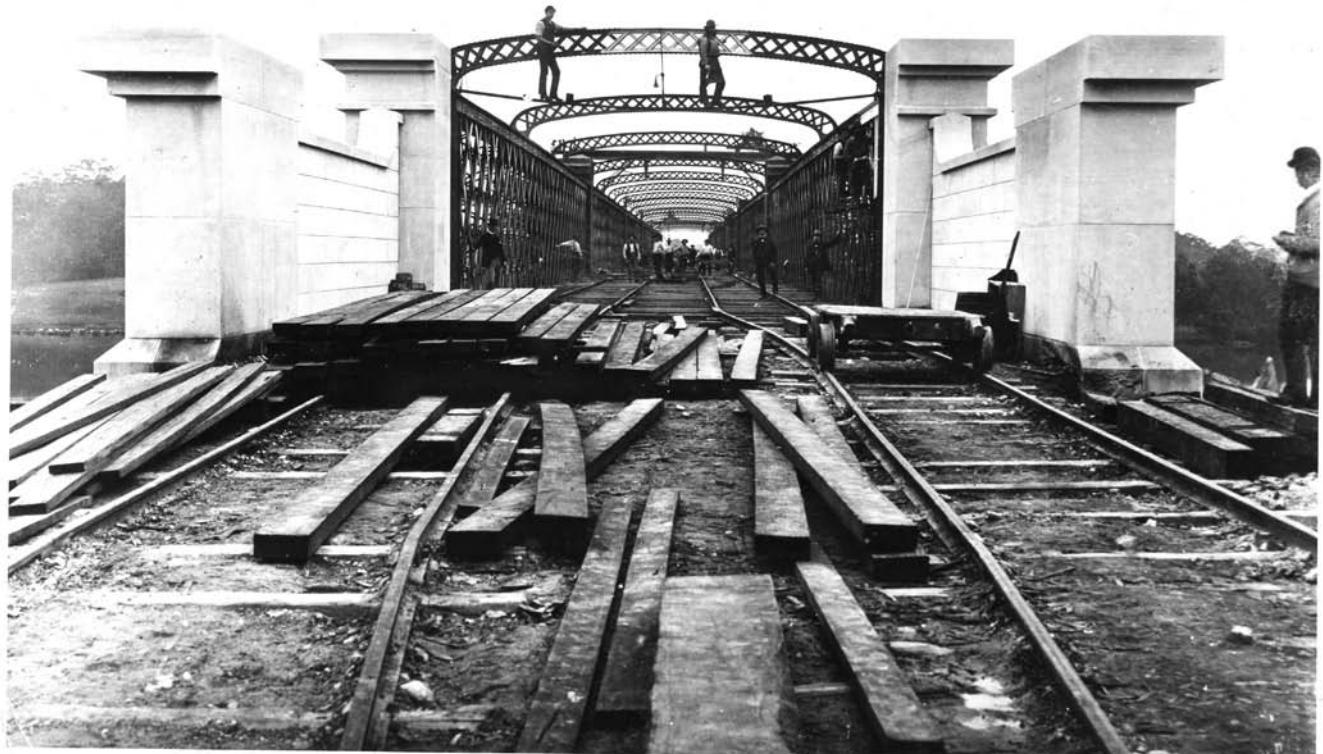
Image 6, 7. Construction photos. The timber falsework used to support the ironwork until it was self supporting is well illustrated.

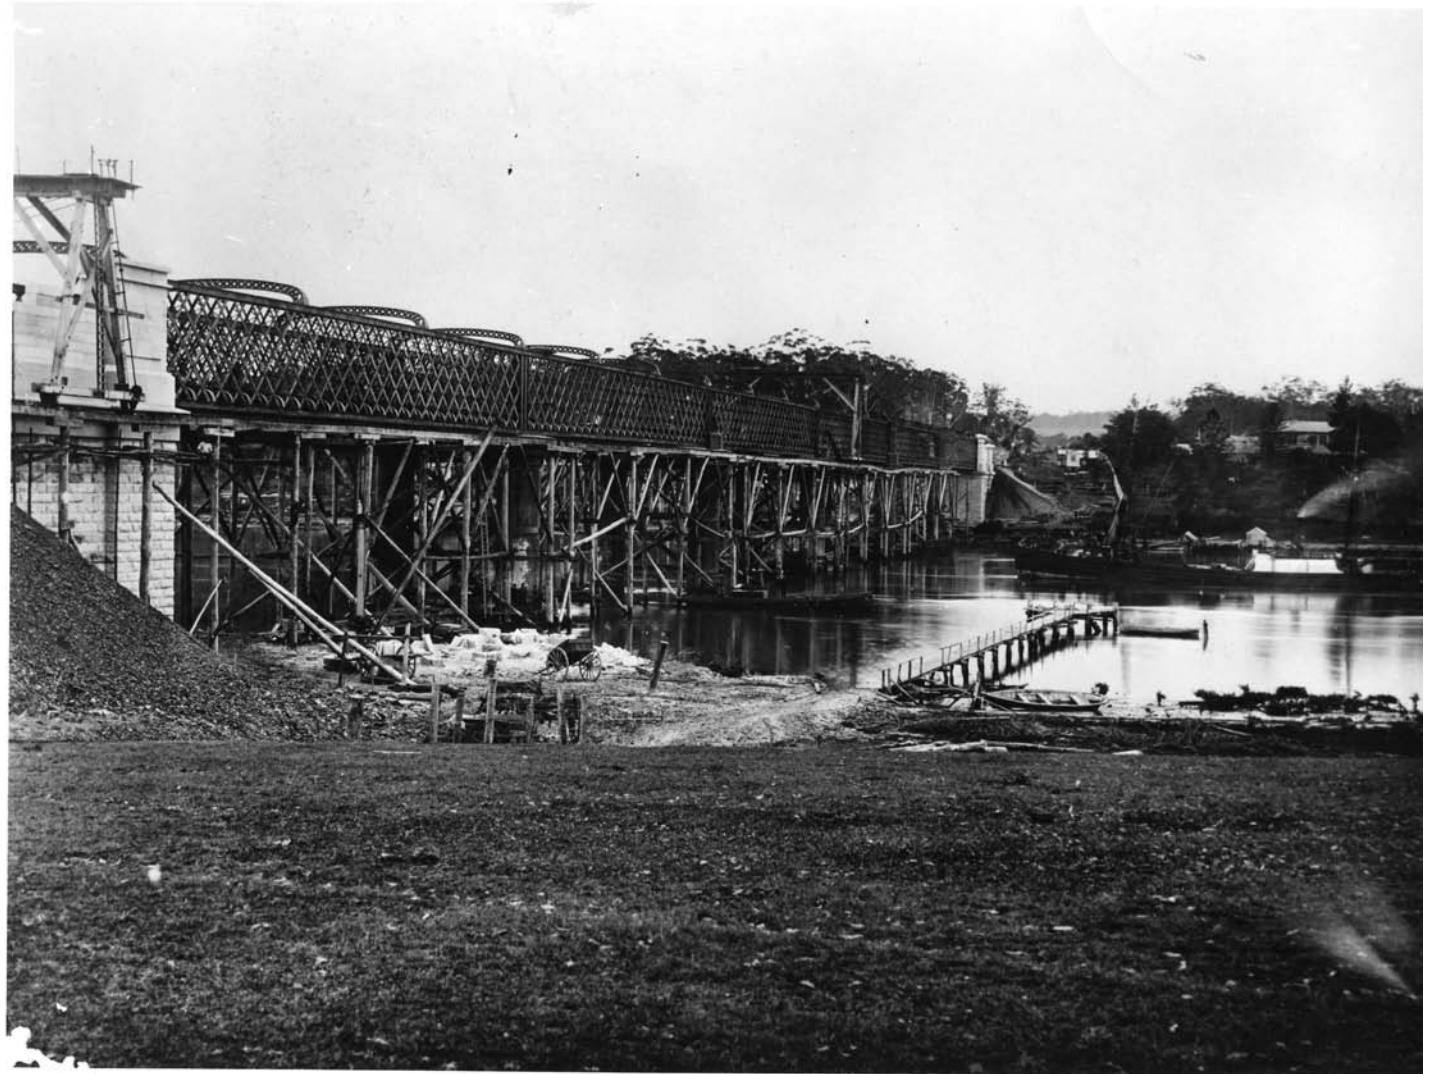
Image 8. Construction photos. The timber falsework used to support the ironwork until it was self supporting is well illustrated.

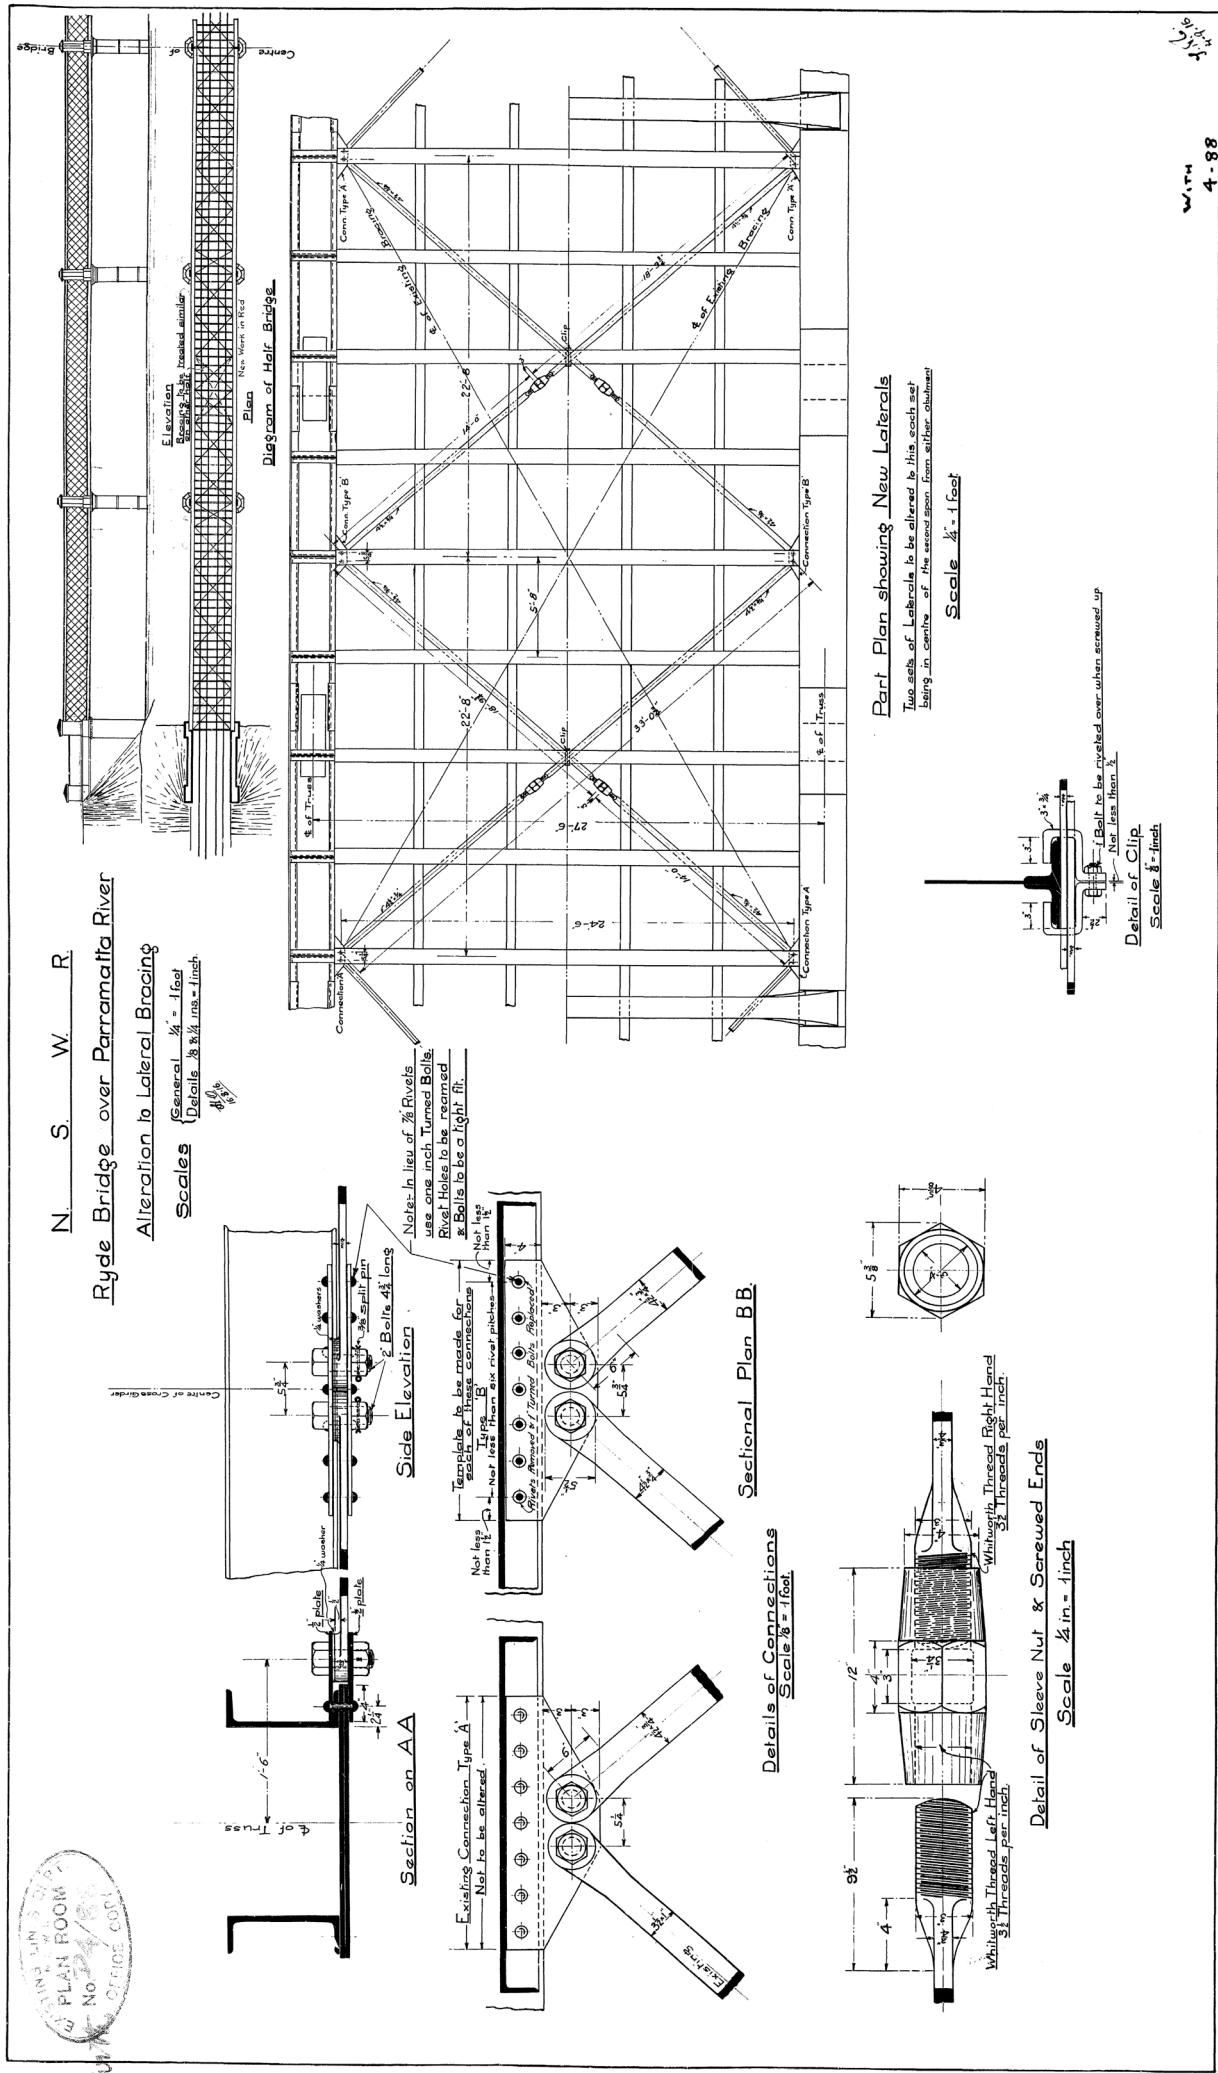
Image 9. The second set of transverse bracing added in 1916.

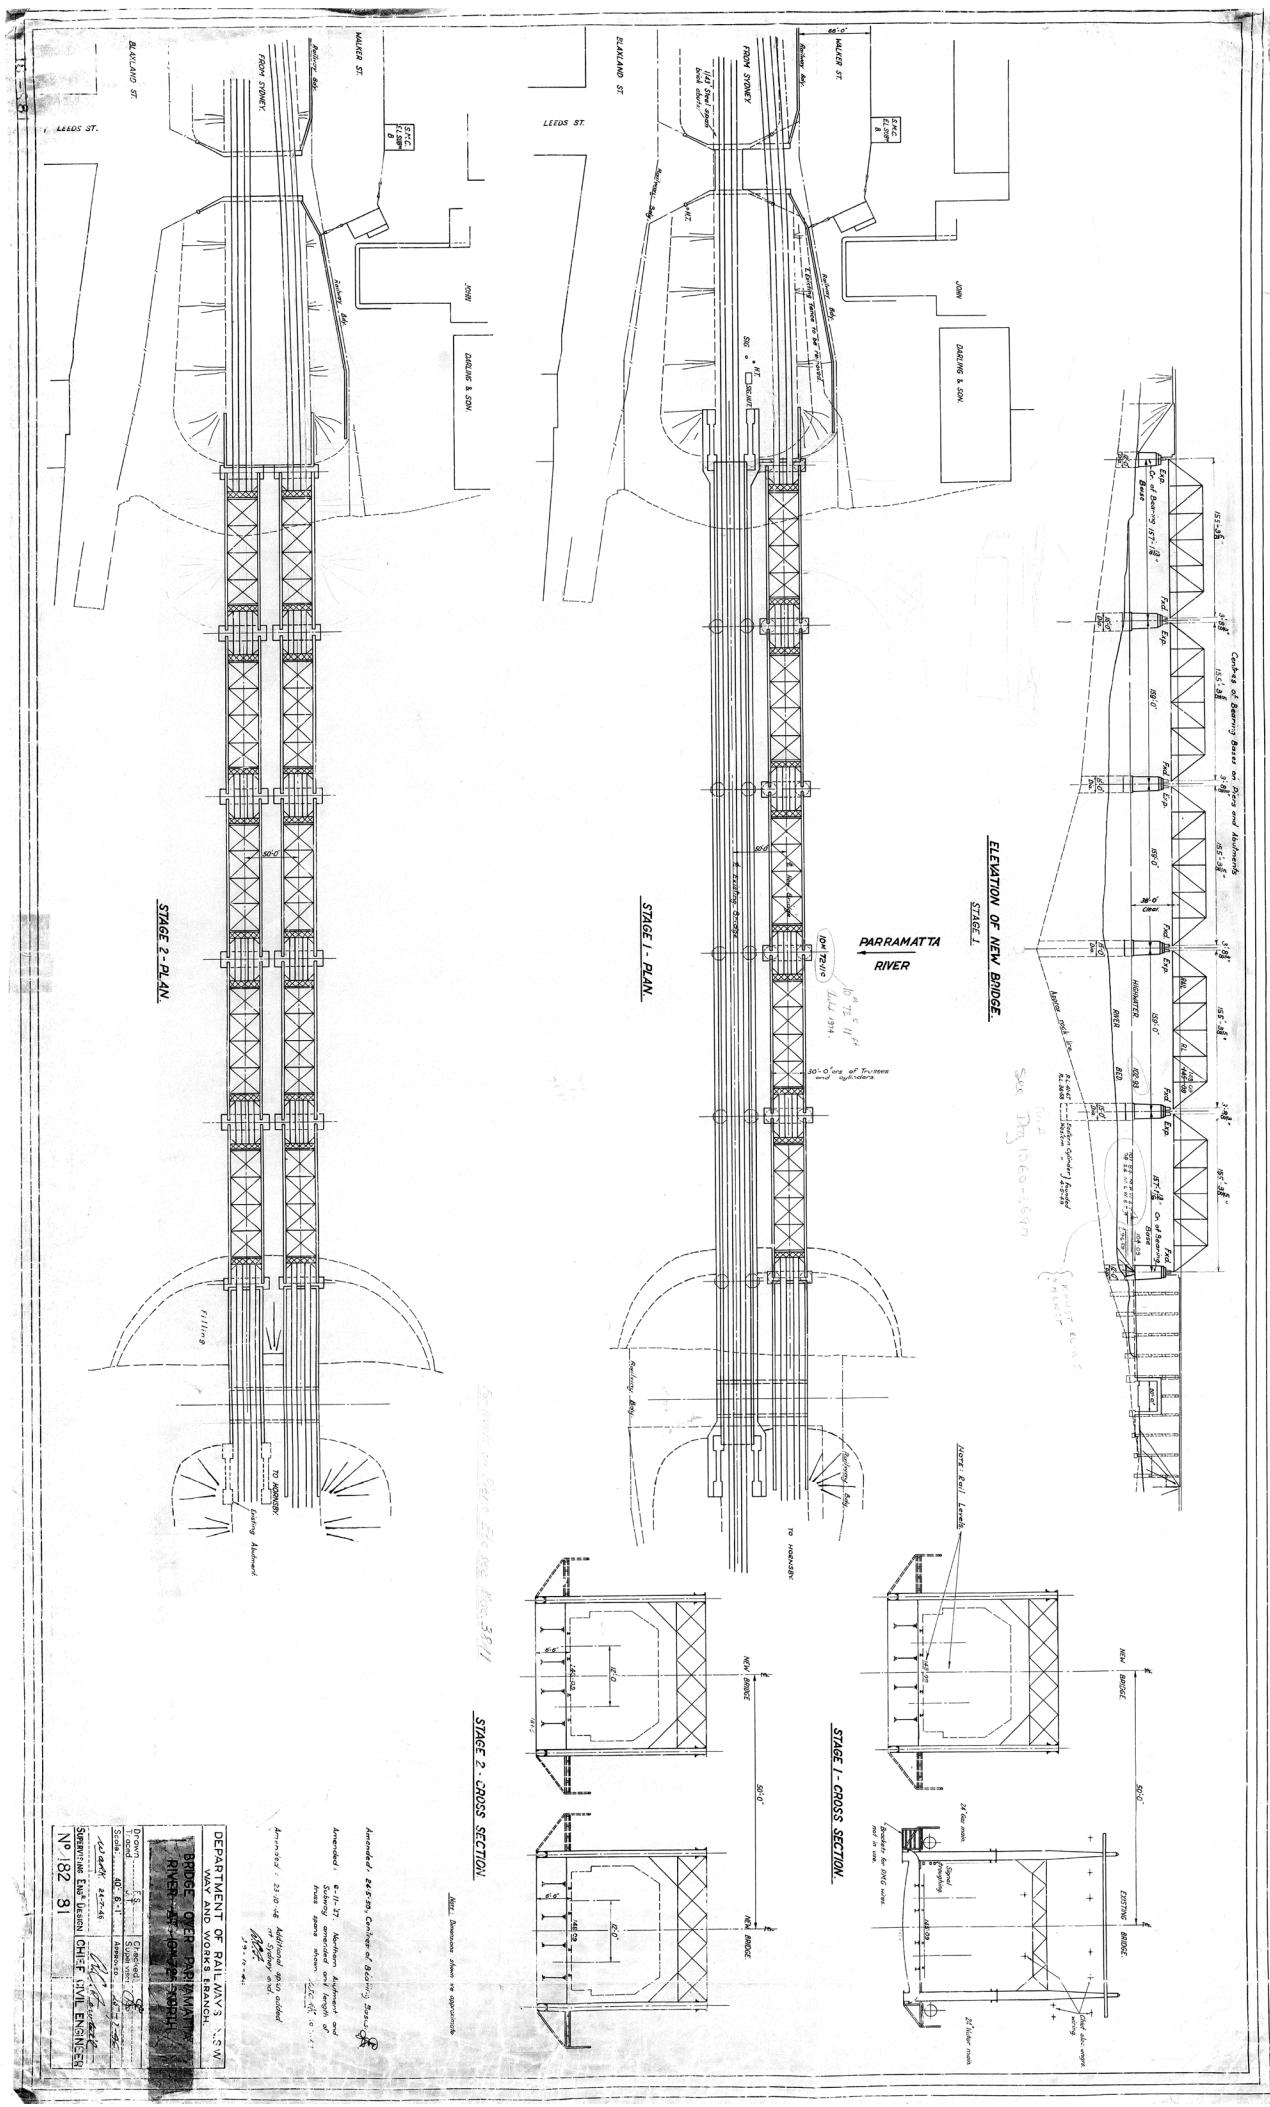
Image 10. The original proposal for replacement in the 1950s. The similarity to the short spans at Hawkesbury River is clear.

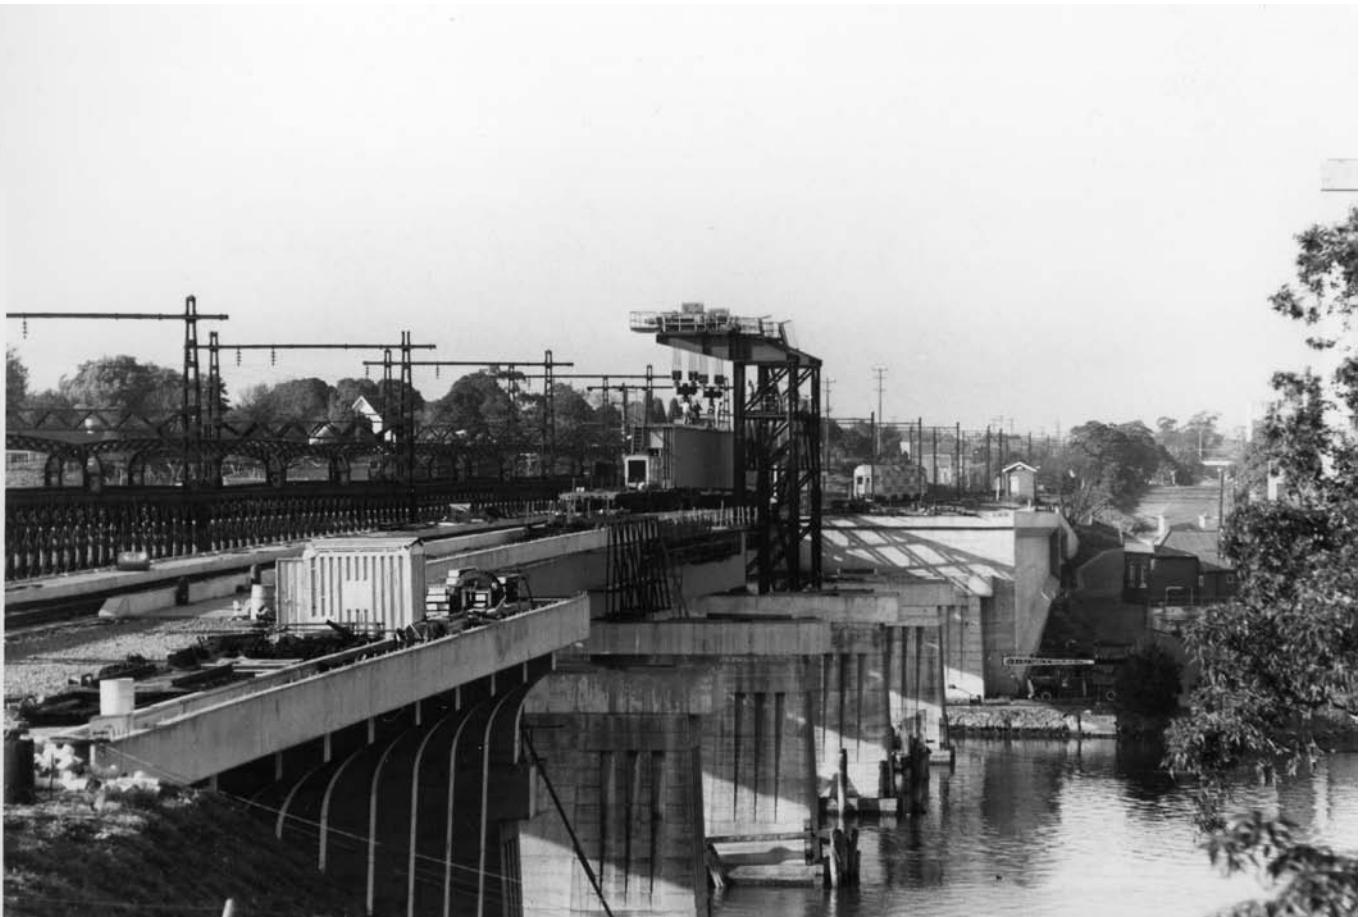
Image 11. Placing the box girders for the new bridge. The floating crane has lifted the girder off rail wagons shunted onto already placed spans.

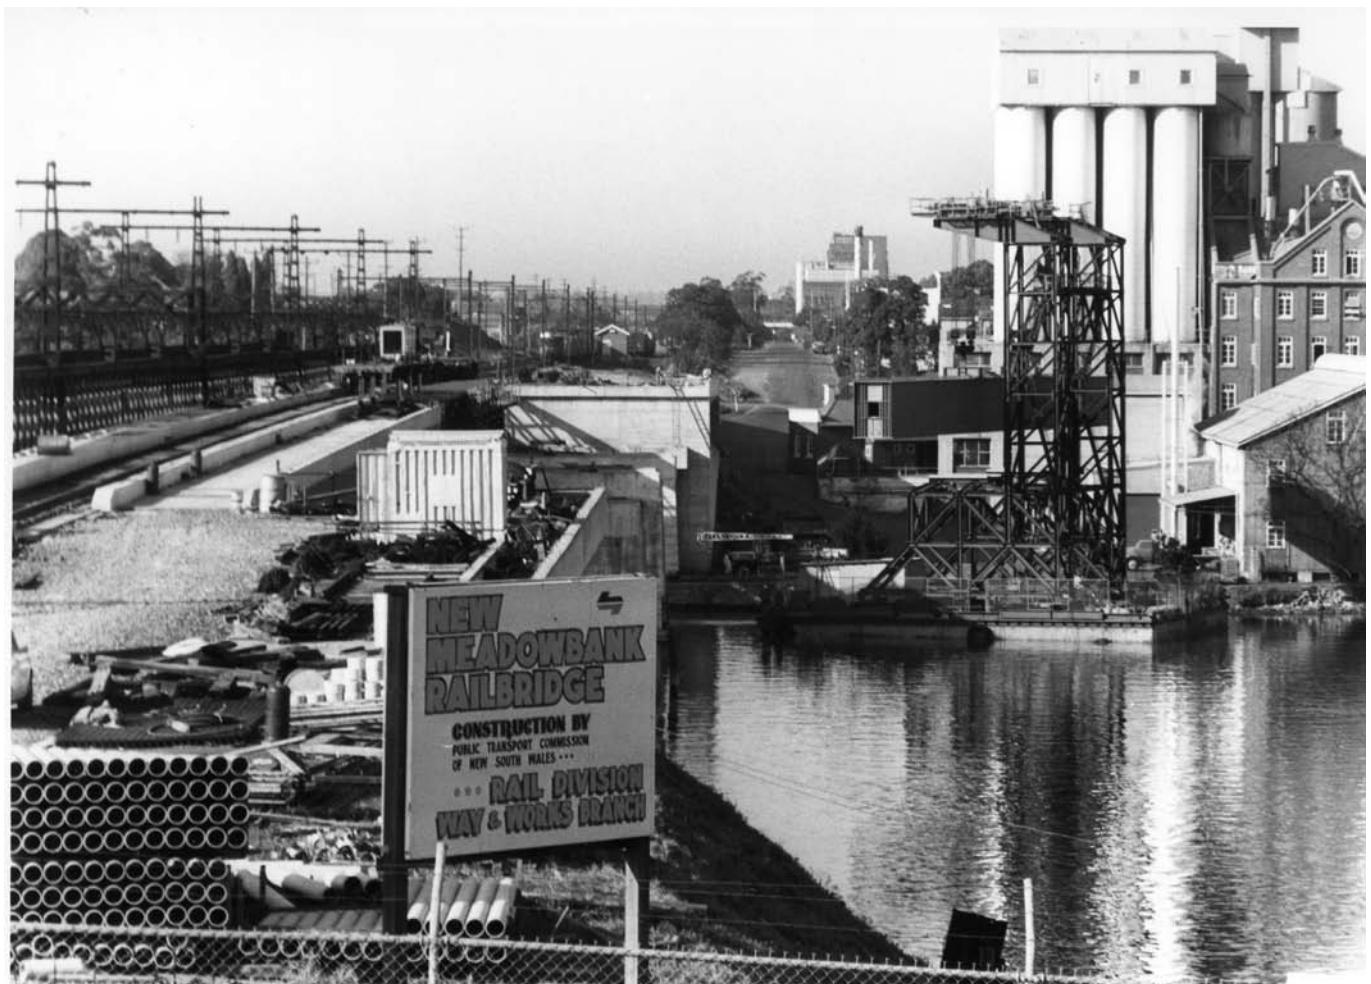
Image 12. The floating crane moves the girder to its final location.
