# Conquering Lapstone Hill

A Fresh Look at the History of the Emu Plains—Blaxland Section of the Main Western Line

Neville Pollard and Graham Harper

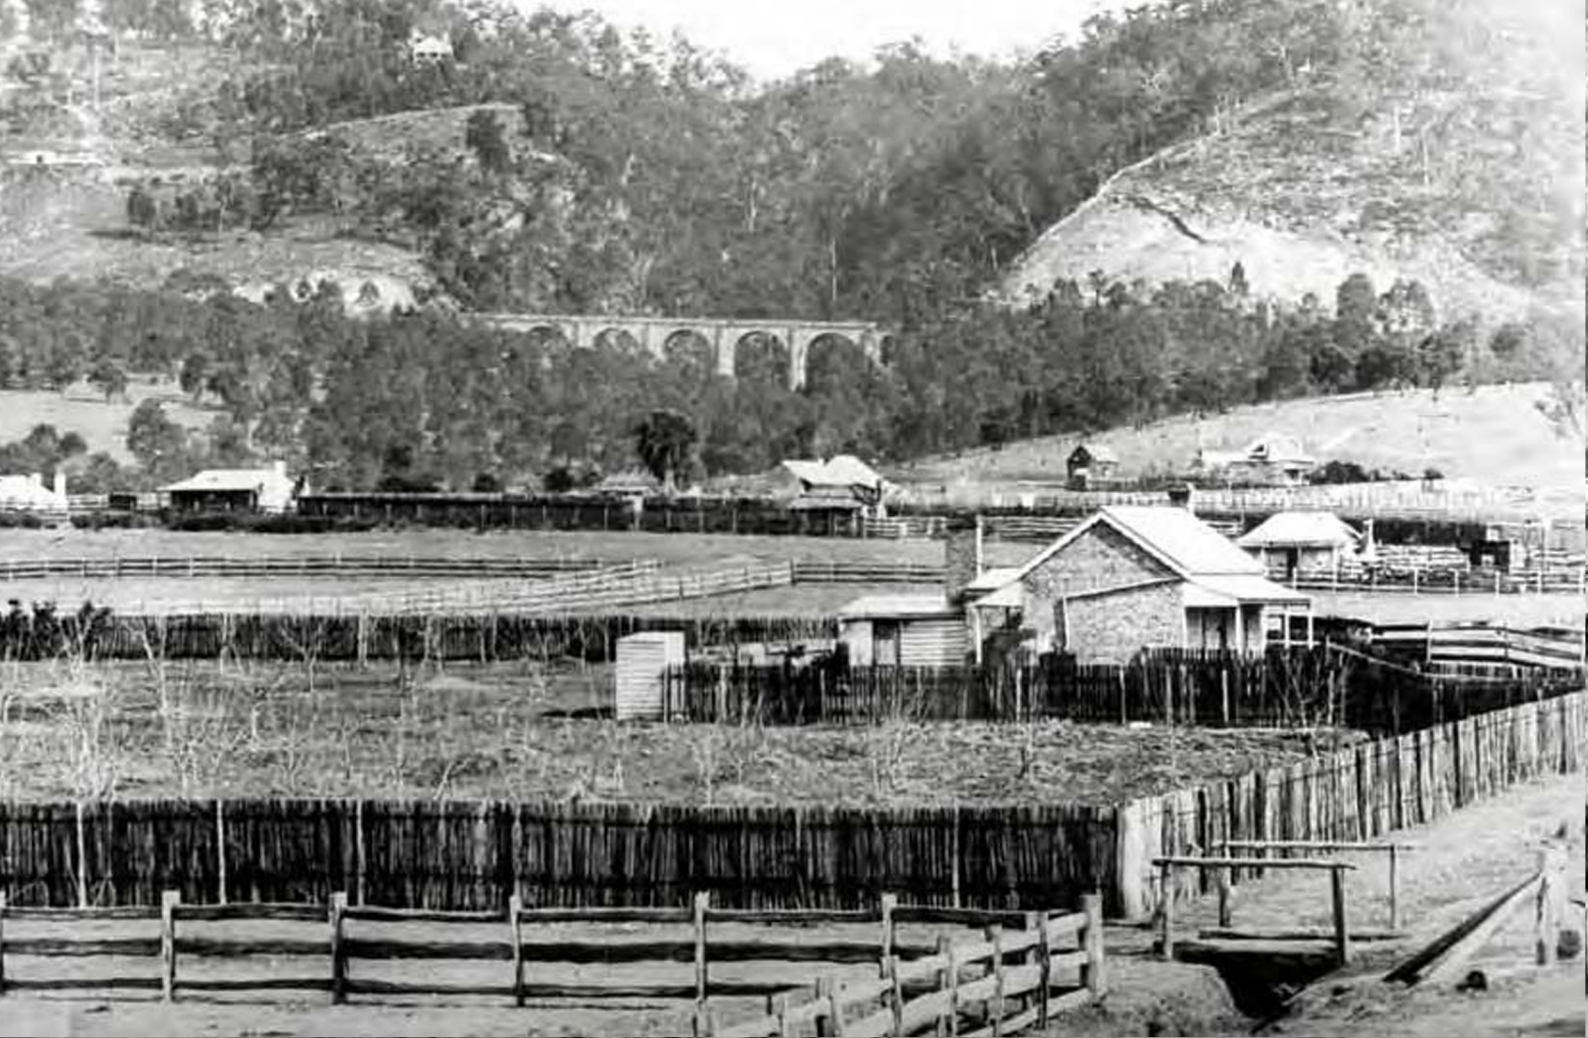
An early photo of Knapsack Viaduct. The end of Top Road on the Lapstone Zig Zag was located at the top of the cleared hill on the left hand side of the bridge. The landscape is vastly different today, the farmland in the foreground has given way to the suburb of Emu Plains and trees now block the view of the bridge from this angle. **ARHSnw Railway Resource Centre 51152**

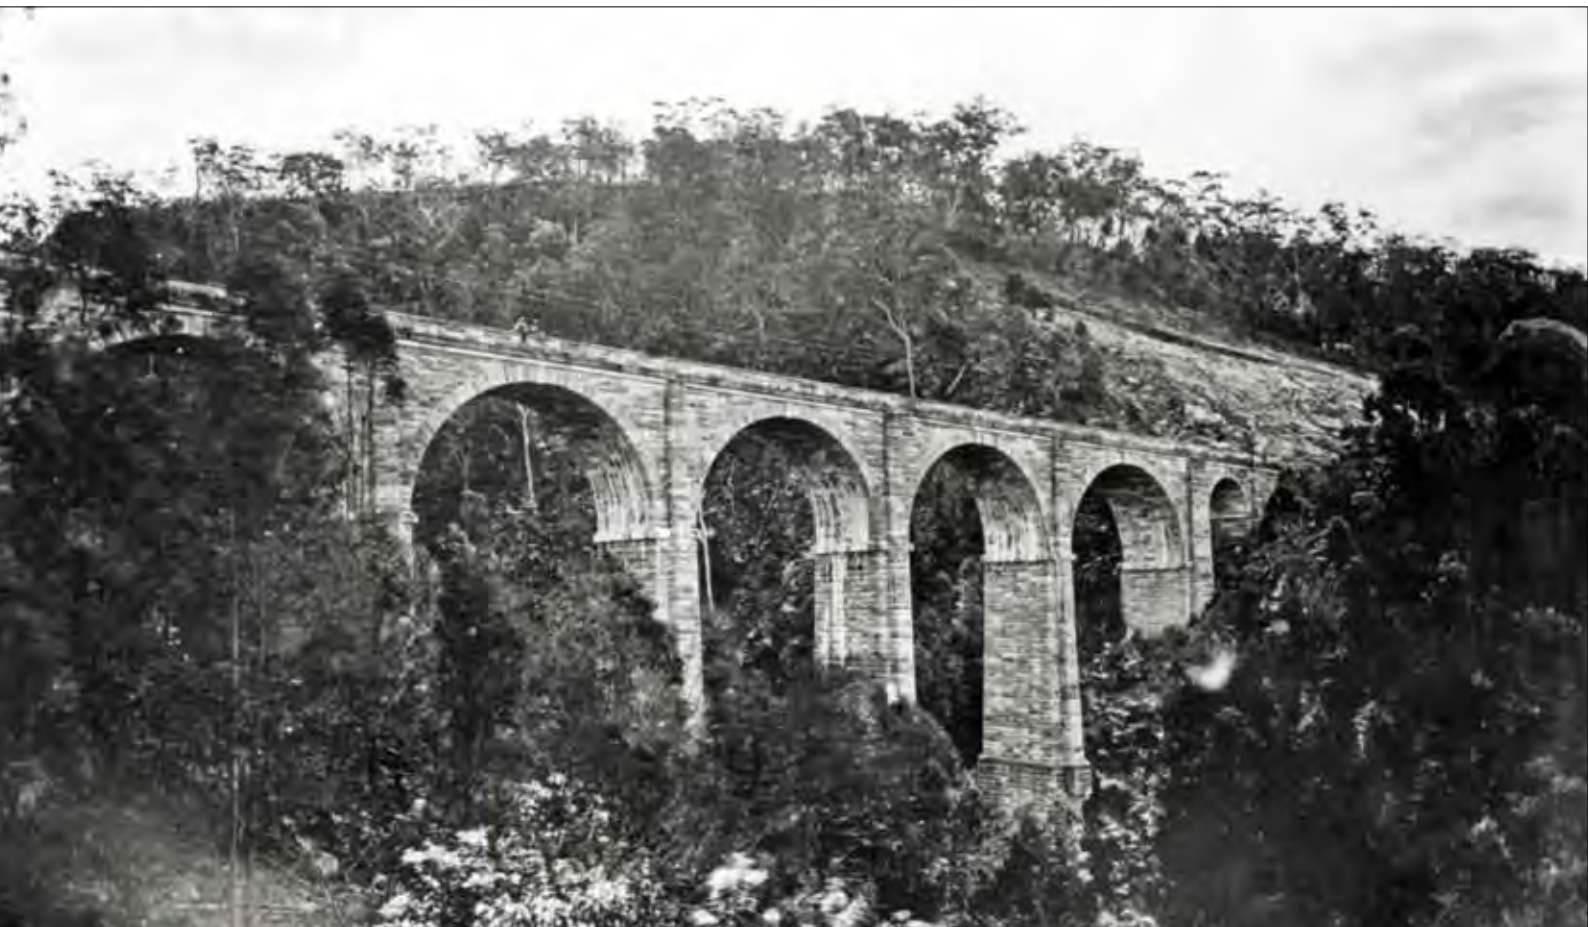
*Knapsack viaduct . The first Knapsack Block Post was located south (left hand end of the photo). The second site of Knapsack was located about four hundred yards to the right of the bridge. The Down Refuge Siding ended at the top of the gully on the extreme right of the photo. The bridge was widened when taken over as part of the Great Western Highway. N Thorpe collection ARHSnsw Railway Resource Centre 23764a*

Knapsack Gully was spanned by an impressive single-track bridge on a 1 in 30 grade, requiring 6,713 cubic yards of masonry in construction. It has five 50-foot and two 20-foot arches set in Portland cement. The structure is 388-foot long and 126-foot in height from foundations to rail level<sup>10</sup>. It is considered to be one of Whitton's finest bridge structures.

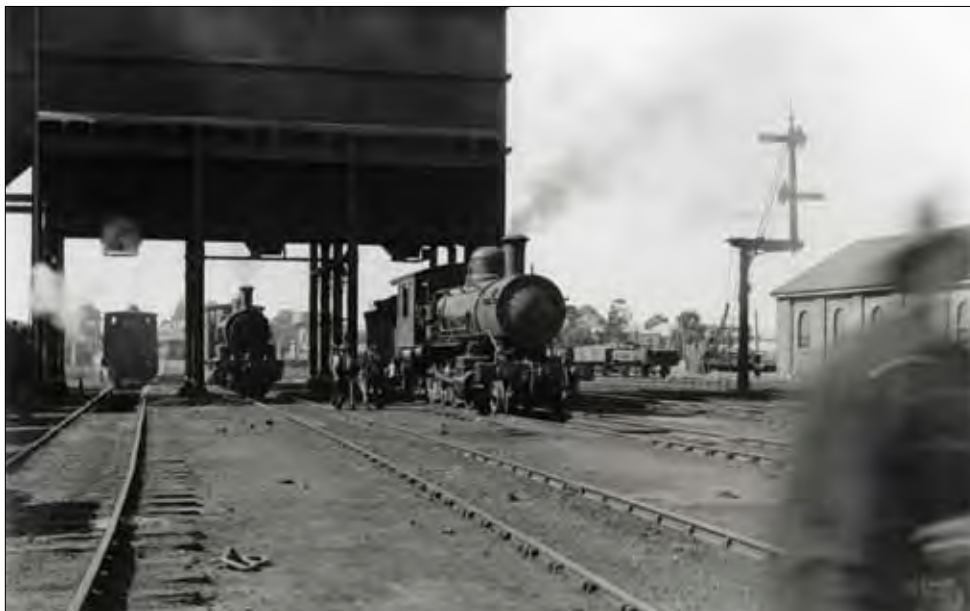
*An I Class and a T Class, plus J485 in Loco at Penrith 13 February 1909. Penrith at this time was still supplying bank engines for the steep climb through the notorious single line tunnel. Note the Penrith West Box Down Distant signal on the back of the Station Box Up Home signal—a fairly common practice of the day.*

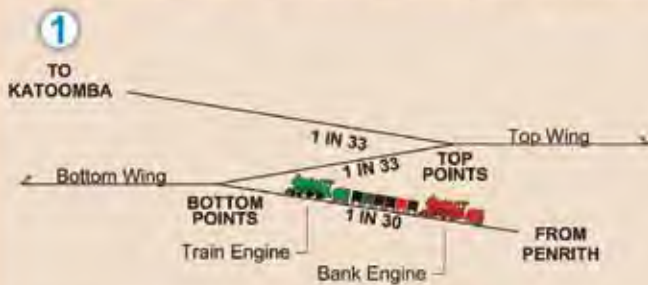
Goods train from Emu Plains assisted by a bank engine arrives clear of Bottom Points.

The method of working would have been as follows: (see diagram p392)

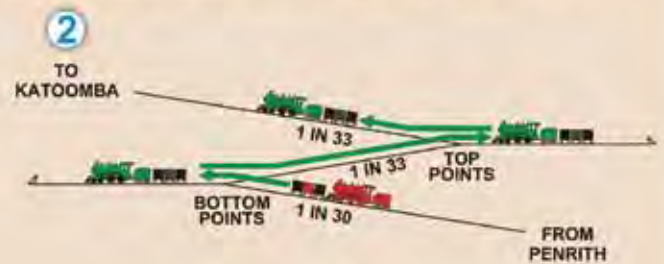
The train engine takes half the load into the Bottom Wing, propels it up the Middle Road into the Top Wing and then hauls the train onto the Top Road as far as the Advanced Starting Signal

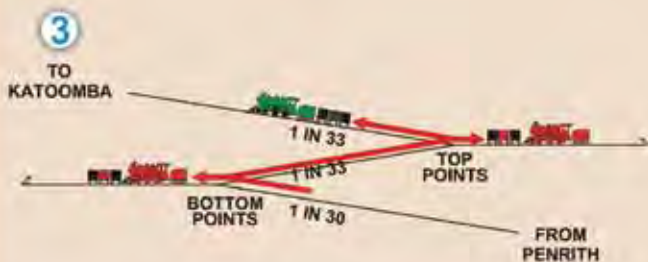
The bank engine propelled the rear half of the train into Bottom Wing. The train was then hauled up Middle Road engine first into Top Wing and then propelled onto the first half of the train.

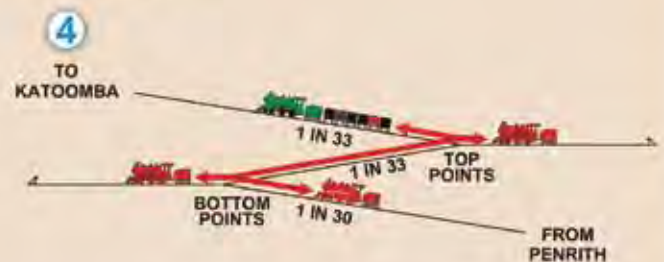
Once the two portions were coupled up the goods train then proceeded to Glenbrook as normal. The Bank engine then returned to Bottom points, reversed and proceeded to Penrith.

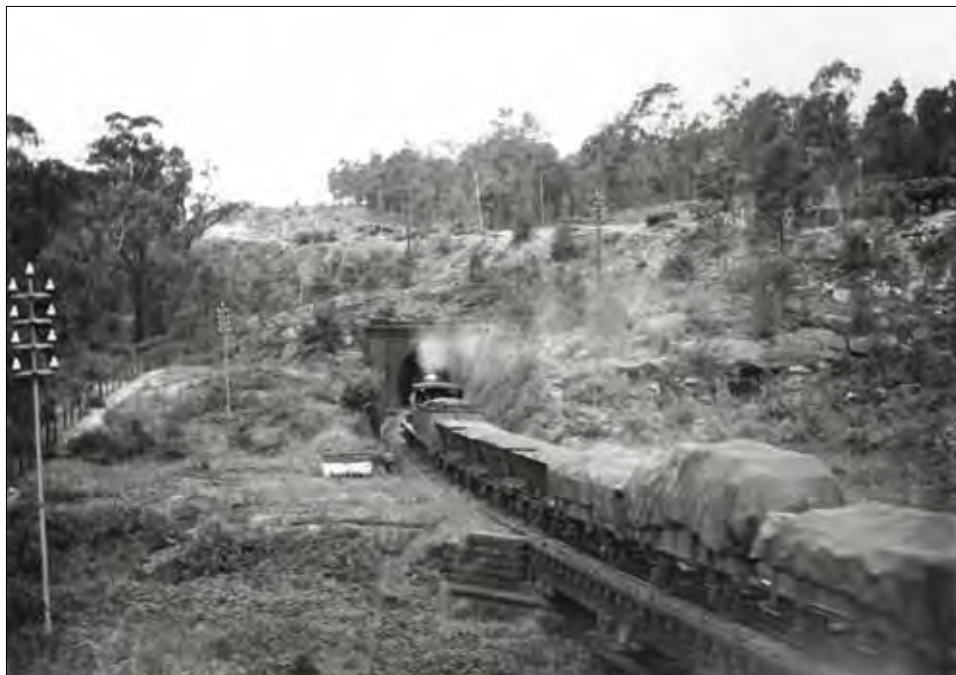
A T Class on an Up freight at the western end of first single line tunnel at Glenbrook, 23 December 1911  
O B Bolton, ARHSnsw Railway Resource Centre 23767

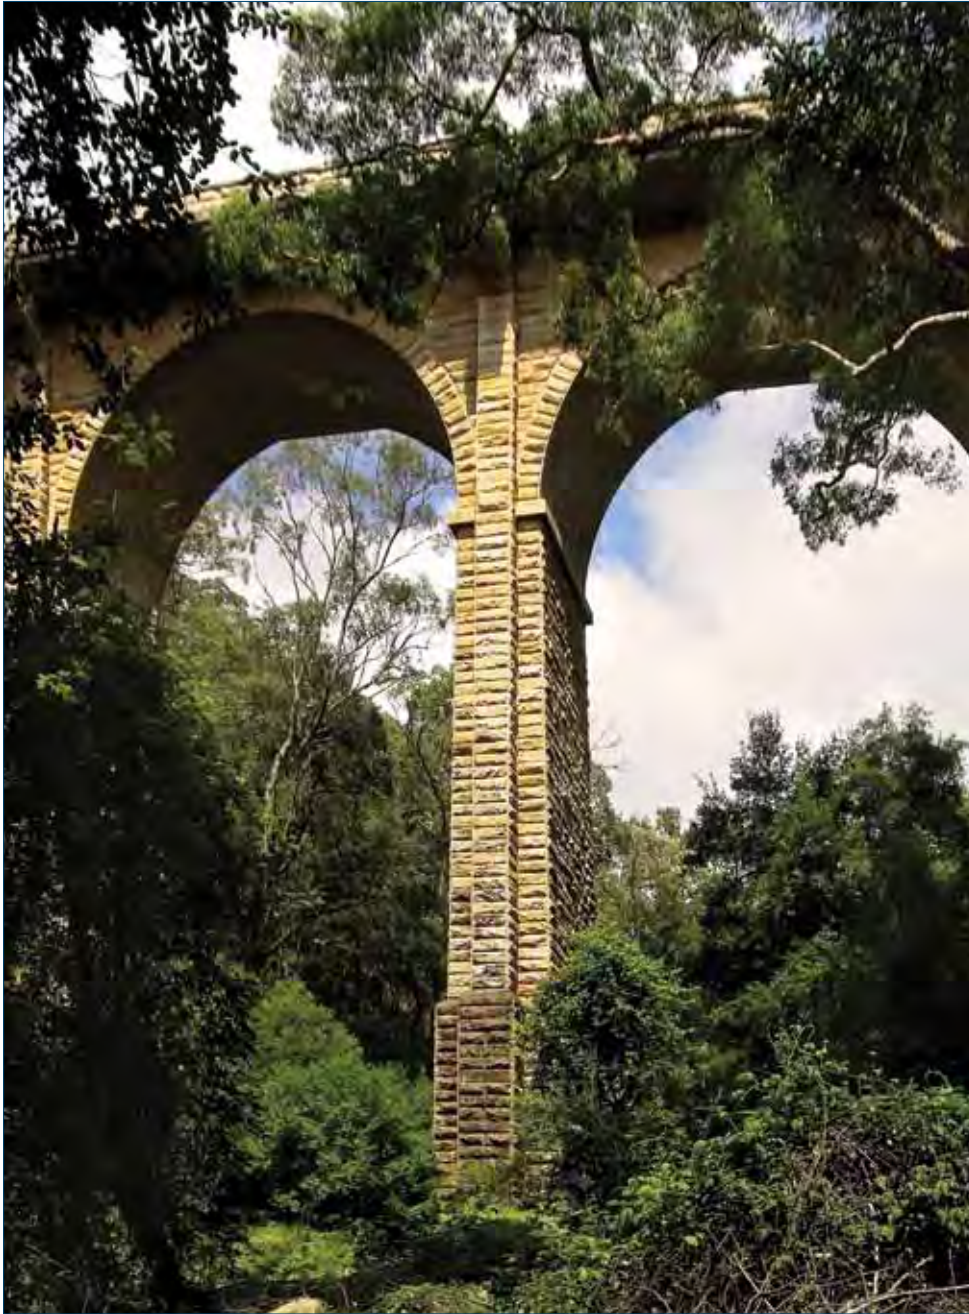
**Page 399 and left:** The arched, sandstone Bottom Road viaduct of the former Lapstone Zig Zag, as it appeared on Tuesday 13 January 2009. The nearby lower viaduct remains part of the current day Main Western Line between Emu Plains and Lapstone. The older bridge is now accessed only by a public walking track—although it was, for around sixty years, part of the Great Western Highway, before that road was deviated during the early 1990s.

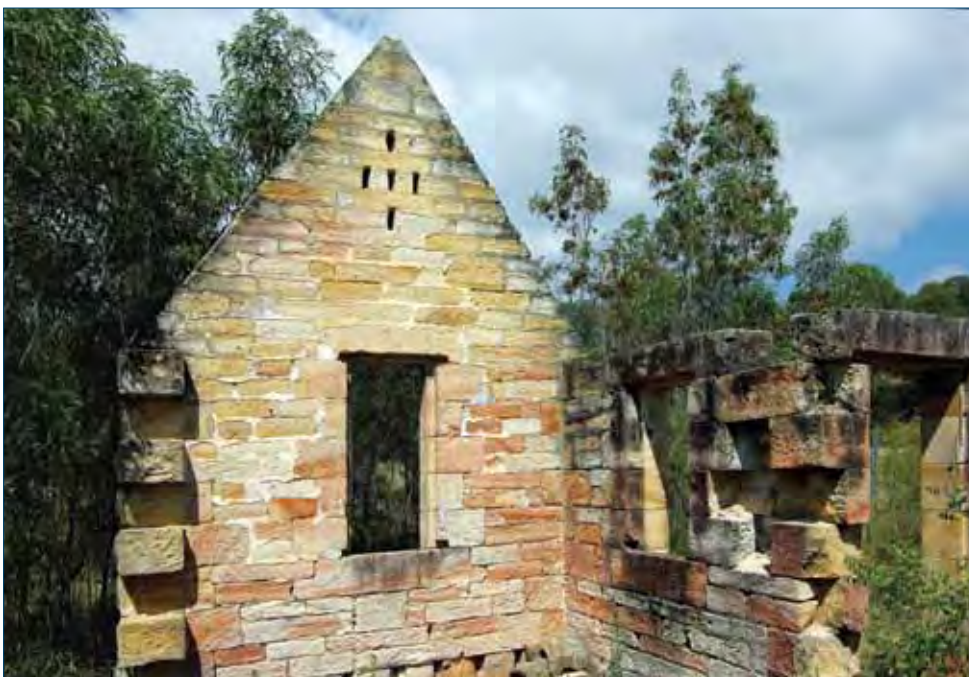
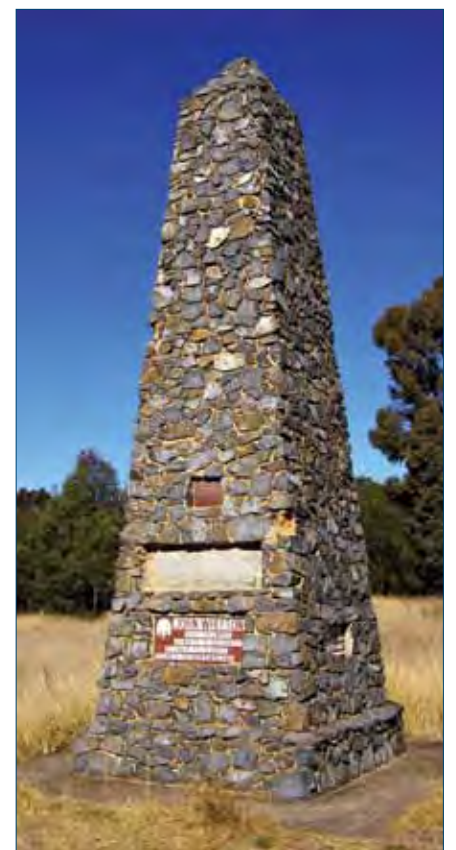
**Below:** The John Whitton monument on 13 August 2008. The plaque records “John Whitton—Built railways Penrith to Bathurst, Sydney to Albury, Sydney to Queensland”. A separate plaque on the side of the obelisk also reads “In memory of men who worked with Whitton”. This memorial, and the adjacent Gate Keeper’s Cottage ruins (see photo, below left), is located where Bathurst Road (Mitchell’s Pass) crossed the single line. The second site of Knapsack was located a hundred yards or so to the south of the Whitton monument. The present line passes behind the ruins and crosses Mitchell’s Pass by a bridge.

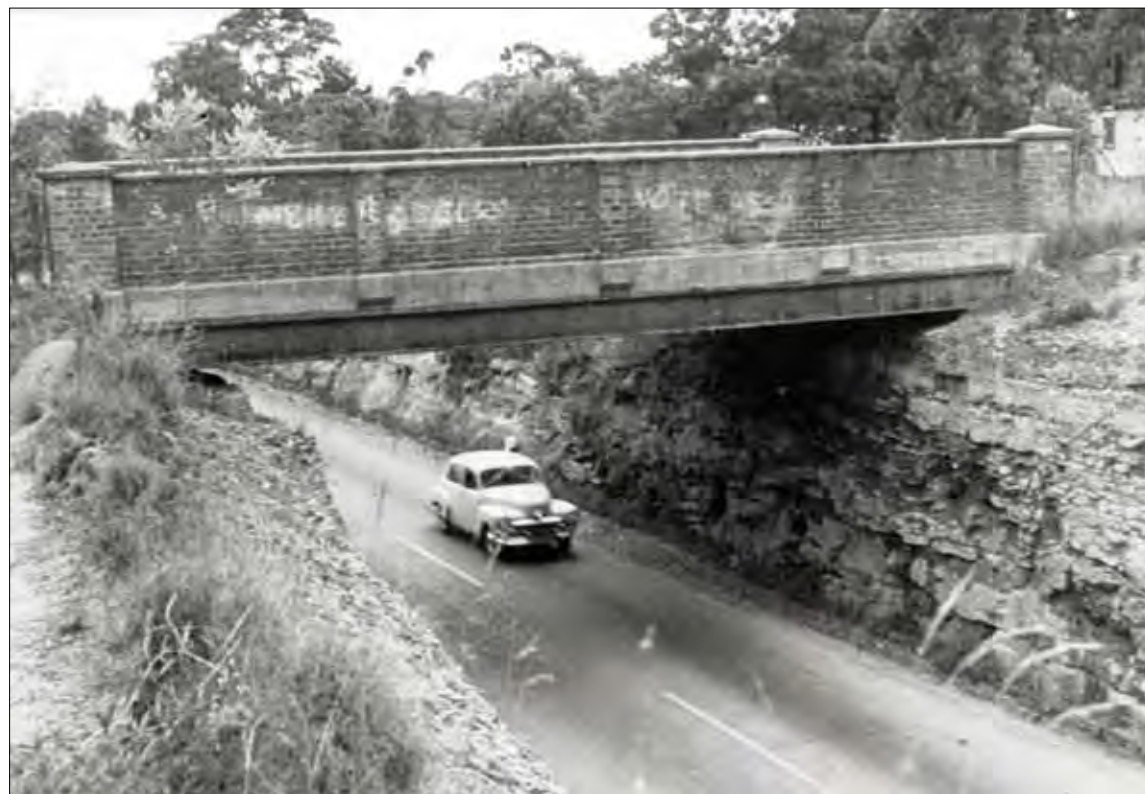
*The Great Western Highway took over the old rail formation from about the present RAAF base to Blaxland. This photo is taken just west of the site of the first Glenbrook. The bridge and cutting lasted until the early 1980s when the highway was widened to four lanes and a new roadbridge was constructed.*

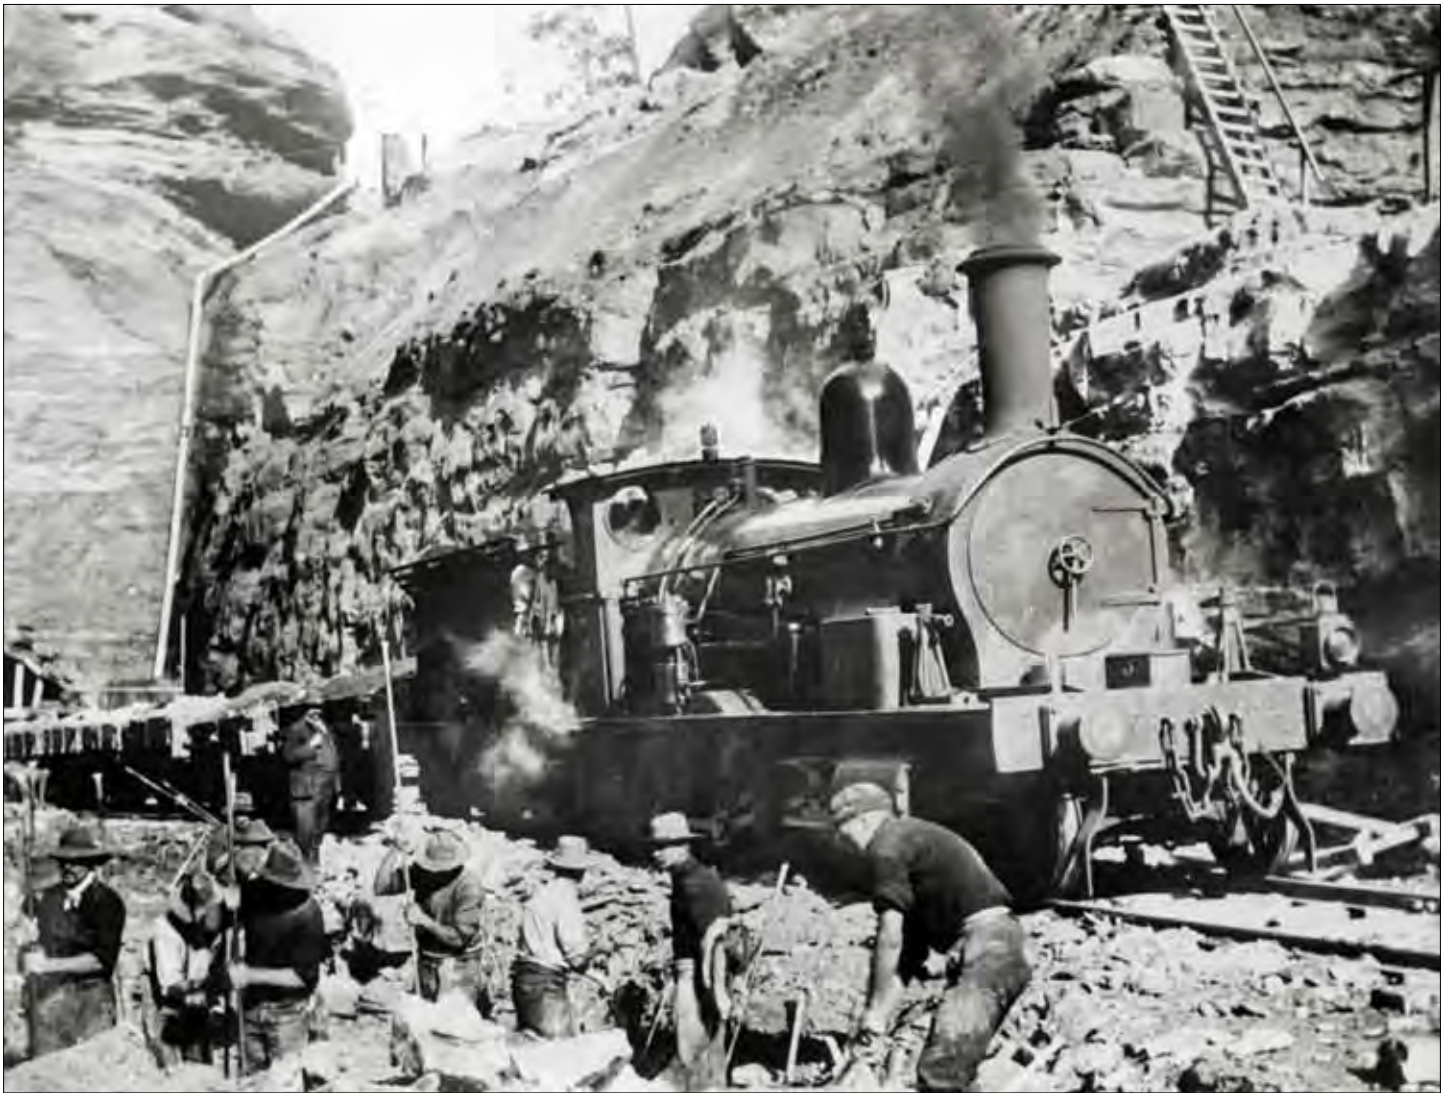
*A scene during the construction of the 1913 deviation. As many as fourteen hundred men worked on the deviation, many arriving after completing the deviation around the Lithgow Zig Zag. B205 (later Z25) Class 2-6-0, 327, is seen here during the Glenbrook Tunnel construction.*

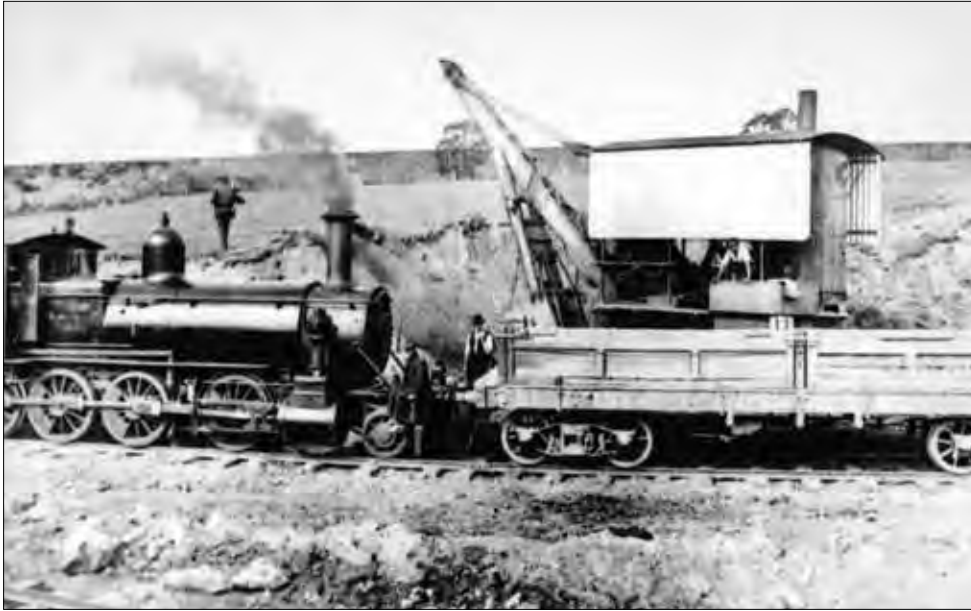
A Ruston steam navy appears to have been used here for the first time in NSW. This is a 2-8-0 tender type locomotive, one of the Baldwin-built 131/J131/X10/Z28 Class locomotives. It would have been on the Glenbrook Gorge deviation construction branch.

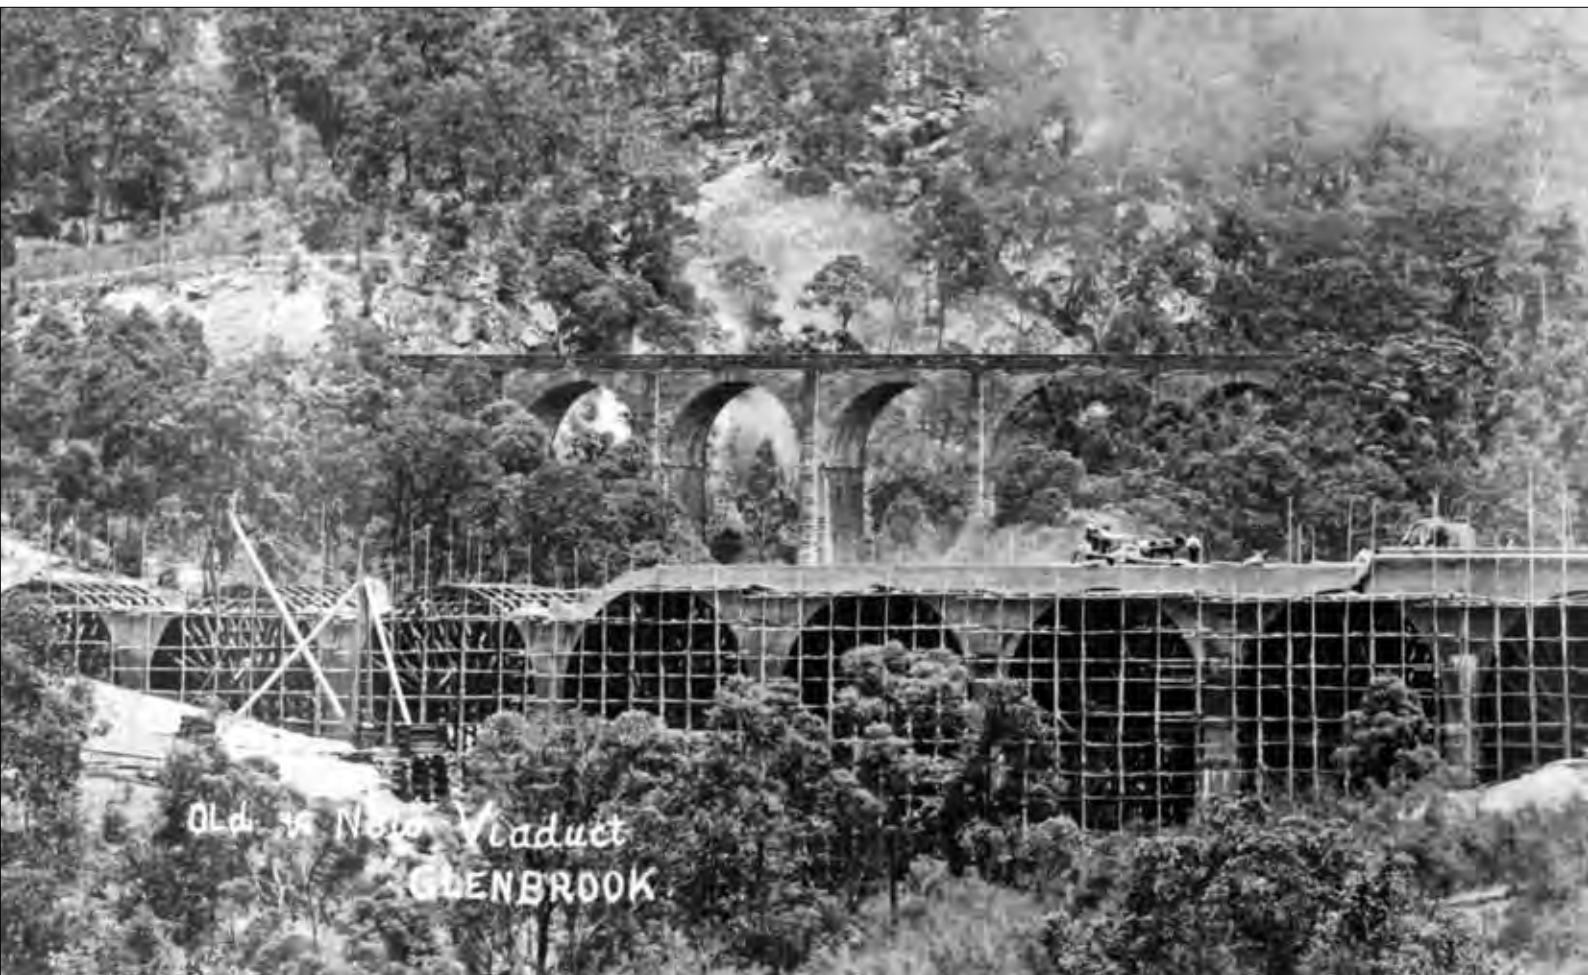
*Old Knapsack Viaduct with new viaduct under construction circa 1911.  
N Thorpe collection, ARHSnsw Railway Resource Centre 23764b*

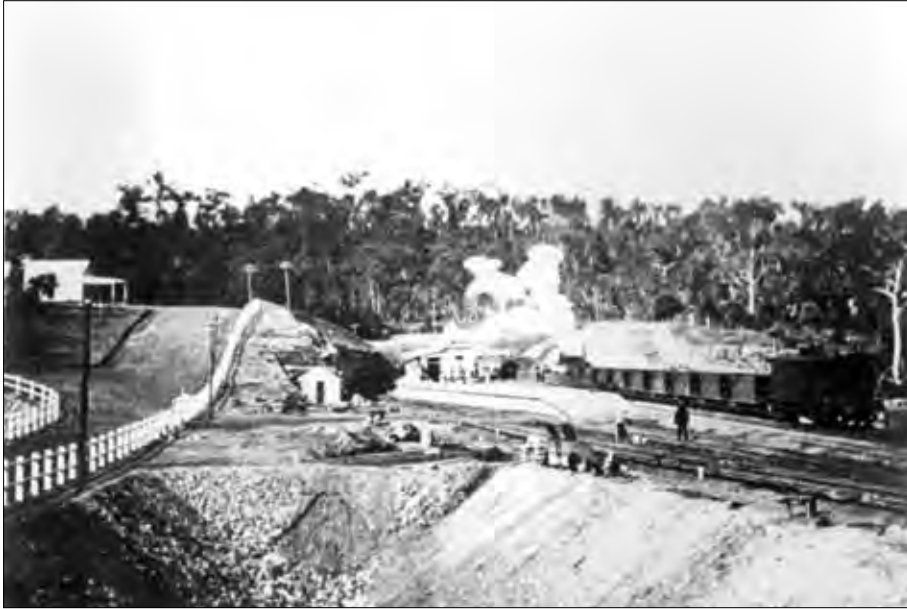
*The new Glenbrook Station on the second deviation. This view was taken from the west, and the short goods siding is in the foreground, while the recent earthworks and the positioning of the ballast train in the wrong direction suggest that work may have still been in progress.*

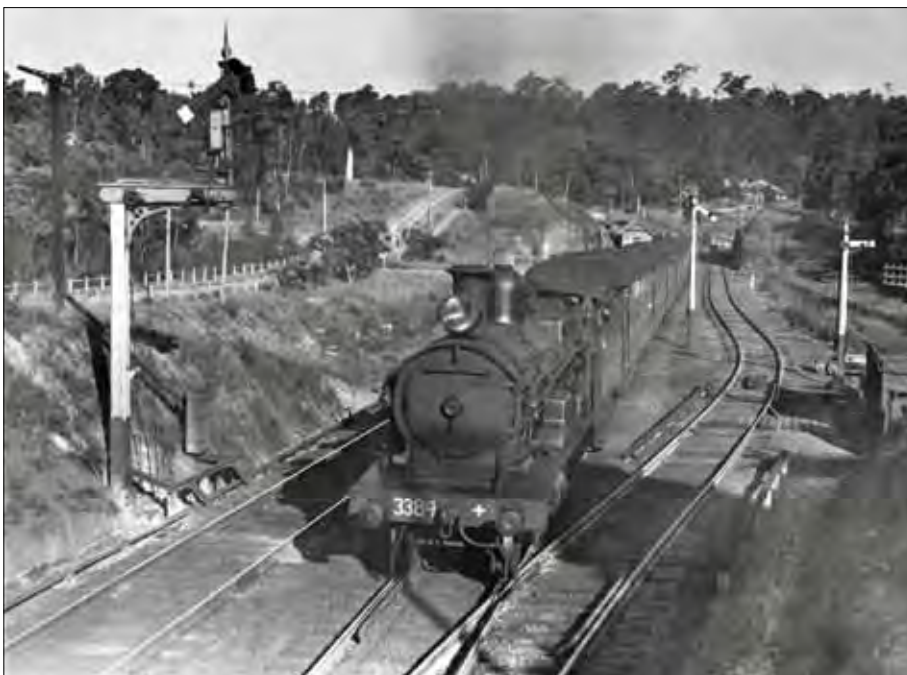
*3384 hauls a Down passenger train through Glenbrook during 1935.*

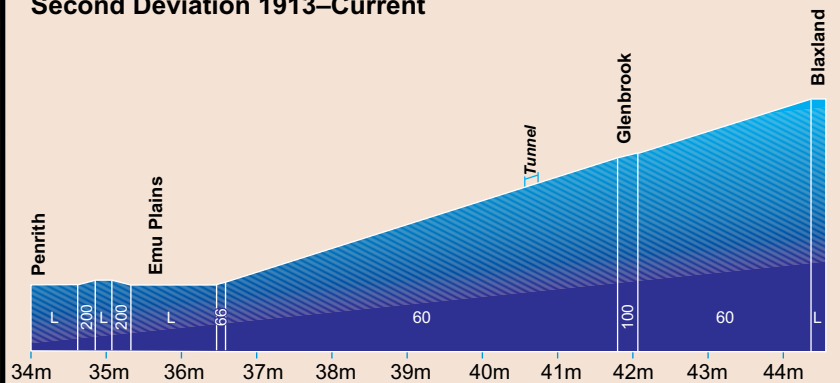
Second Deviation 1913–Current

The diagrams on this page have been revised from the originals drawn by C C Singleton in issue 227, September 1956 ARHS Bulletin.  
© ARHS 2009 Bob Stack

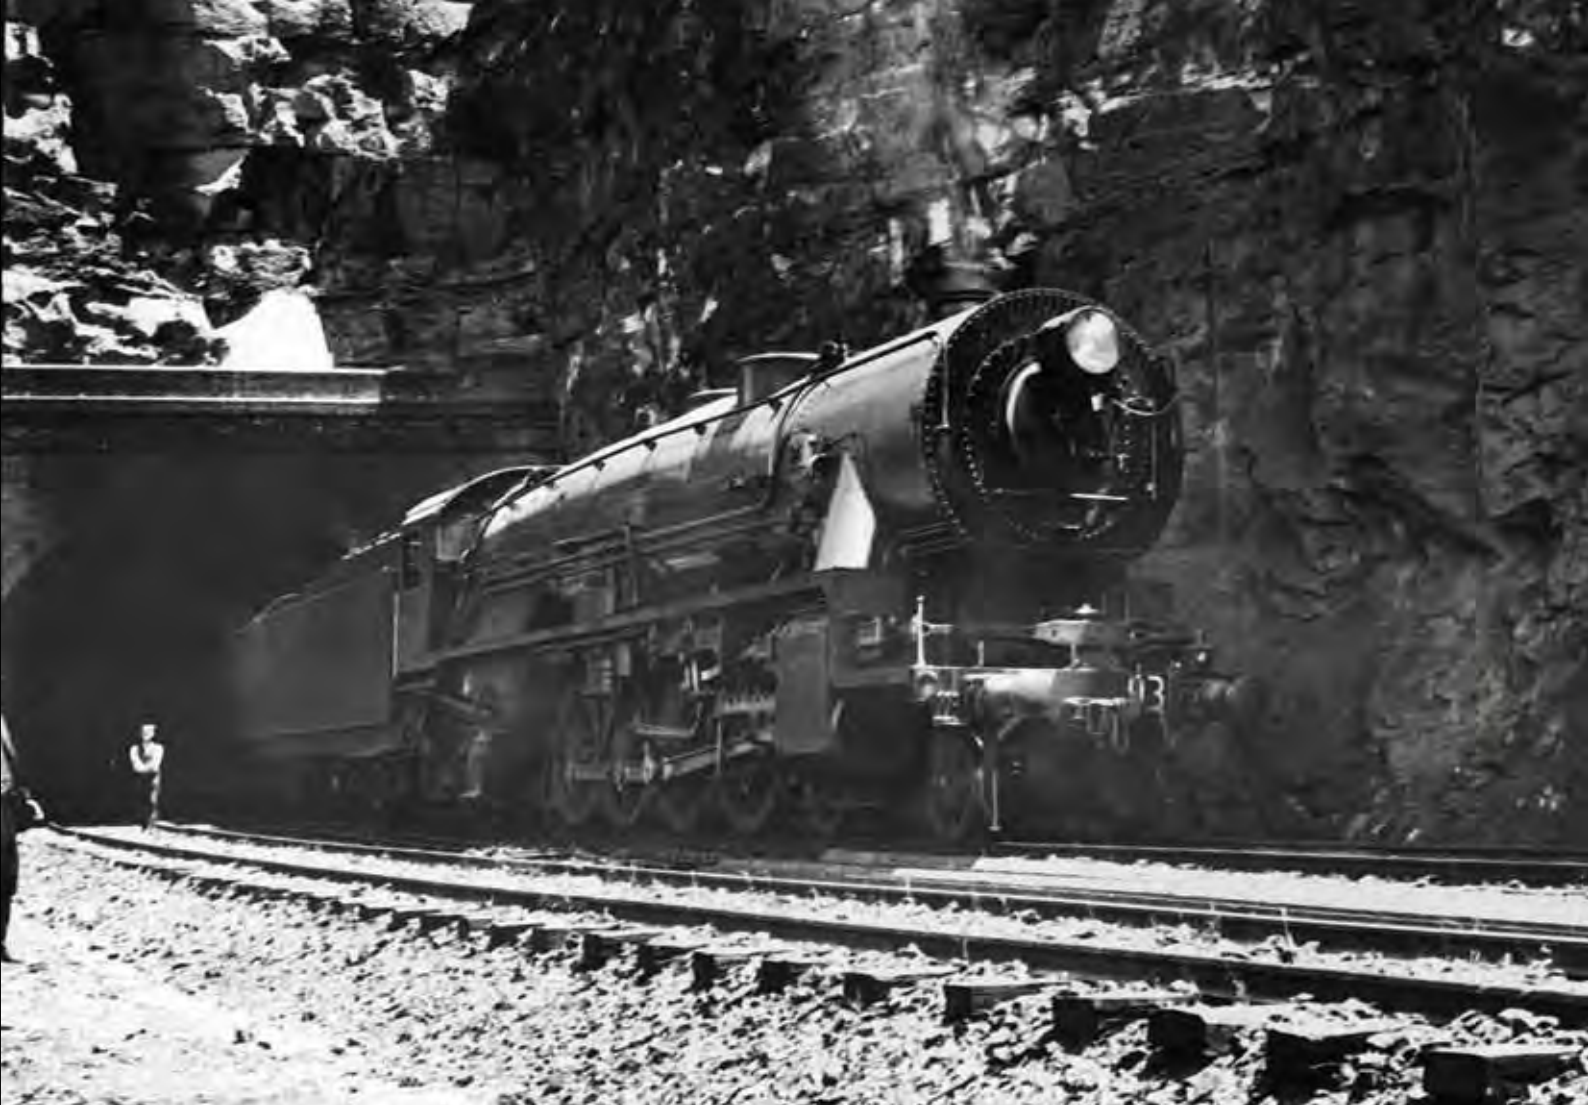
*Then new 4-8-2 'Mountain' locomotive 5703 exits Glenbrook Tunnel with an Up Goods on 30 October 1929.*

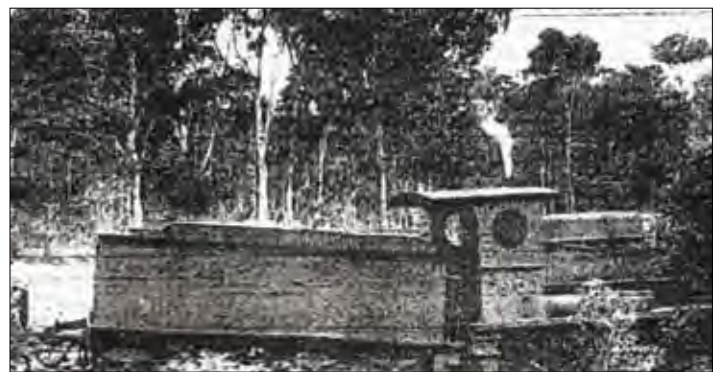
*In January 1926, 5365 and a wagon ran away from Falconbridge as a result of a broken coupling and the driver falling out of the cab. The train reached an estimated speed of fifty miles per hour through Springwood. It was stopped by being routed into the 'head-in' refuge siding at Blaxland Junction. This Siding Formed Part Of The Original Main Line.*

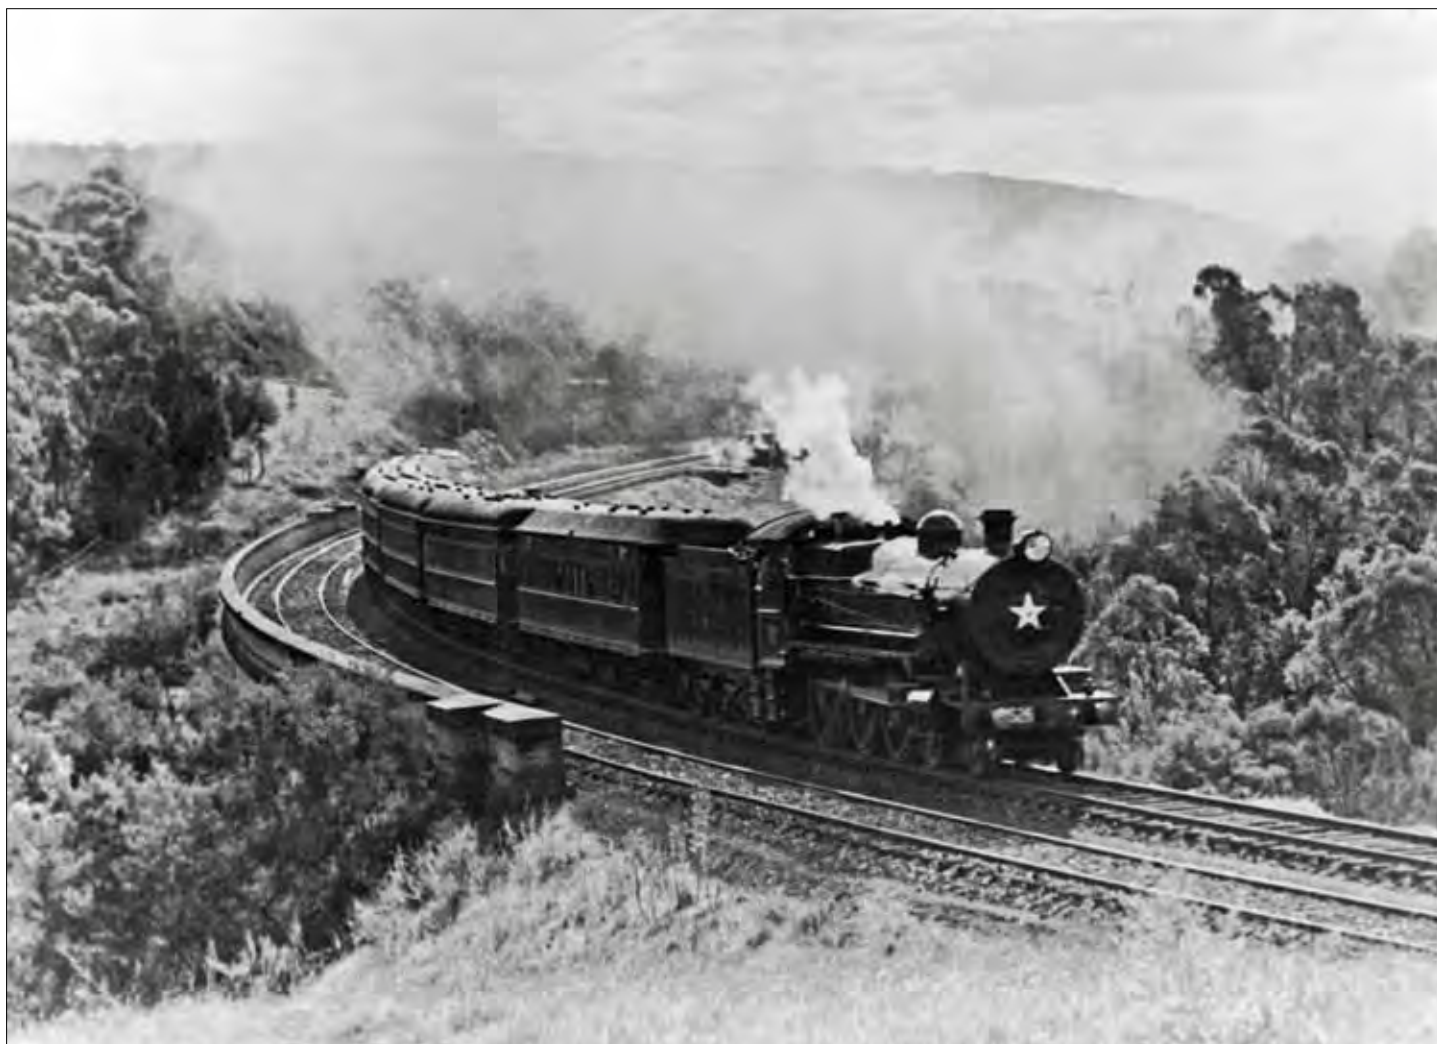
3526 hauling the Caves Express over the new Knapsack Viaduct on Lapstone Hill.

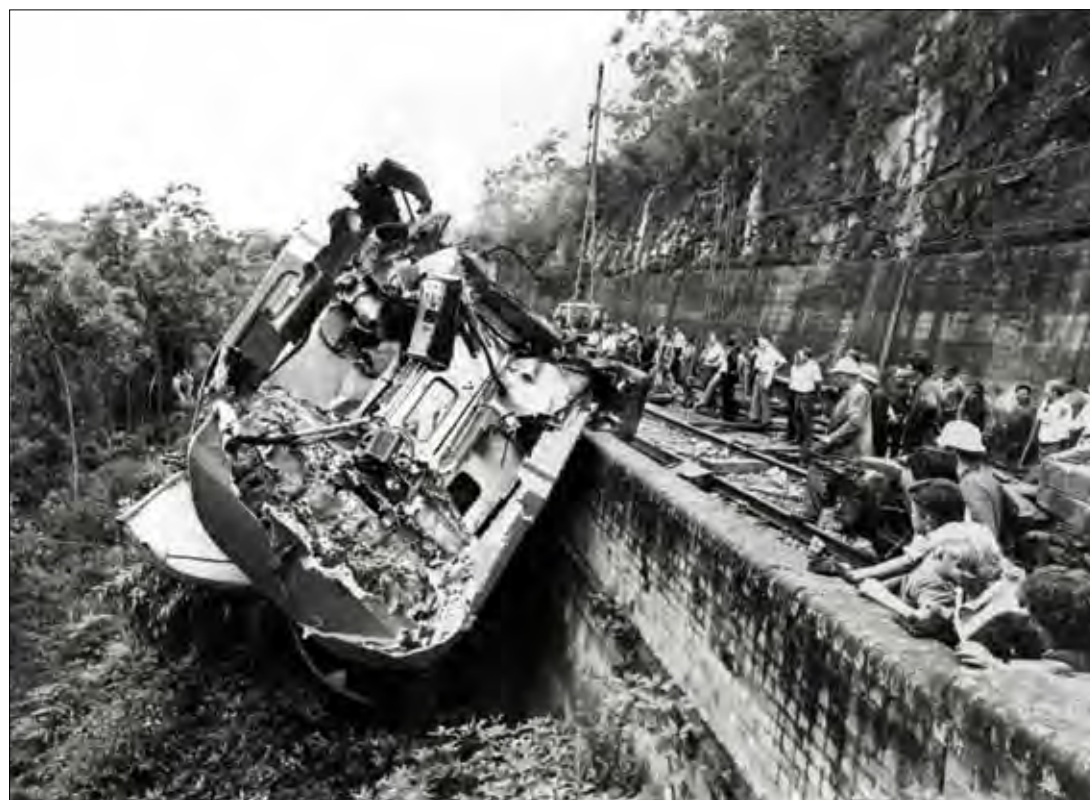
On 16 January 1976, 21.30 Sydney–Mount Victoria Interurban train stalled outside Glenbrook tunnel and was hit in the rear by 4622 hauling 20.20 goods, Darling Harbour–Orange at 22.45. Double-deck car DCF8004 is seen here being rolled over the embankment in an effort to clear the Main Western Line.
