# ***COWAN RAILWAY STATION***

**A CASE STUDY IN DEPARTMENTAL FRUGALITY,  
WITH A TWIST OF WASTE**

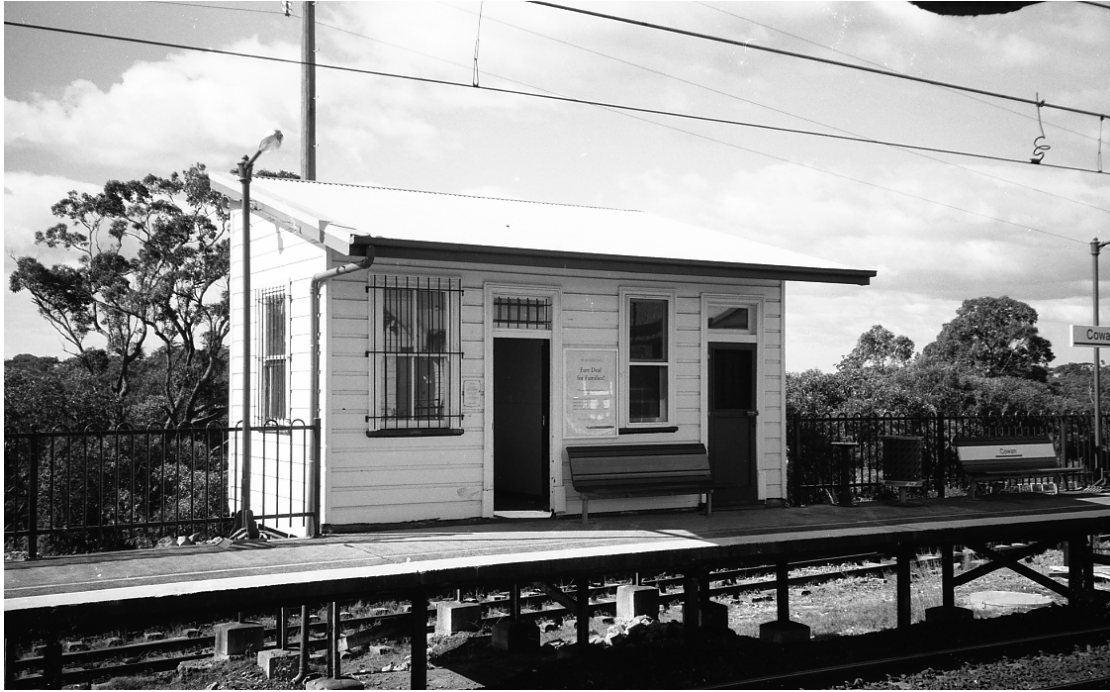
*This 1996 photograph of the southbound platform building shows the relocated waiting room with the subsequent addition of an office/ ladies' waiting room on the righthand side.*

After the opening of the station in 1901, the next big event was track duplication which occurred in 1909. In May 1908, a plan was issued for the relocation of the then existing two room structure on the northbound platform, containing an office and waiting room, to the southbound platform. The former office was converted into a ladies' waiting room. That structure is possibly the original station building dating from 1901 and the early origin of the structure is reflected in the use of wide weatherboards; the fluted timber door frame; the rusticated weatherboards on the external walls and the absence of ornamentation under the window sill. The waiting shed, with its replica (but fake) internal seat, remains in position in 2022. It was in 1909 that the second platform was provided and, like the one built for the station opening in 1901, it had a frame of timber with a timber deck. Frugality was demonstrated in the extensive use of timber and the reuse of an existing structure.

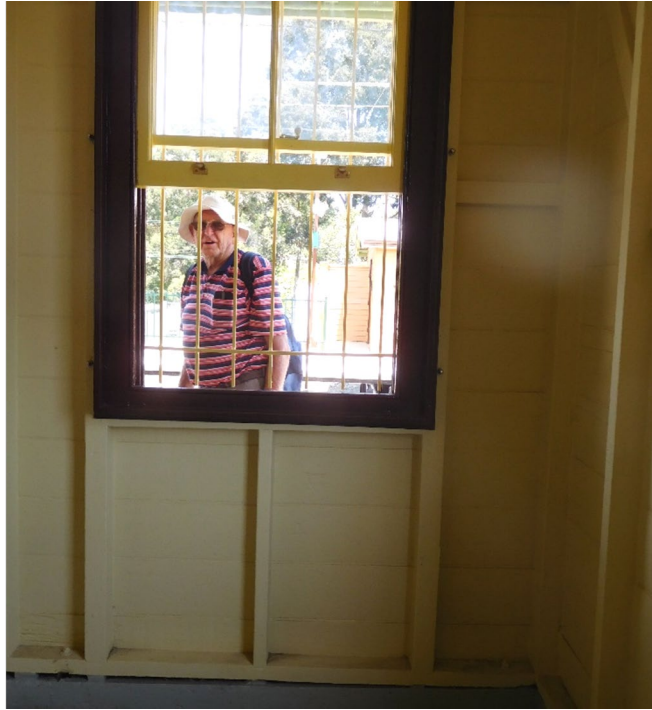
*The platform buildings have received the attention of Sydney Trains. This image shows the authentic treatment of the internal walls of timber platform buildings throughout the rail system between 1890 and 1931. Timber framing was sheathed externally but without internal walls. However, not all the fabric on display in 2022 is authentic. The seats inside both the waiting sheds have the appearance of authenticity but are fakes. Life Member, Gary Hughes, spots one of the fake seats. He enquires, unsuccessfully, as to the location of the interpretive plaque. Taken on 18<sup>th</sup> December 2019.*

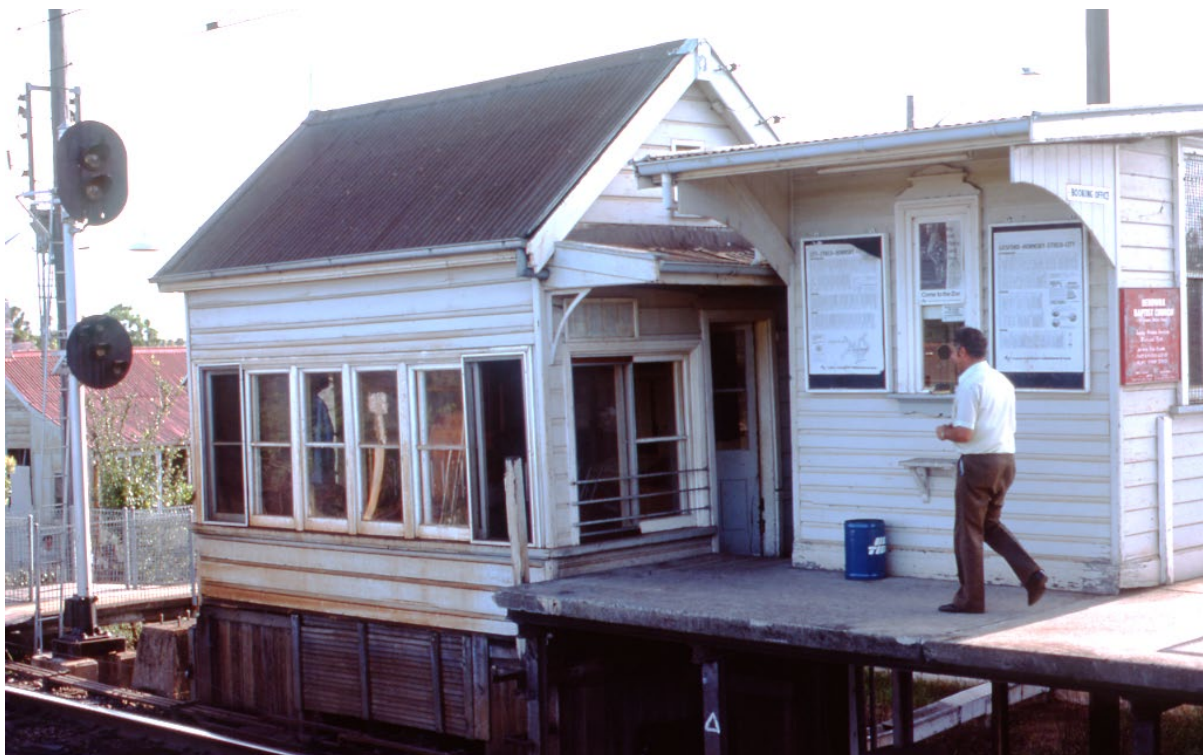
*The above photograph of the signal box and ticket office dates from 5<sup>th</sup> February 1977. The external walls of the ticket office featured two types of weatherboards – rusticated on the front wall and lapped on the side wall. The timber moulding surrounding the ticket window was very decorative. The blue “Be Tidy” rubbish bin was typical of the times. Note the shelf below the ticket window so that ladies could rest their handbag while they secured the correct money for their ticket. Those were the days when bureaucracy cared a little bit about their customers. The photograph shows a local resident walking towards the open door of the signal box to determine from the Signaller whether his intended train was running on time.*

The now demolished signal box was located at the south end of the Northbound platform. The floor of the box was below the platform level from the time of the platform reconstruction in 1959. When the platform was provided, the floor of the signal was consistent with the then height of the platform. This is clear in the photograph on page 12. Bob Taaffe points out that the Signal Engineer at the time would not have paid too much attention to the height of the platform had there been an existing platform because signal boxes and platforms were managed by different branch of the organisation. Bob states that the height of the signal box was pre-determined because there existed a standard height of platform level signal boxes, notwithstanding the provision or otherwise of a platform.<sup>5</sup> The signal box came before the platform by 12 years. The raising of the platform in 1959 created a vertical difference between the signal box and the platform.

The frugality of the signal box, which dated from 1889 at the time of the opening of the crossing loop, was reflected in the absence of an awning over the windows facing the railway line. Behind the signal box in later years was an electrical relay building which was timber framed, clad in Fibrolite and, seemingly inconsistent, possessed a roof covered with terracotta tiles. Certainly, the use of tiles was not an expression of frugality but it was an expression of the virtual autonomy of the branches of the Railway organisation to spend and, in this case waste, money without accountability. A significant number of relay huts were built wearing an inconsistent combination of frugal wall material and extravagant roof material. Bob Taaffe defends the Signalling and Telegraph Branch by suggesting that “the terracotta roofs of relay huts may have also been to reduce the heat load on the relays”. Cowan was one of those examples and Bob Taaffe has a photograph (on page 241) of the signal box in volume one of his multi-volume work on signal boxes.

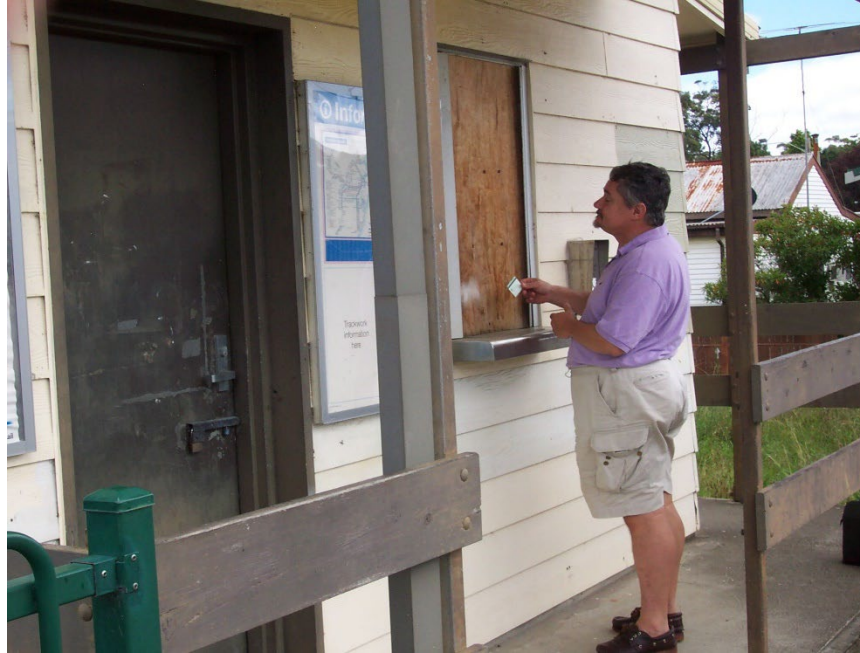
*Taken on 23<sup>rd</sup> February 2008. Member, Jim Longworth, stands at the former ticket window in the ticket office, seeming to have received his ticket through a mysterious, super-natural force, known as modern technology, that could penetrate Plywood. The window has since been removed and the ticket office repainted. The 1891 residence is to the right of the image. Note the replacement timber sheathing on the walls.*

Adjacent to the signal box on the northbound platform was a timber framed and timber clad ticket office with the ticket window facing directly onto the platform. The location of a ticket window facing on to the platform was not too unusual for a very small, insignificant station as Cowan was.<sup>6</sup> It had a single-pitched roof sloping to the rear. The juxtaposition of the signal box and the ticket office was a reflection of frugality, and also of good sense, in that it allowed one person to both work the interlocking frame and undertake coaching business. Had the signal box being located at the platform level, perhaps a ticket window would have been placed in one wall of the box, thus avoiding the need to construct an additional building.

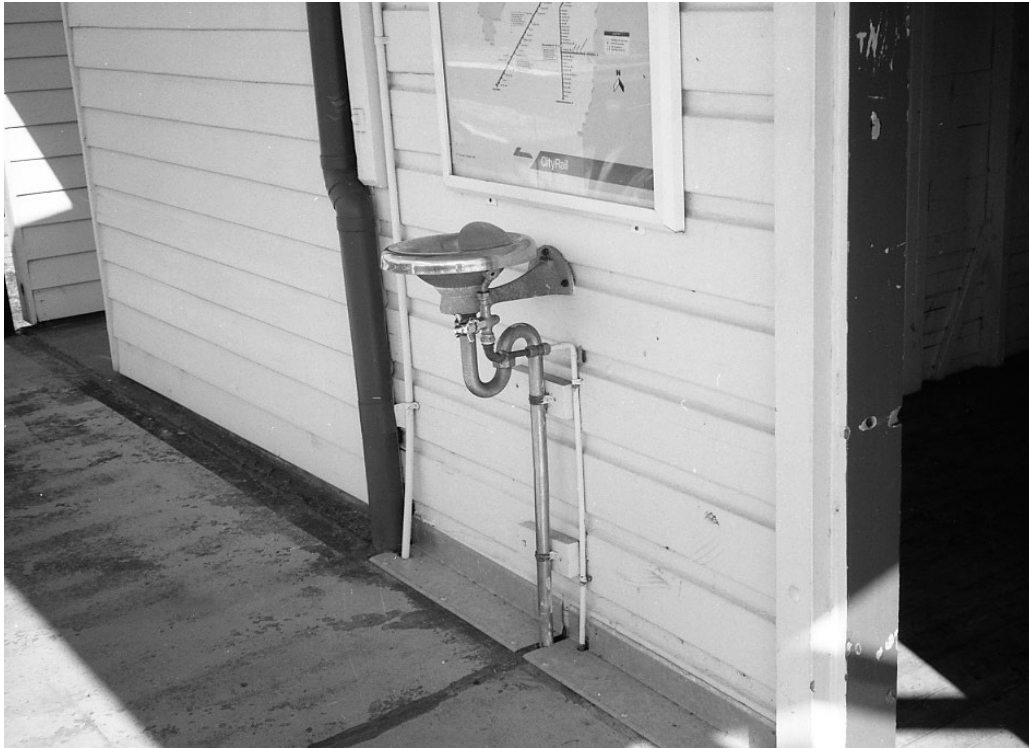
*This photograph shows the different types of weatherboards. The older boards are those on the right with a shaped profile, which the Railway Department called rusticated, on the northbound waiting shed. The newer boards, called lapped, have been used on the male toilet.*

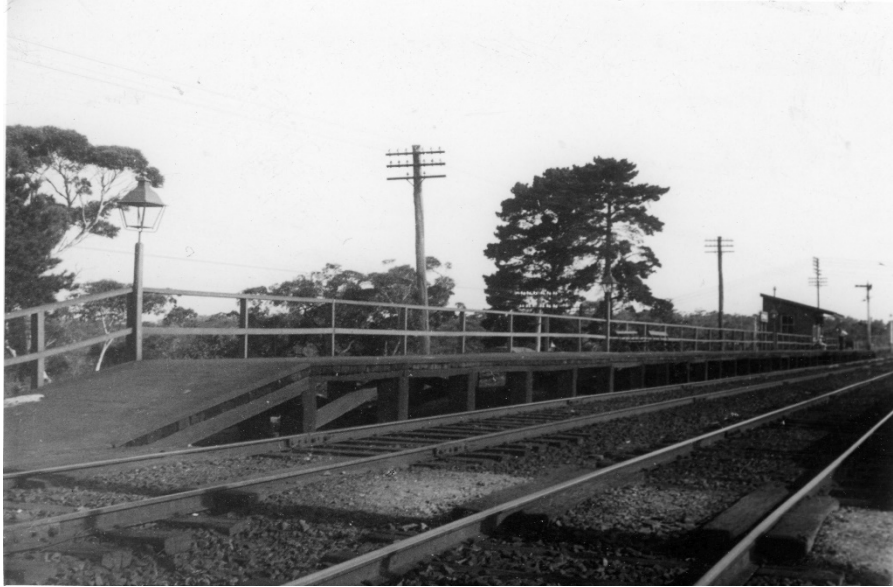
*This photograph has been taken from the north end and shows the southbound platform. The deck of the platform has been raised. A kerosene fuelled light has been thoughtfully placed at the end of the platform to facilitate pedestrian access across the tracks. **SOURCE:** Photograph by R. B. McMillan on 10<sup>th</sup> February 1949 No. 000147 ARHS collection.*

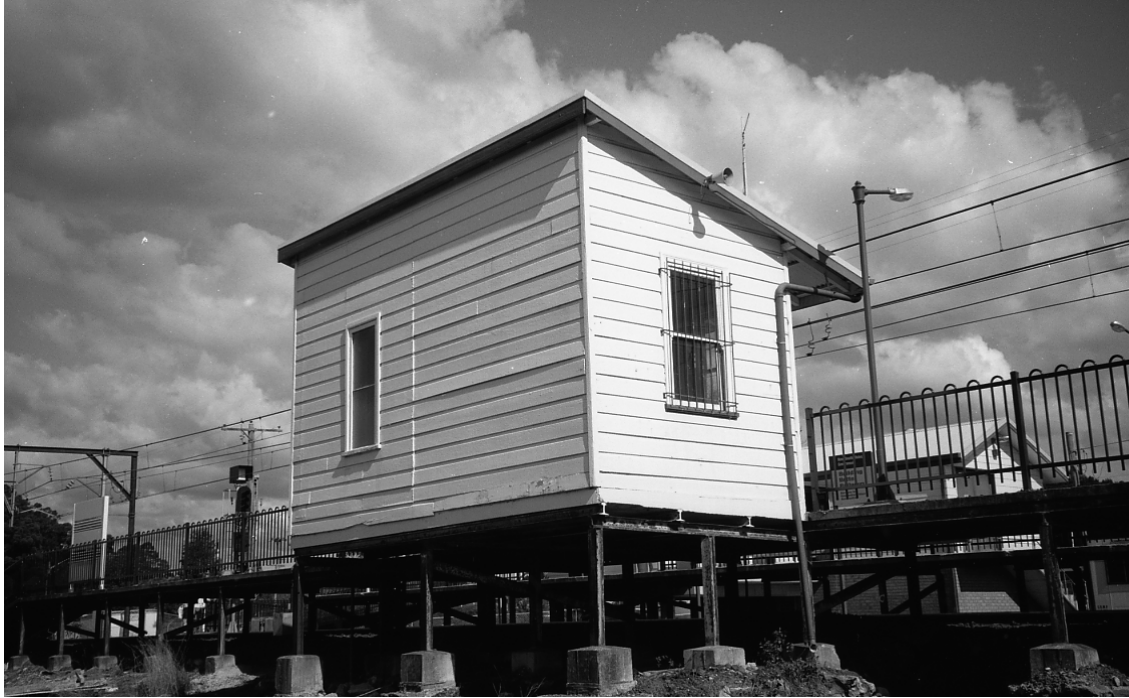
*This photograph of the rear wall of the southbound platform building clearly shows the vertical join between the 1901 waiting shed and the subsequent addition of the office/ladies' waiting room, which is identified by the rear window. The building was raised in 1960 to meet the new platform height.*

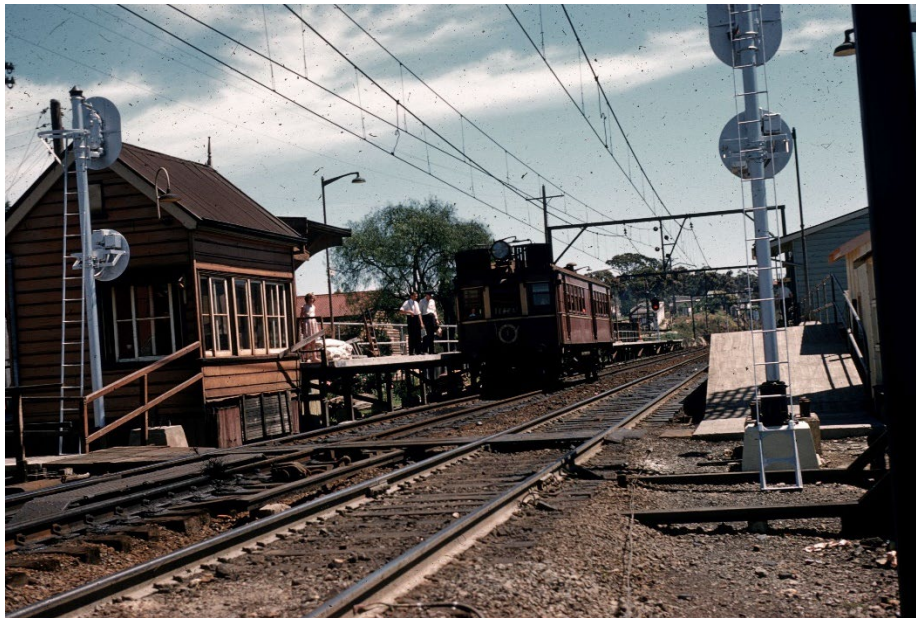
*This photograph has been taken, allegedly, one week before the opening of electrification and shows the signal box and the residence, mostly obscured, painted in the old stone colour scheme while the waiting shed on the southbound platform has been painted in one of the post-1952 pastel colours. Both platforms have been renewed using a substructure composed of old*

*railway lines with concrete decks. Pedestrian access between the platforms was primitive.*  
**SOURCE:** Photograph by Peter Sage on 9<sup>th</sup> November 1958 No. 553146 ARHS collection.

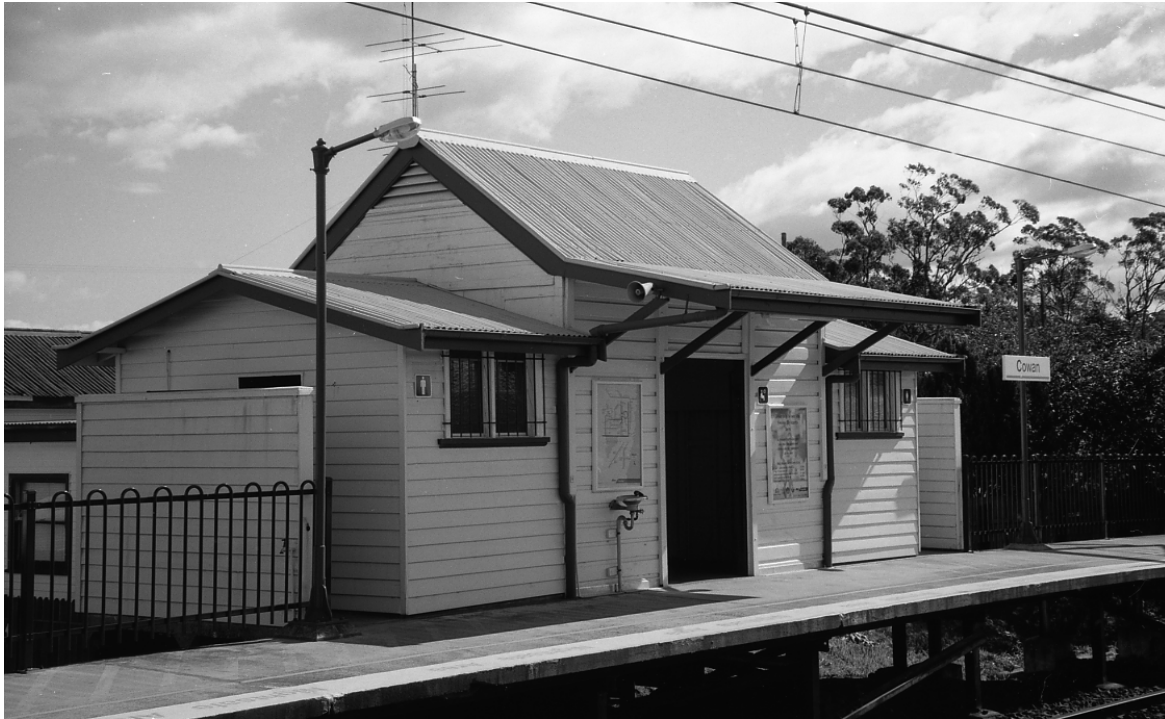
*The 1961 toilets added to each side of the 1909 waiting shed. It was policy on the New South Wales Railways to separate the toilets for the two sexes to minimise loitering by men outside the female facility. This was achieved in this instance by placing them either side of the then existing waiting room. Men are on the left and women on the right.*

Norm Vogan approved on 13<sup>th</sup> June 1961 the addition of new public toilets at platform level at Cowan station. The previous toilets were off-platform. The new toilets formed the only improvement in platform facilities for the travelling public since the station opening in 1901 and remained the only improvement. They were located on the northbound platform. The male toilet was added to the south side of the existing timber waiting shed and the female toilet was added to the north side of the same shed. The additions are obvious not only in the different pitches of the roofs but also in the style of the boards on external walls. The original waiting room in the centre has rusticated weatherboards and the toilets have lapped boards. The pressure on the Department to save money was reflected in the decision to attach the toilets to the existing waiting room as such action eliminated the need to construct one wall of each facility. Also, frugality was displayed in the small size of the closets. The standard floor area for toilet cubicles was 231 square feet at those at Cowan were only 180 square feet. The

Department spent the next few months reflecting upon the adequacy or otherwise of the length of the urine absorption trench connected to the toilets and, in late 1961, officers decided to provide parallel trenches 12 feet apart for length of 40 feet between the station and the adjacent Pacific Highway. In 1963, the Department installed a 450 gallon septic tank.

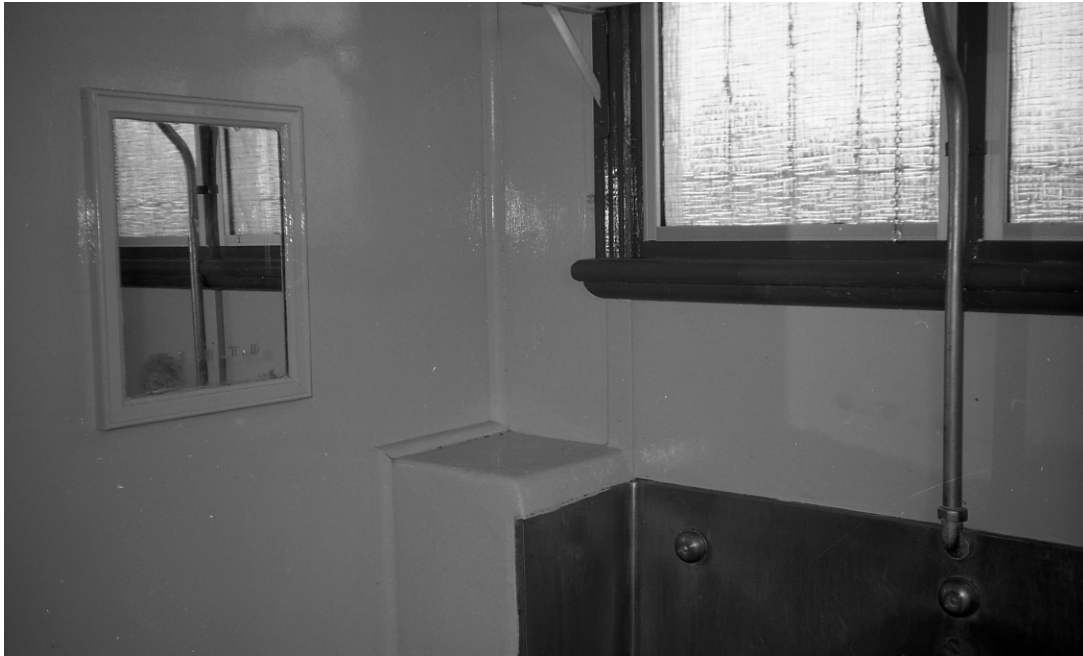
*With the public toilets now locked, it is impossible for visitors to inspect the facilities provided in 1961. Luckily, this 1996 photograph gives us a snippet of information. The stainless-steel urinal held two simultaneous users. Toilet-goers at Cowan were extremely fortunate as the installation of mirrors in male toilets was highly unusual for most New South Wales station toilets.*

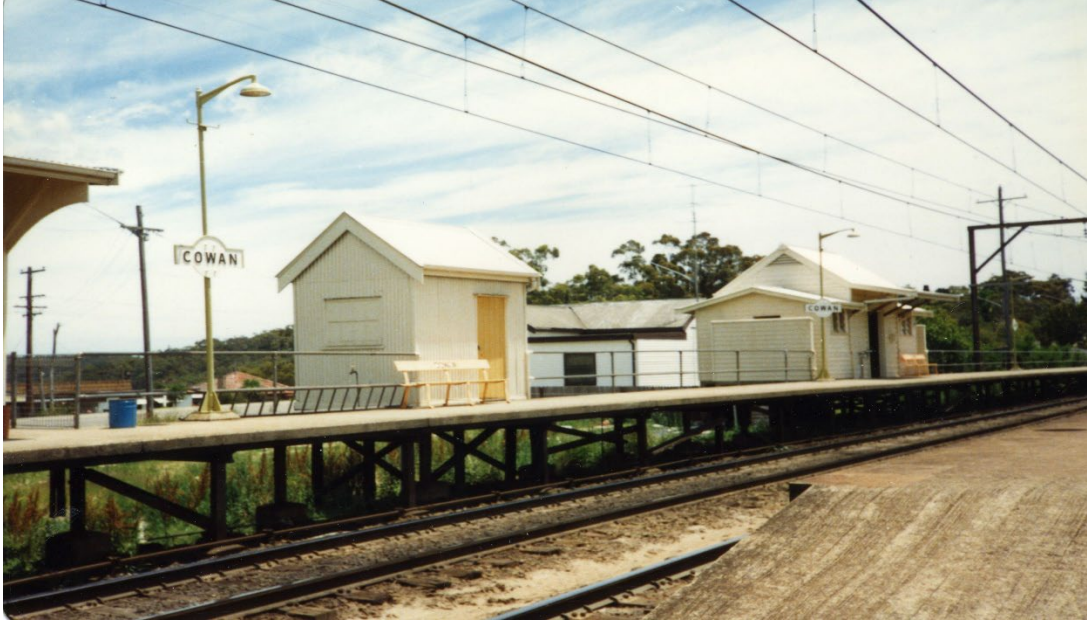
*The above photograph shows the colour scheme of station buildings that was typical of the 1970s and 1980s. The typical colours were white or cream for buildings and orange for platform seats and garbage tins. Between the ticket office on the left and the waiting shed on the right is the out of room, the walls of which are sheeted with corrugated iron. The original timber fence at the rear of the platforms has been replaced by pipe fencing. The 1961 approved separate male and female toilets have been added to each side the of the waiting shed. The station name boards are of the circle and bar variety, which was in use between 1926 and 1960. **SOURCE:** Photograph by G. Dorman c1985 No. 027046a ARHS collection.*

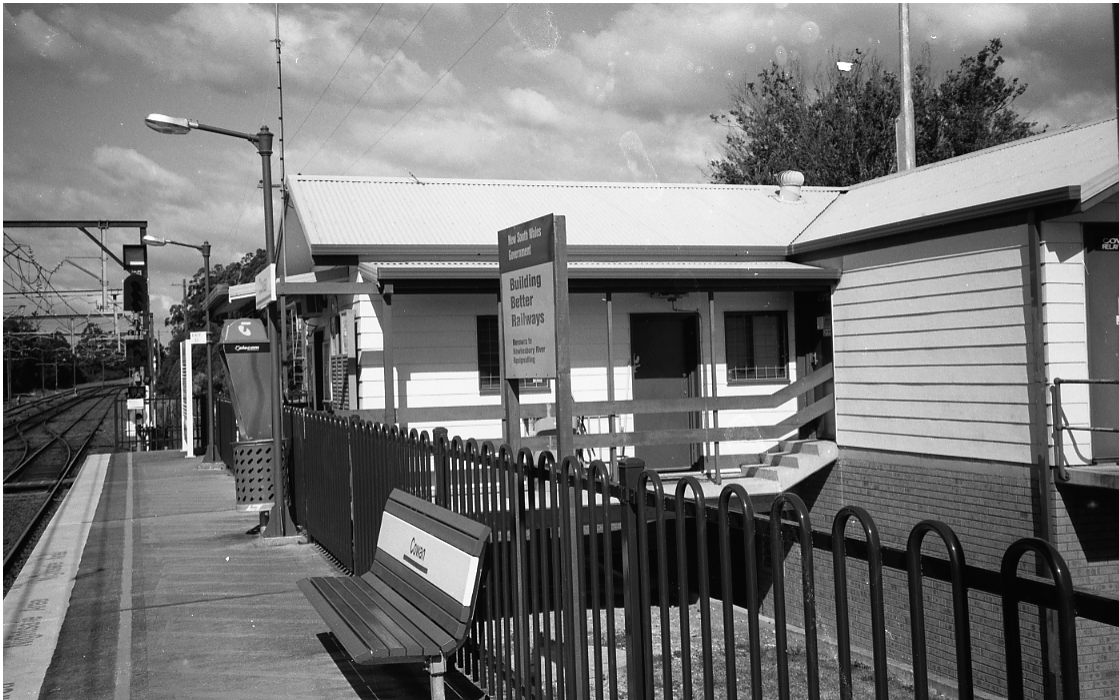
*The sign in 1999 says it all – Building Better Railways. The platform seat is in the early CityRail colour scheme of red and white. The loop top fencing was painted green rather than the far more usual white. The selection of green was meant to be an acknowledgement that CityRail was aware of the natural bush setting and was providing station upgrading facilities that reflected its understanding of the sensitivity of the station location.*

While the fencing at the rear of the platforms is the typical CityRail pool fencing 1990s, it is painted dark green rather than usual white. The use of green paint was usually only

applied where there was community protest about the ugliness of the white paint against the green foliage given the location of stations in bushland settings.

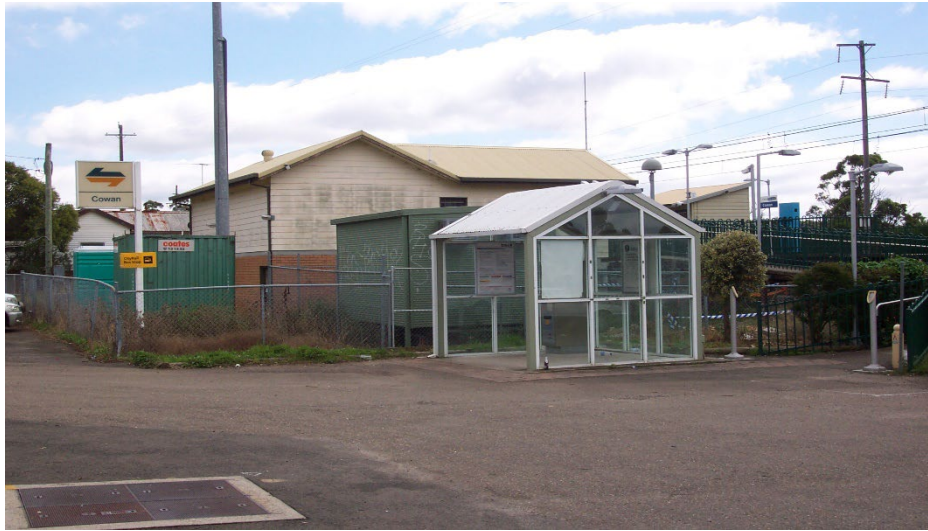
*This image shows the early version of the back-lit station name sign used by CityRail between 1989 and 1995 or so. The 1889 signal box has been demolished and replaced by the 1990-opened new signal box and signal relay building, comprised of a brick base and Hardie Plank walls, complete with fungal growth. The impact of CityRail following the cessation of suburban electric passenger services in 1992 is most obviously seen in the construction of a shelter shed adjacent to the Pacific Highway for those periods when trackwork prevents train operations. Another marker of the CityRail period is the posts for pre-Opal ticket card readers adjacent to the green fencing at the station entrance for an electronic ticketing system which was never brought into service. They were small monuments to the large waste of taxpayer money. Taken on 23<sup>rd</sup> February 2008.*

Following the establishment of CityRail in 1989, there was a major change at the south end of the northbound platform which involved the demolition of the signal box, the ticket office, the relay hut and the out of building. All were located on or behind the northbound platform. A new relay hut was incorporated into a new signalling building behind the platform some time about 1990.

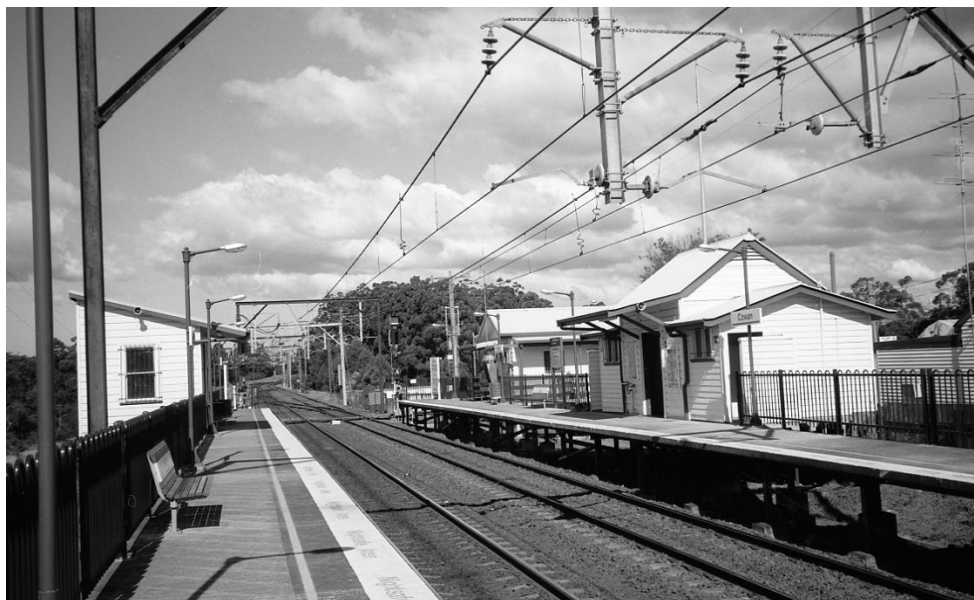
*The foregoing image shows the platform structures in 1996 looking south. The northbound platform is on the right.*

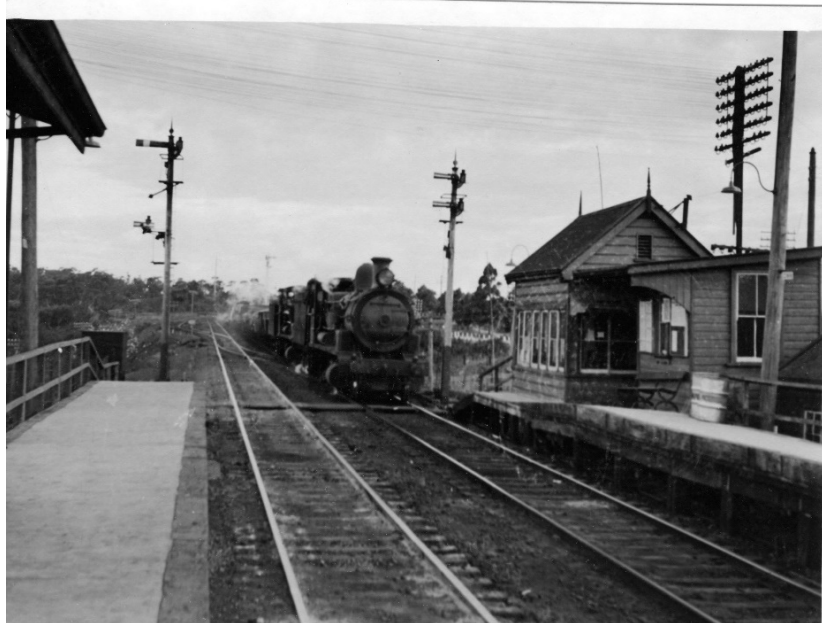
*This photograph shows 5422 and 5420 passing the 1889 signal box on 21<sup>st</sup> August 1951. The defining features of the signal box were its location at platform level; its gabled roof and the absence of an awning over the windows on the rail elevation. Adjacent to it is the ticket office with the ticket window facing onto the platform. Note that the seat in front of the ticket office is on a slope, marking the ramped end and pedestrian access point to the platform. **SOURCE:** Photograph by R. B. McLaughlin No. 017234 ARHS collection.*

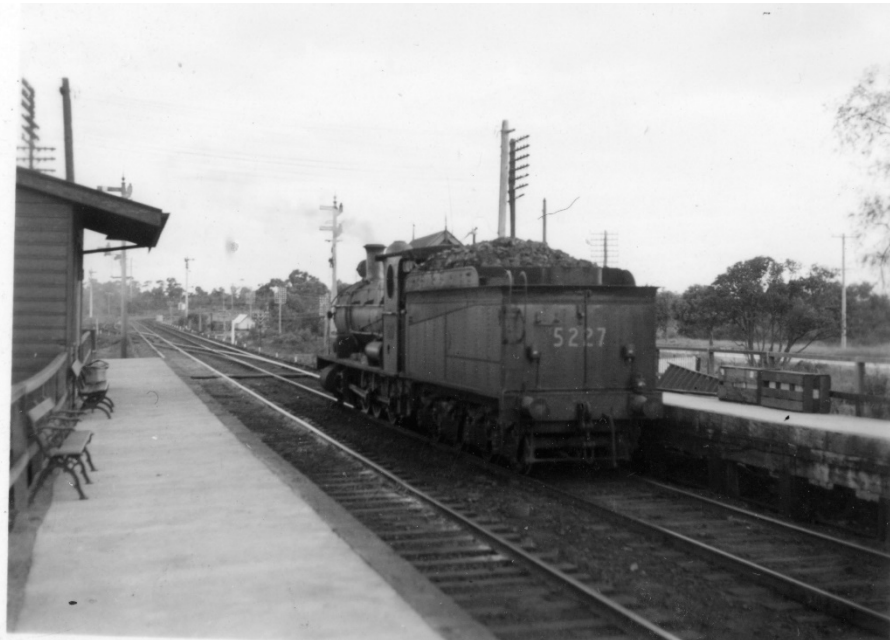
*As described by Ray Love, the photograph shows 5227 running from Hornsby to Hawkesbury River as a 'fresh' engine to take up bank duties. This photograph also shows several interesting features. The decks of both platforms have been raised with what looks like concrete positioned directly on top of the original timber deck. On the Southbound platform are two seats. Both date from the 19<sup>th</sup> century. The one closer to the camera is older and has the ornamental arm rests while the one further away is a simplified version with curved bases and no armrests. The fencing at the rear of the platforms has been repainted from white to dark stone. Cowan was a*

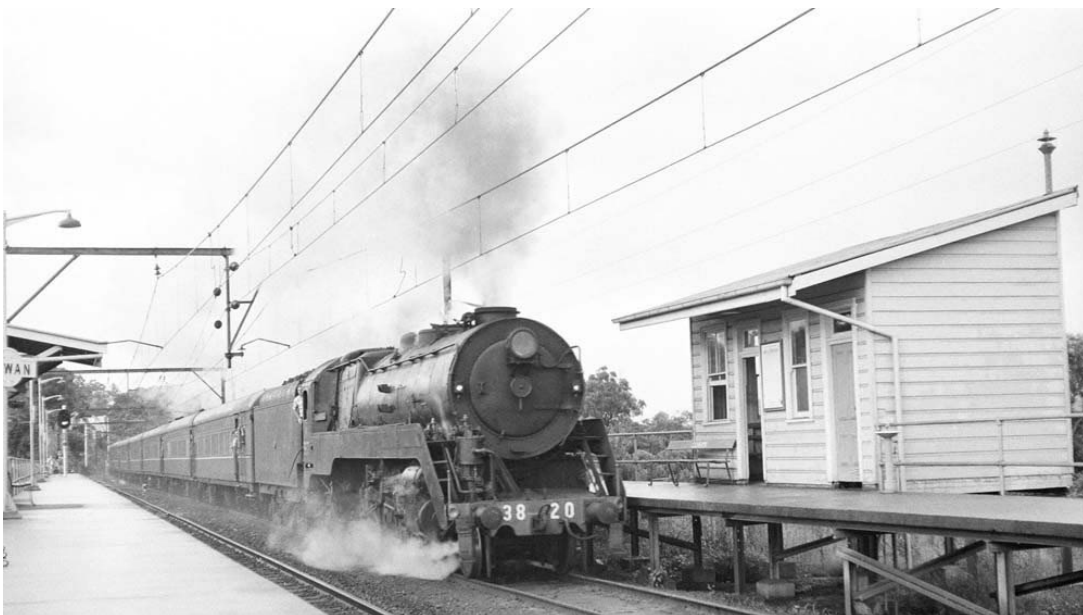
*Neal Munro photographed locomotive 3820 on No. 32 Newcastle Express on 29<sup>th</sup> December 1970. Clearly, bank engine assistance was not required. SOURCE: Photograph No. 462937 ARHS Archives*

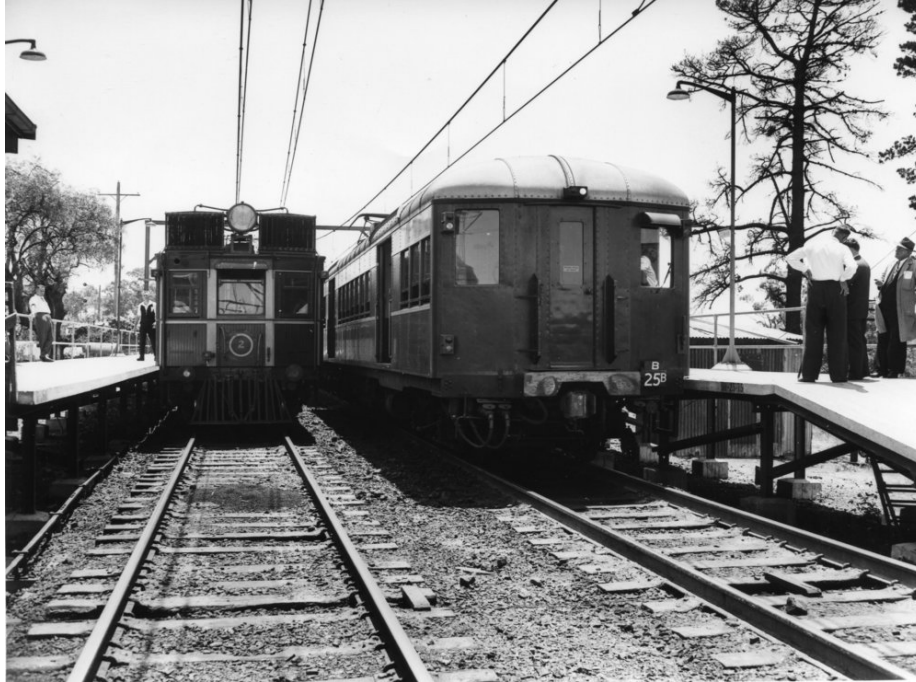
*This official photograph taken on 12<sup>th</sup> November 1958 shows the last regular rail motor service and the first electric train service. **SOURCE:** ARHS Archives, Photograph No. 127531.*

In November 1958, the Sydney suburban electrification was extended from Hornsby to Cowan. As a result, the steam hauled suburban trains between Hornsby and Cowan were replaced by suburban electrics in either two-car, four-car or eight-car sets. The off-peak shuttles between Hornsby and Cowan were provided by two-car sets marshalled as Power Car + Driving Trailer Car. The steam bank engines continued until April 1959, when the electrification was extended and opened into Hawkesbury River.

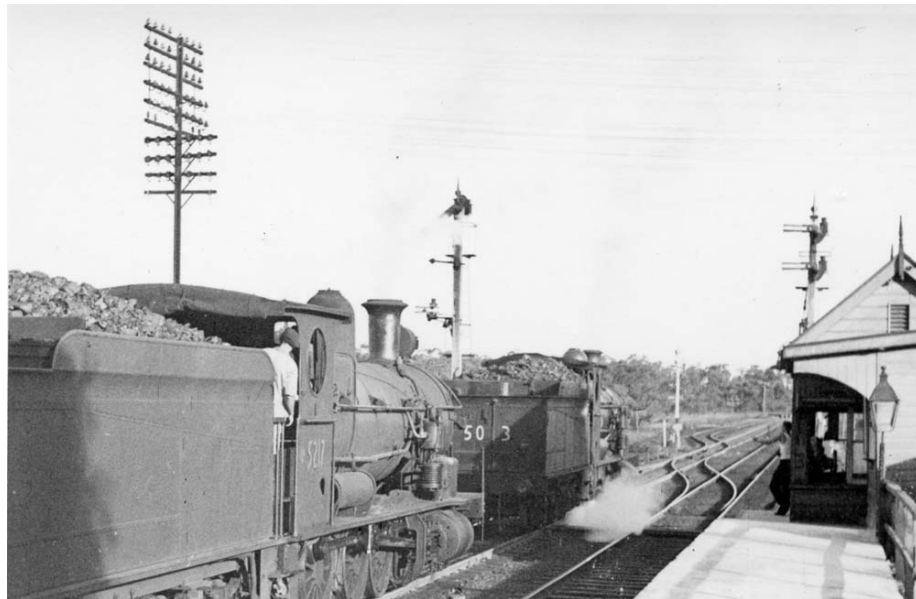
*Ken Winney was on hand on 11<sup>th</sup> May 1947 to witness the bank engine detaching from the goods train. Note the kerosene lamp. **SOURCE:** ARHS Archives, Photograph No. 113176.*

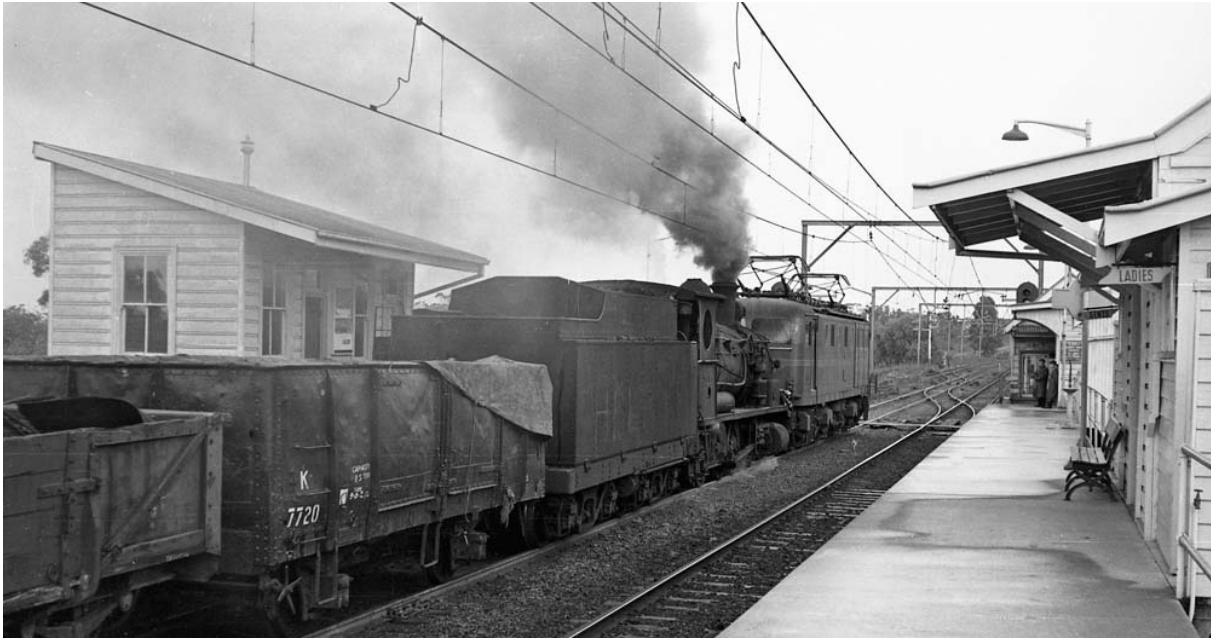
*Electricity had been connected to the station when John Ward visited the site in 1965.*

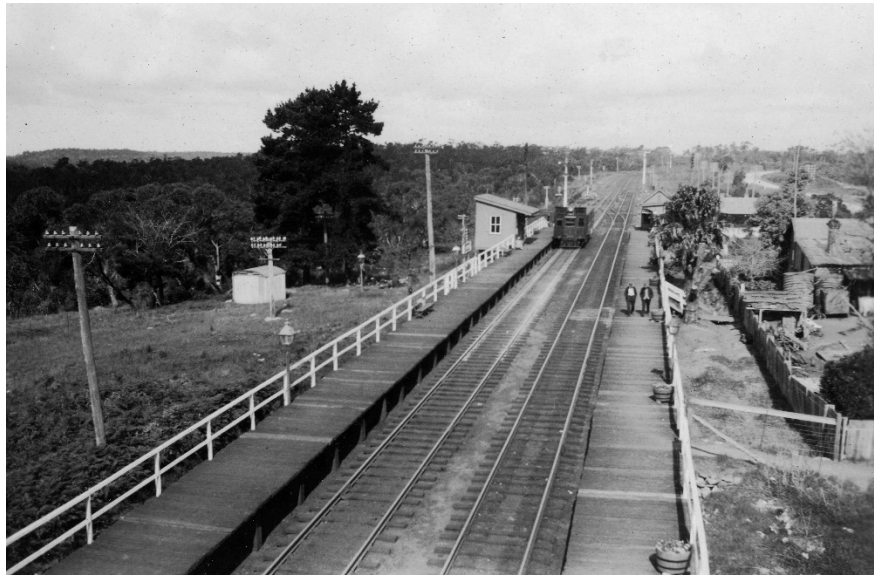
*The above photograph shows the following fixed station infrastructure: timber framed and timber decked platforms; two-rail, timber fence at platform rears; timber waiting shed on Southbound platform; no waiting shed on Northbound platform; male toilet off platform with arched roof; steps for the Station Officer to walk between his house and the station; 1891 and 1897 official residences; ticket office and signal box at the extreme South end of the Northbound platform; platform lighting and pot plants only on the Northbound platform. **SOURCE:** Photograph by O. B. Bolton in December 1932 No. 000147 ARHS Resource Centre.*

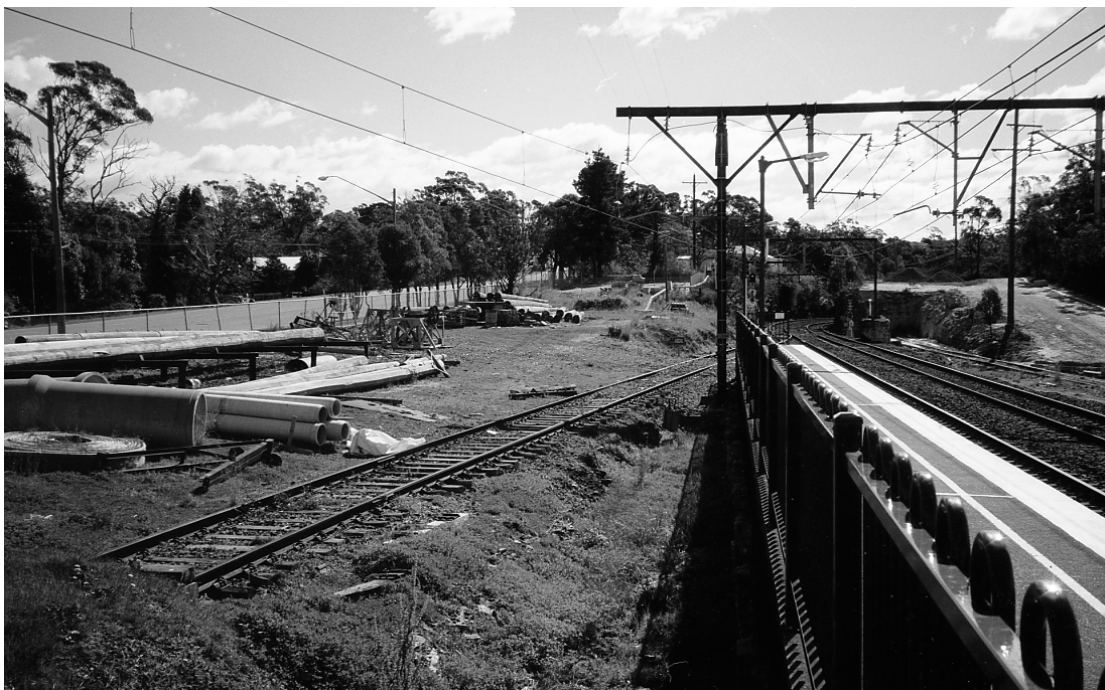
*This foregoing photograph shows the goods siding with a trailing connection to the Down Main line at the north end of the station. The date of the installation of the goods siding is unknown, but it was in place in 1930. It retained the name of the goods siding until 1990.*

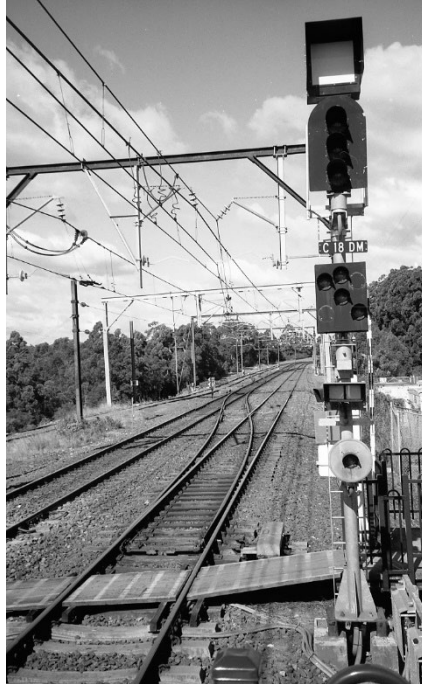
*The photographer is looking towards Hornsby and shows the southern approach to Cowan, the photograph having been taken after the closure of the old signal box in 1990. The signal is the Up Starting signal from the Down platform, as reconfigured in 1996.*

*Also, in the box is one right at the top of the nest in the centre. This is the signal's red marker light, which is another standard arrangement that provides a back-up in case the main red light in the signal head fails. The marker light shows red, except when one of the signal indications to proceed has been activated. Once that occurs, the marker light is extinguished.*

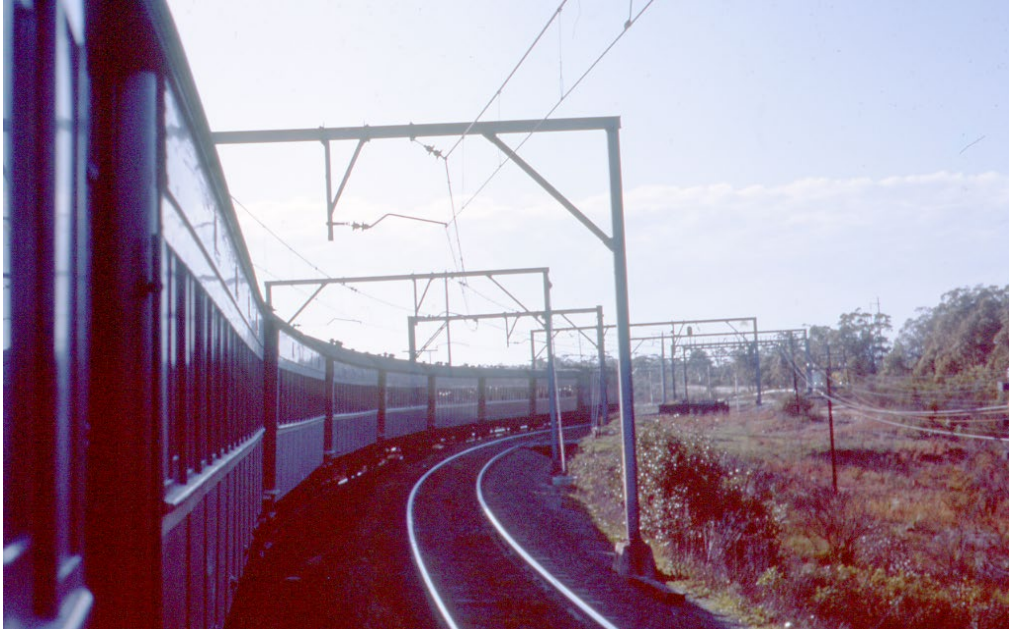
*Our visit to Cowan is over and it's time to enjoy the train ride back to Sydney Terminal with American-style, open end loading cars and a 46 class electric locomotive. Oh, for the pleasures of 1965 with the outing ended and the film expended!*
