# ST. MARYS RAILWAY STATION

## A STRUCTURE FOR THE ANALYSIS OF THE STATION HISTORY

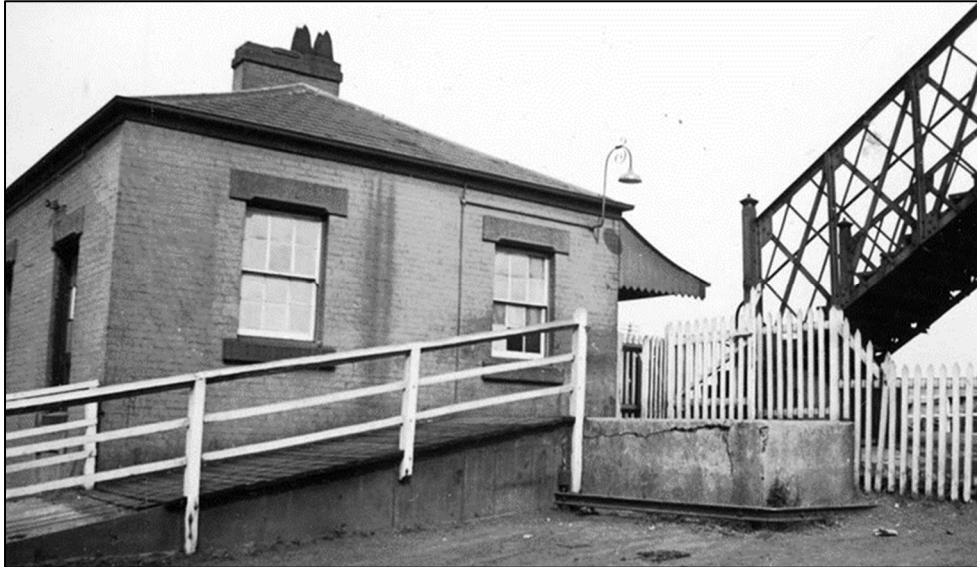
*No photographs exist that indicates the first building at St. Marys. However, the combination building at Rooty Hill was of the same overall design though smaller, having only four rooms under the main roof, as reflected by the central chimney at the apex of the roof. Like the building at St. Marys, the Rooty Hill structure was replaced during World War 2. **SOURCE:** Photograph No. 001281, ARHS Railway Archives.*

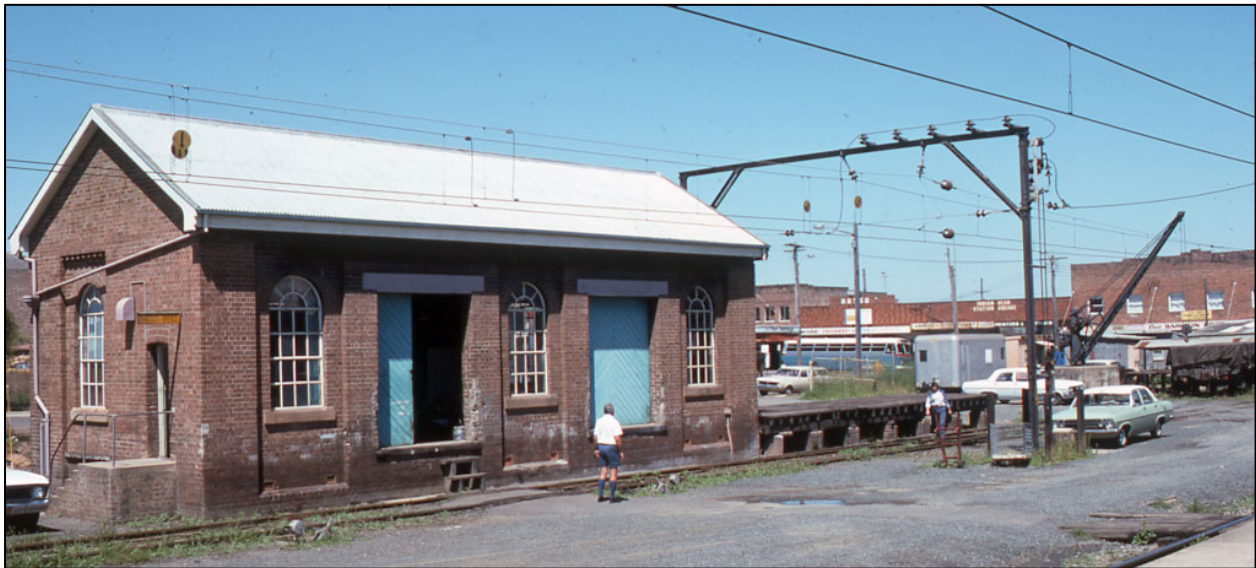
*The above photograph shows the 1887 goods shed. It was one of only a few brick goods sheds, others being at Penrith, Liverpool, Goulburn and Waratah. For St. Marys to receive such an attractive building, someone of influence must have resided nearby. The photograph was taken on 22<sup>nd</sup> January 1977.*

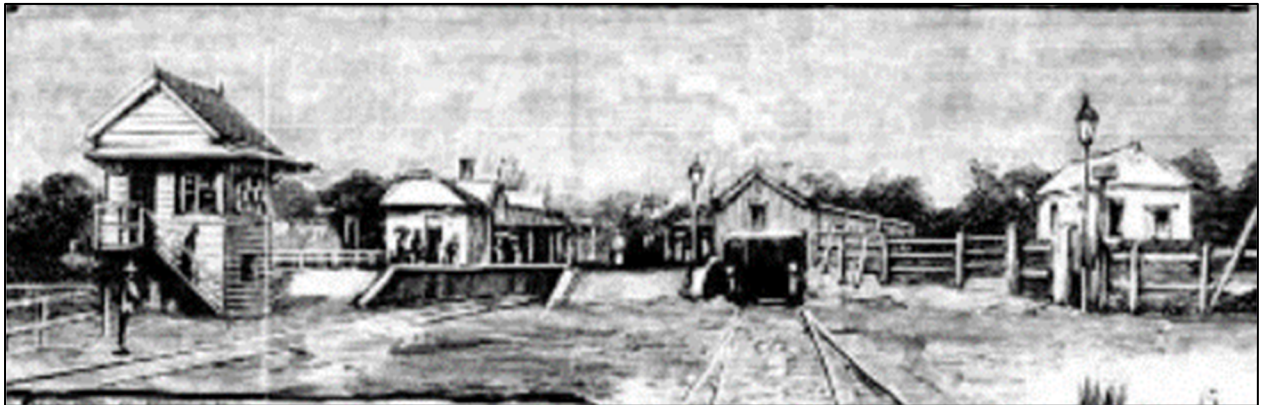
*This sketch of the buildings at St. Marys appeared in the Sydney Mail and New South Wales Advertiser on 2<sup>nd</sup> August 1890, p. 256. The artist is facing west. Although difficult to see, it shows buildings on the platforms roughly equating with the planned structures. However, the roof on the eastbound platform building is inconsistent with the 1887 plans. It appears that there was an existing shed on that platform and the Railway Department decided to retain it. The 1887 structure is behind the existing shed.*

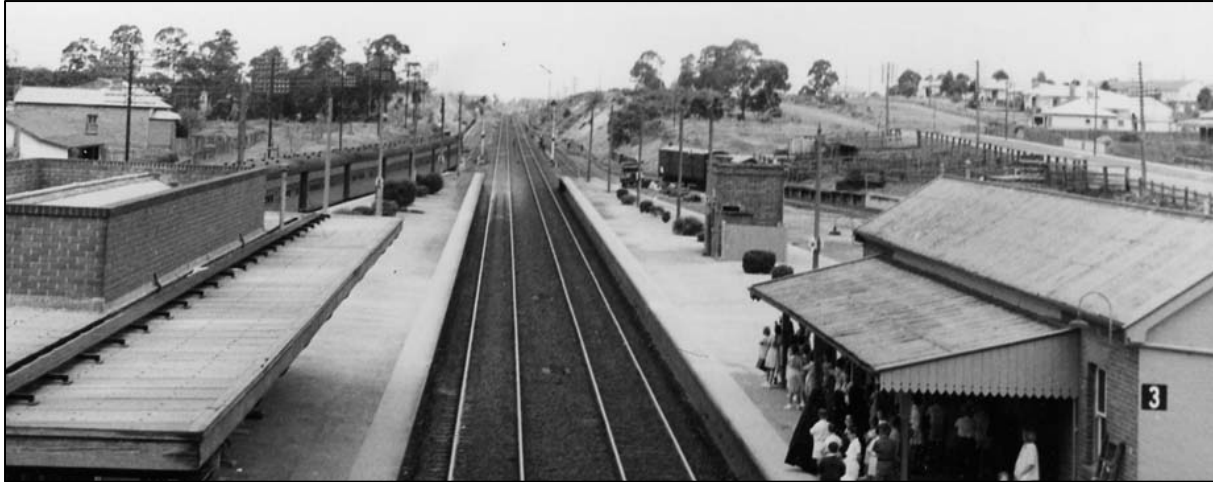
*This photograph, taken on 10<sup>th</sup> April 1953 shows the 1943 building on the left and the 1887 waiting shed on the right-hand platform. Of particular interest on the westbound platform on the right-hand side is the male toilet which was located approximately in the centre of the platform. The structure is unusually tall and may have concealed a water tank to flush the urinal and closets. At that time, septic tanks were in use on each platform. **SOURCE:** Photograph No. 001302 ARHS Railway Archives.*

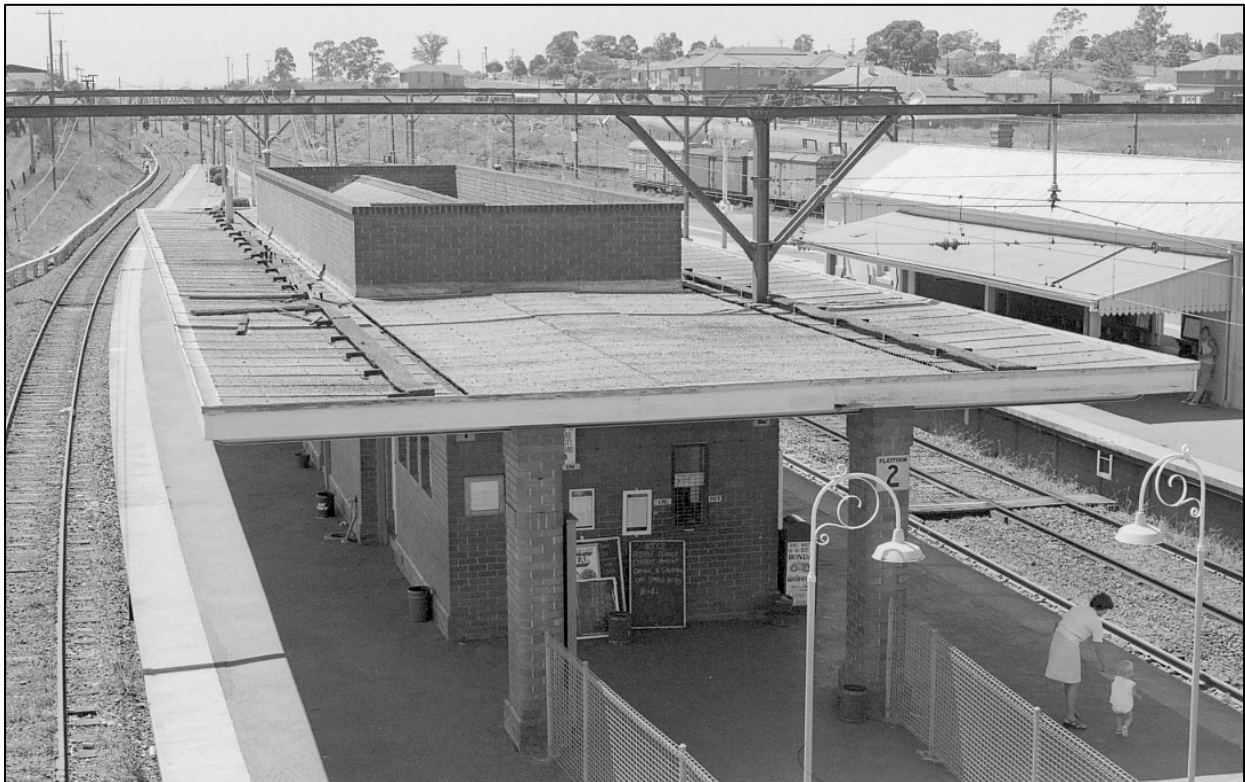
*The very unusual aspect of the construction of the new platform building and signal box in the 1940s was the noticeable reduction in the level of presentation. This January 1977 photograph shows the complete absence of ornamental brickwork on the gables, a feature on all similarly designed structures westward of Westmead. The explanation is speculation. Note the attempt to provide order with the words “in” and “out” written on each side of the ticket window. The rubbish bins are of two types. On platform No. 2 is the old-fashioned round top with a spring-loaded cover while the small bins on platform No. 1 are a manifestation of the policy of the Public Transport Commission of the 1970s. When originally built in 1943, the fencing between the bottom of the stepway was formed by timber posts and rails and extended all the way to the ticket window.<sup>3</sup> It was replaced and truncated in the 1960s by the usual roll-top, galvanised mess fencing.*

- William Beaver approved on 4<sup>th</sup> August 1942 a brick building on platform Nos. 1 and 2 but he left the remaining building, dating from 1887, on the Penrith-bound platform.

- The 1942 structure at St. Mary's was of moderate size, but clearly designed by someone different to the other buildings between Westmead and Toongabbie.

- There were two striking features that made the structure different to those between Westmead and Seven Hills. Firstly, there was the use of a brick parapet enclosing a gabled roof on all four sides of the structure, rather than parapets restricted to the roof terminals for the structures between Westmead and Toongabbie.

- Secondly, both ends of the building were square, unlike those between Westmead and Toongabbie which had one end rounded. Behind the roof parapets at St. Marys, the double-pitched roof was covered with corrugated asbestos cement sheets.

- The St. Marys structure had all the identifying features of the Inter-War Functionalist style, including the use of near-flat platform awnings, a string course of contrasting-coloured soldier bricks above the window heads on all external walls and asbestos cement sheets for a soffit between the extended roof joists supporting the platform awnings.

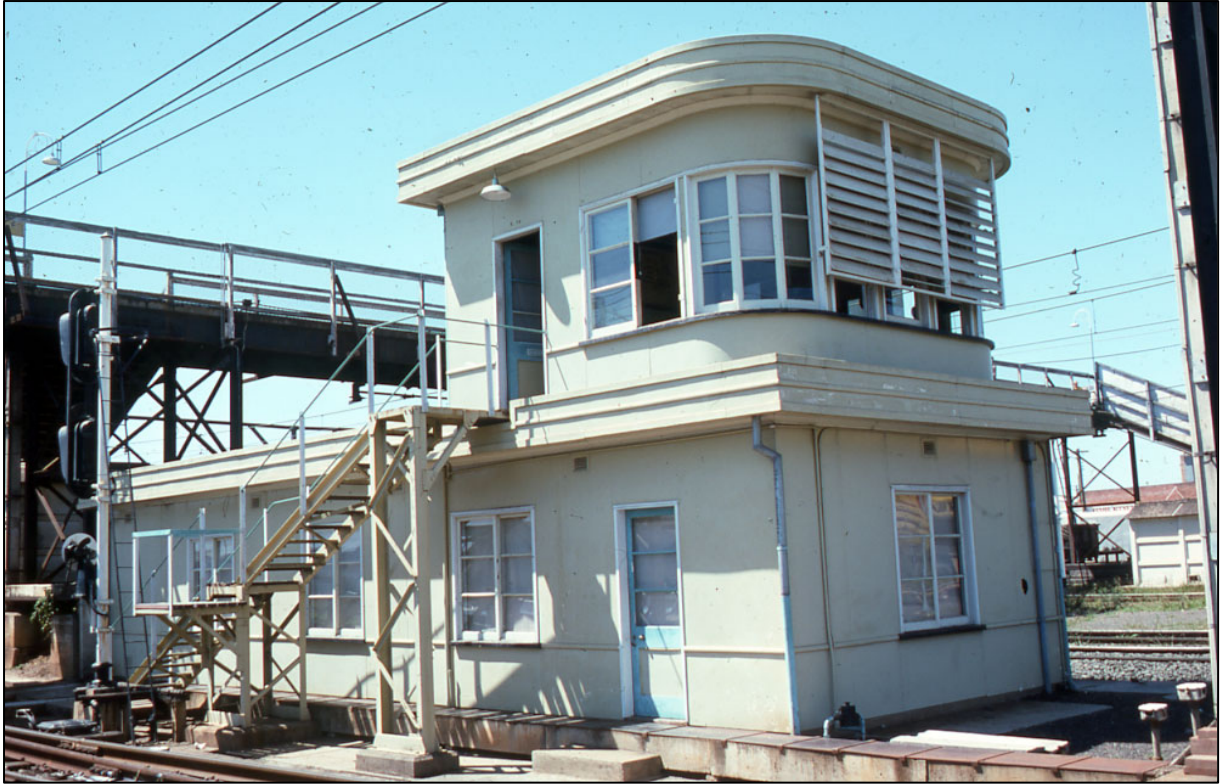
*Cheap design. Note the absence of vertical cover strips between the sheets of asbestos cement. This was purposefully done to emphasise the horizontal expression of the structure.*  
22<sup>nd</sup> January 1977

- A new, two level signal box at St. Marys opened on 19<sup>th</sup> of May 1942.
- The St. Marys signal box followed broadly the Inter War Functionalist design, which was reflected in the use of cover strips restricted to the horizontal joints, the use of a flat roof, wide metal fascias with rounded corners and a rounded building wall facing the Penrith direction.

What was interesting was the idea to erect the signal box using Fibrolite sheets instead of brickwork

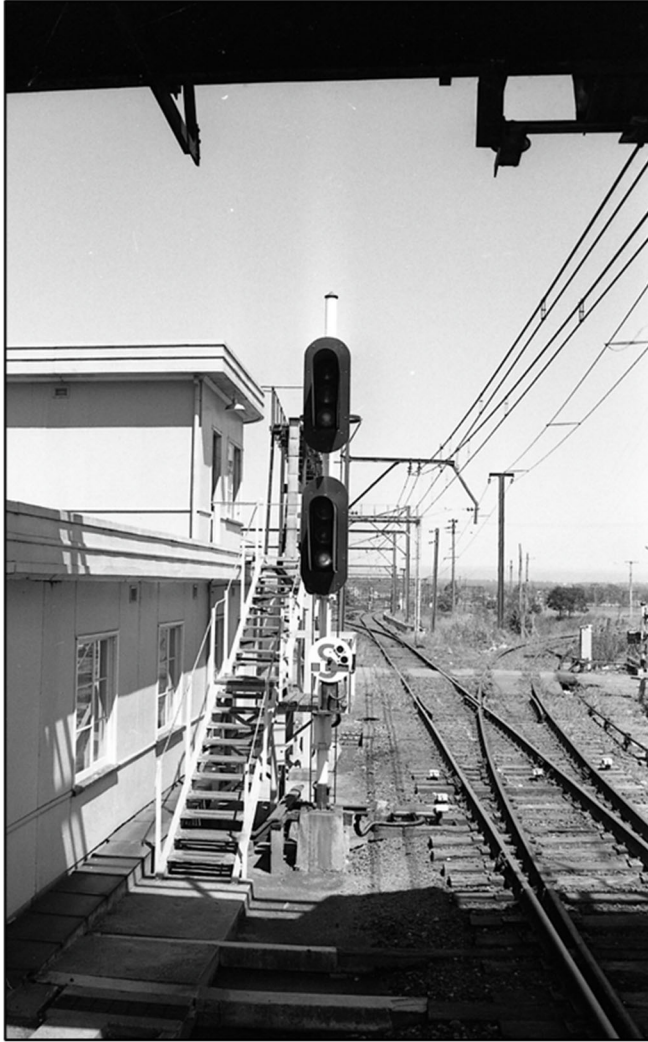
*This photograph was taken on 22<sup>nd</sup> January 1977. Noted signalling and safeworking historian, Graham Harper, writes on 12<sup>th</sup> January 2023: "This photograph looks west from the end of No.1 Platform. It shows the signal box atop a large relay area. Compared with the area for relays, the operating room at first floor level is quite small.*

*The line branching to the right in the foreground is the A. E. Goodwin Siding. Formerly, during the Second World War, this line extended to Dunheved and served the military's Stores and Transport section close to St. Marys and the Fuse section nearer to Dunheved. The 1949 rail recovery project saw the lifting of the line at the Dunheved end, as well as at other locations in the Ropes Creek area, leaving only the St. Marys end connected. When the lifted tracks were replaced in 1957, the Dunheved end of this siding was never reconnected.*

*Carefully examined, the stairway from the signal box operating floor shows a definite levelling at about half the height of the relay room window. The stair hand rail closest to the building shows this levelling, while that closest to the running line shows a gap. A small landing extends towards the running line from this point, and this was undoubtedly allowed the signaller to hand out or collect the staff for the branch during the single line period 1949-1957. Of course, if a movement were necessary between the Branch and Platforms 2, 3 or 4, the signaller would have to supply/collect the staff from platform or ground level.*

*The double light colour light signal beside the box can take a train to Werrington or Dunheved, depending on which points have been set. The signal appears to have narrower lens cases than most signals of the type. This is possibly due to restricted clearances between the line and the signal box access stairway.*

*Also of note is the very unusual [unique?] shunt ahead signal placed beneath the main signal lights. Electronically controlled disc signals were not unknown in NSW, but I cannot recall one being painted with an 'S' and used as a shunt ahead. The purpose of this signal at St. Marys is unknown. Clearance of the signal allows a train to shunt as far as a limit board, which can be*

*discerned, with considered squinting, just before the colour light signal in the distance. What purpose could be attributed to such a move is beyond me.*

*Finally, the pedestrian crossing over the running lines can be discerned in the middle distance. This crossing was the remnant of a full road crossing which was replaced by the Glossop Street overbridge to the east of the station around 1957. The pedestrian booms continued to be operated from the St. Marys box for quite some time after the diversion of the road traffic”.<sup>4</sup>*

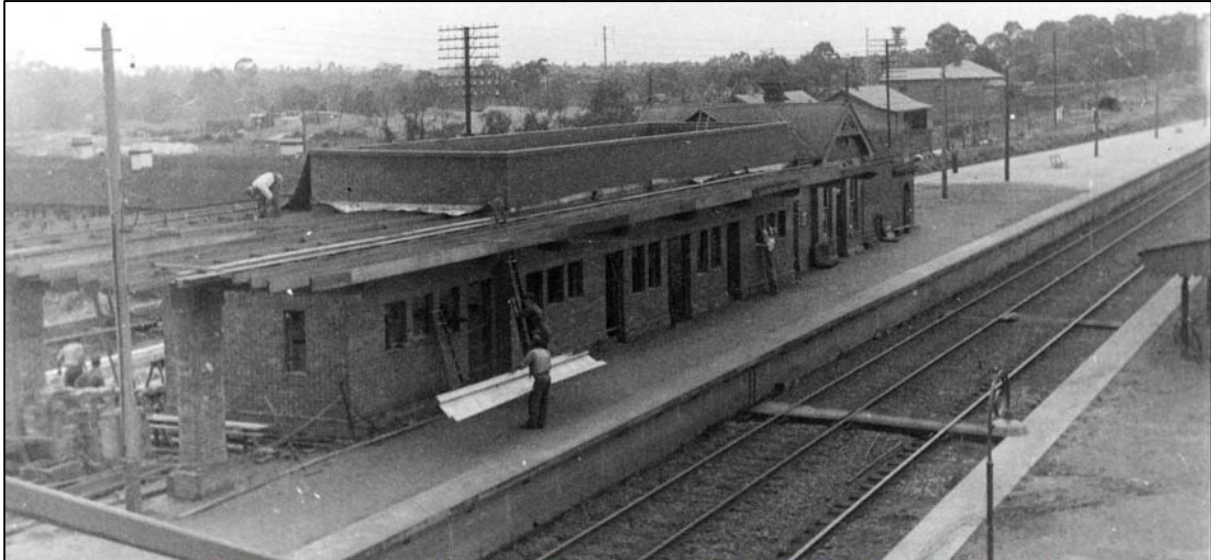
*This photograph shows the building on platform Nos. 1 and 2 well advanced in 1943. Note that the 1887 toilets remained on the platform at the far end but would be demolished once the new structure was completed **SOURCE:** Photograph No. 001294 ARHS Railway Archives.*

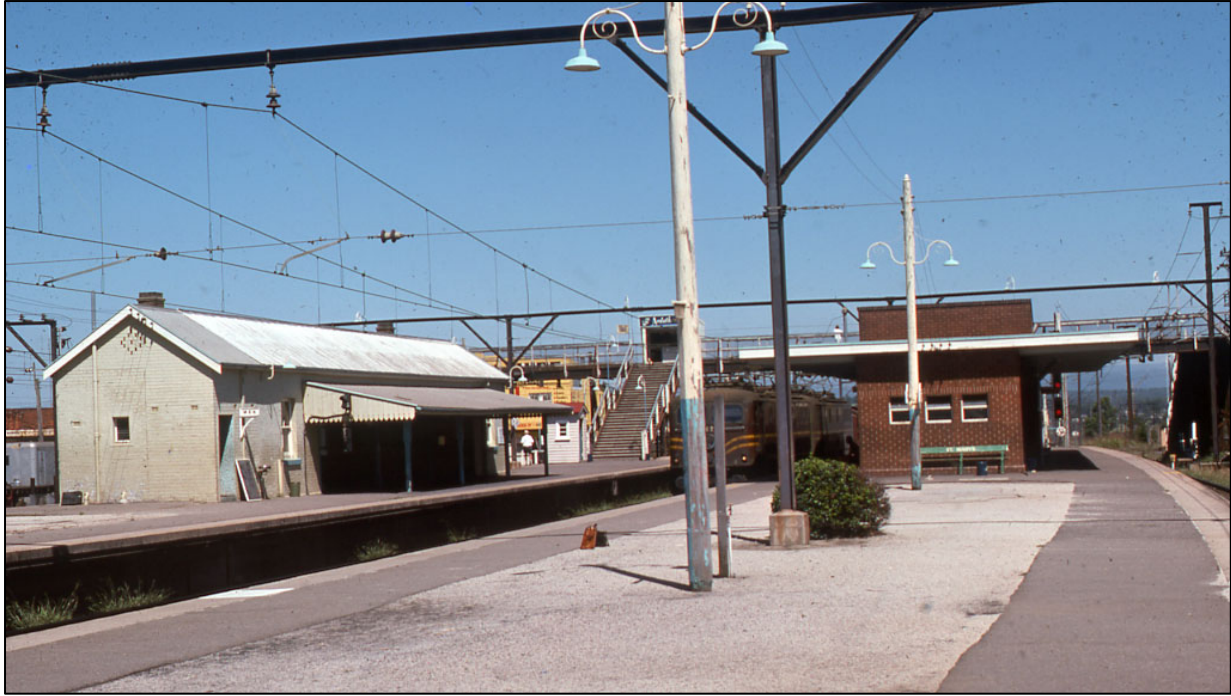
*22<sup>nd</sup> January 1977 is the date of the photograph. It captures the essence of the New South Wales Railways of old – basic, dirty and under-funded. Only a strip of bitumen has been provided towards the edge of each platform with Locksley crushed granite being the remainder of the surface. The platform seat is painted using 3801 special green, which was the standard colour applied to several items, including platform seats. The 1887 building on the left was extended at the eastern end in 1952 to provide space for the male toilet. The small window in the toilet marks the location of the closet. The male toilet was formerly free-standing further to the east on the same platform. At the bottom of the stepway on platform Nos. 3 and 4 is the ticket collector's cabin, which is of a standard design dating from the 1940s. The 1943 building is on the right.*

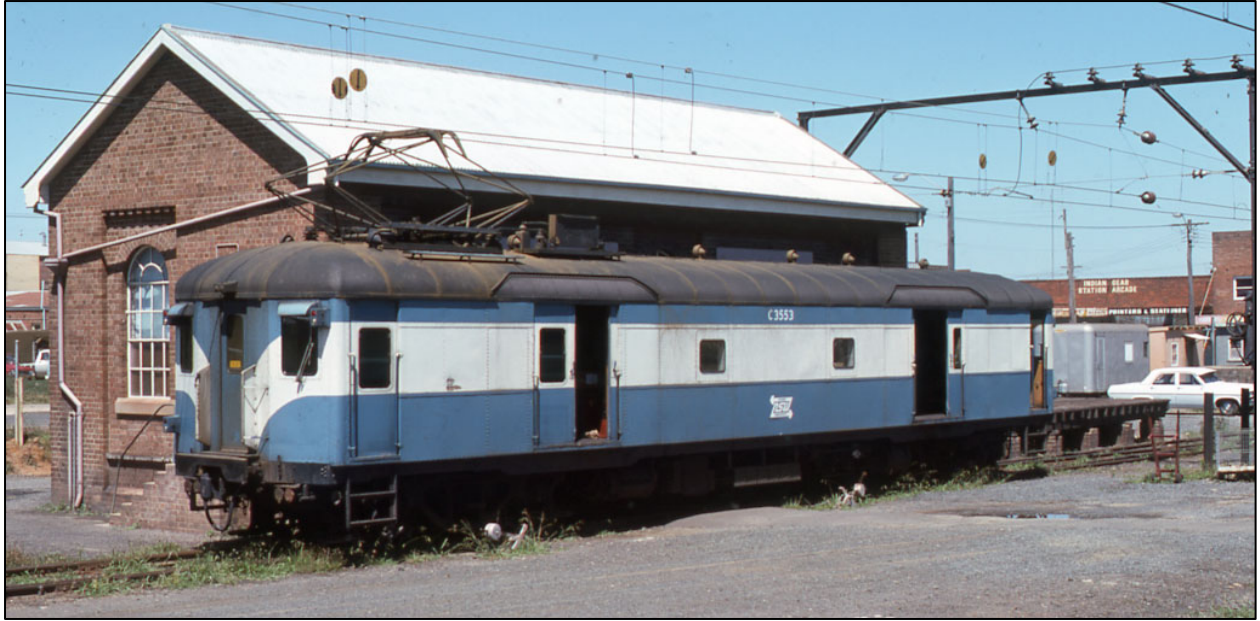
*In 1956, the on-platform parcels office was relocated to the goods shed in an effort to lower the number of staff. Such relocations occurred elsewhere in the decades between 1950 and 1987. No doubt the goods siding was electrified in 1955 or so when track electrification was extended from Blacktown to Penrith. Taken in January 1977.*

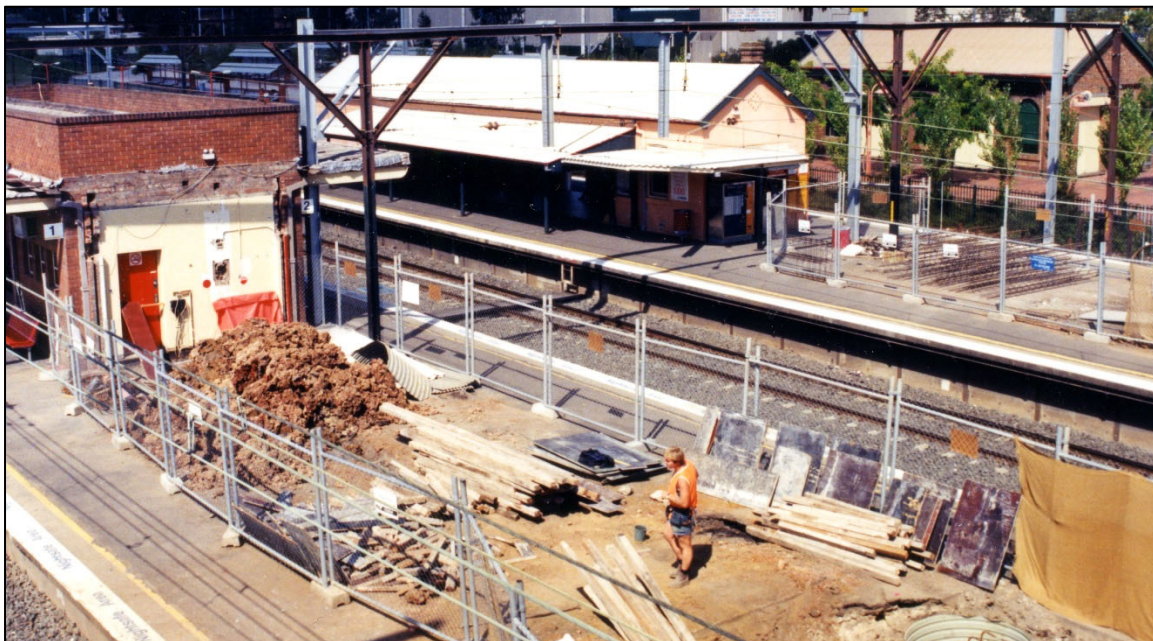
*It is 1993 and CityRail's objective was to replace the 1981 platform awnings on both platforms starting at the bottom of the stepways as well as the demolition of the 1943 building on platform Nos. 1 and 2. CityRail engaged a contractor to demolish the 1943 platform building. The*

*booking office has already gone. Despite being presented with information about the heritage significance of the building, demolition went ahead. The Authority argued that there were many similar buildings. That was true but the significance of the building at St. Marys was considerable because of differences with other locations of the same time period. Demolition was completed in March 1995.*

- Edwards Madigan Torzillo Briggs received the commission to demolish the 1942-approved Inter War Functionalist building on platform Nos. 1 and 2 at St. Marys. A recording of the structure was made prior to demolition. The 1942 building was replaced by an awning.

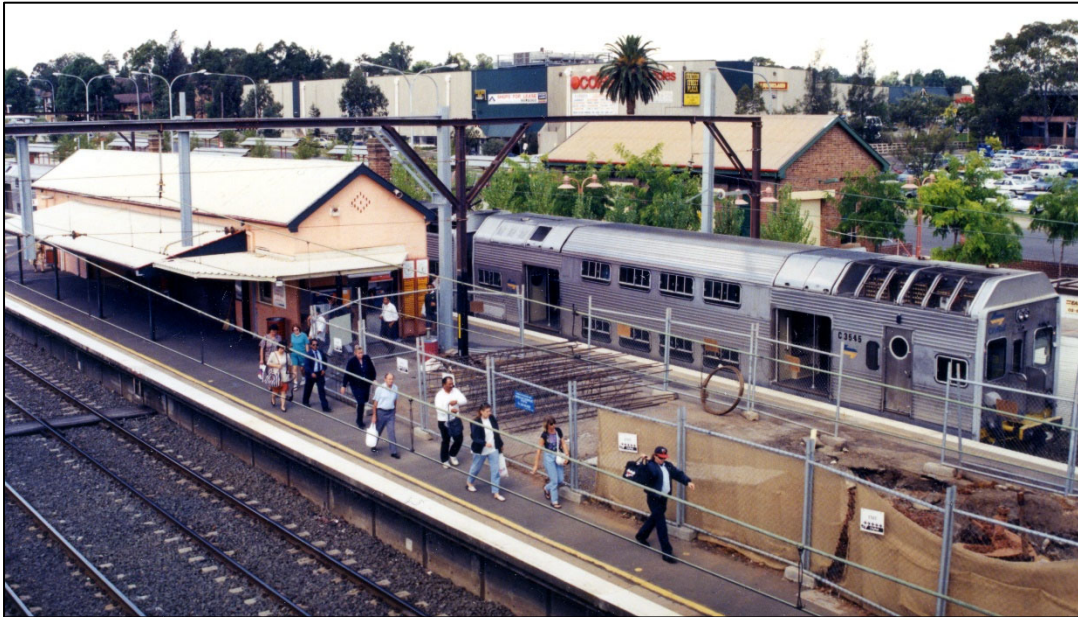
*Work was under way in 1993 in preparation for the erection of new platform awnings.*

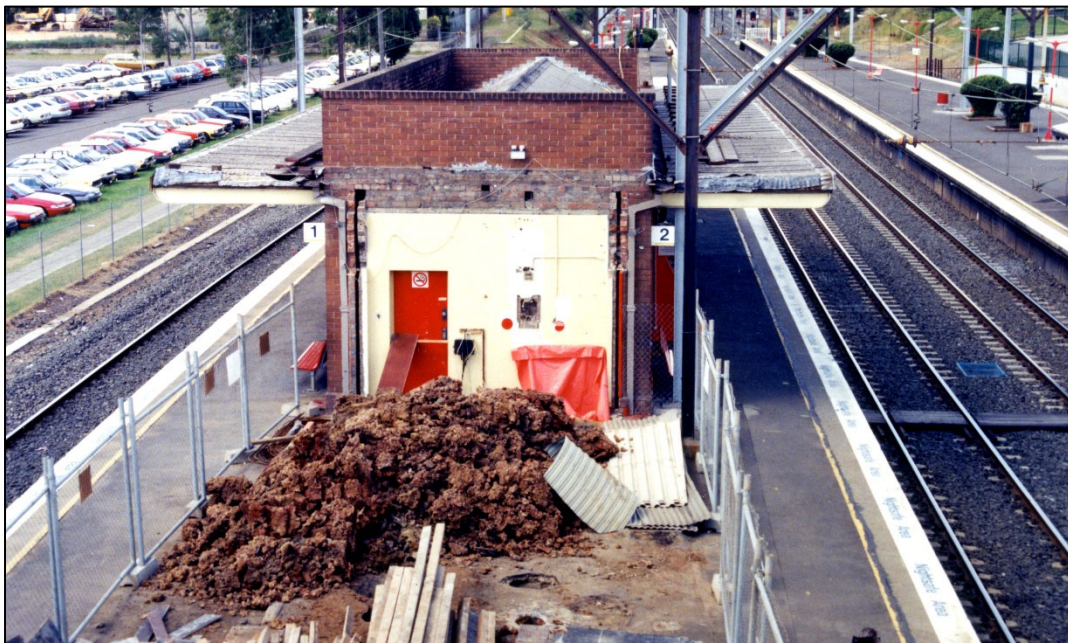
*CityRail had already painted the lamp posts red in 1993 before the replacement awnings were erected. An interesting architectural feature, dating back to the 1850s, was to reduce the width of platform buildings at both ends. The demolition of the booking office above aided the*

observation of this feature. The red painted internal door is not another case of CityRail red being splashed everywhere. The two locks on the door identify restricted staff access. The room may have housed PA or CCTV equipment and entry by station staff was unauthorised. The multi-level car park was yet to be built.

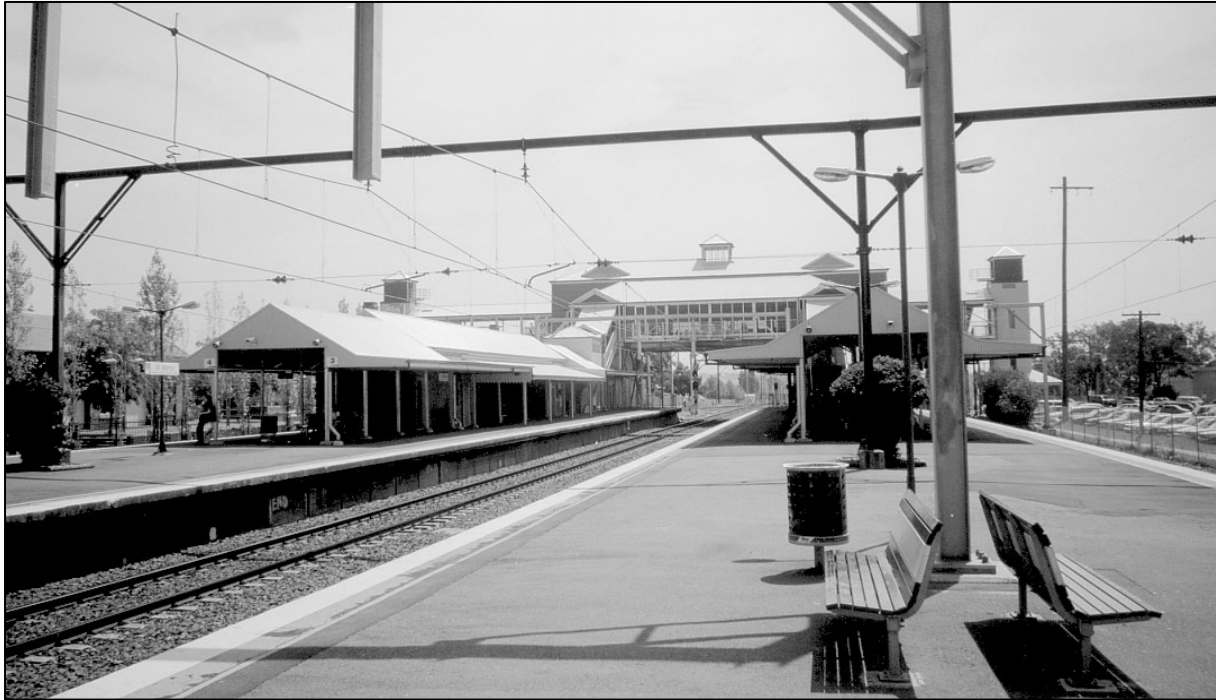
It is the 7<sup>th</sup> February 1997 and the overhead booking office, lifts and new awnings have been standing for two years. The platform awnings were subsequently extended eastward on both platforms.

- Plans were prepared in March 1995 the installation of easy access lifts at St. Marys together with a booking office on a new concourse. The structure had a hipped roof and the walls were constructed of compressed fibre cement panels. Clocks were placed in the lift towers.

- In 1994–95, work included covering the footbridge deck and stairs and a new overhead booking office designed by Spooner Harris & Associates. The 1995

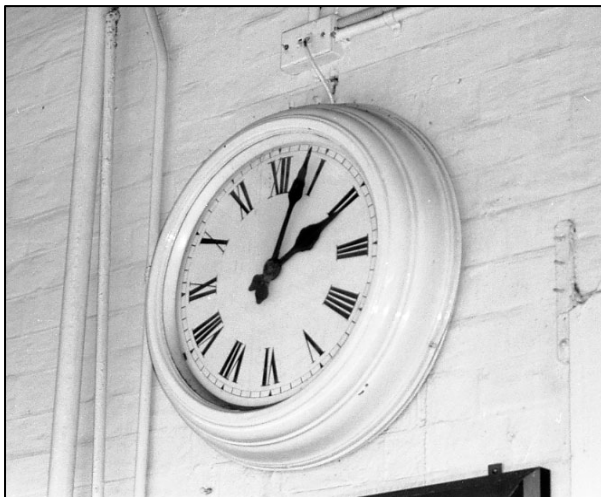
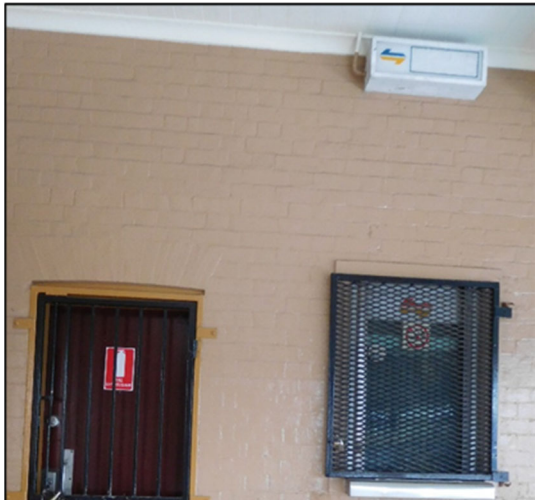
A contrast in electric clocks at St. Marys. A traditional NSW Railways clock is on the left and CityRail's effort is on the right. The pictures were taken on 7<sup>th</sup> February 1997 and 30<sup>th</sup> November 2022.
