# RAILS TO THE BARRIER

## ESSAYS TO COMMEMORATE THE CENTENARY OF THE NSW RAILWAY SERVING BROKEN HILL.

Australian Railway Historical Society NSW Division. July 2019.

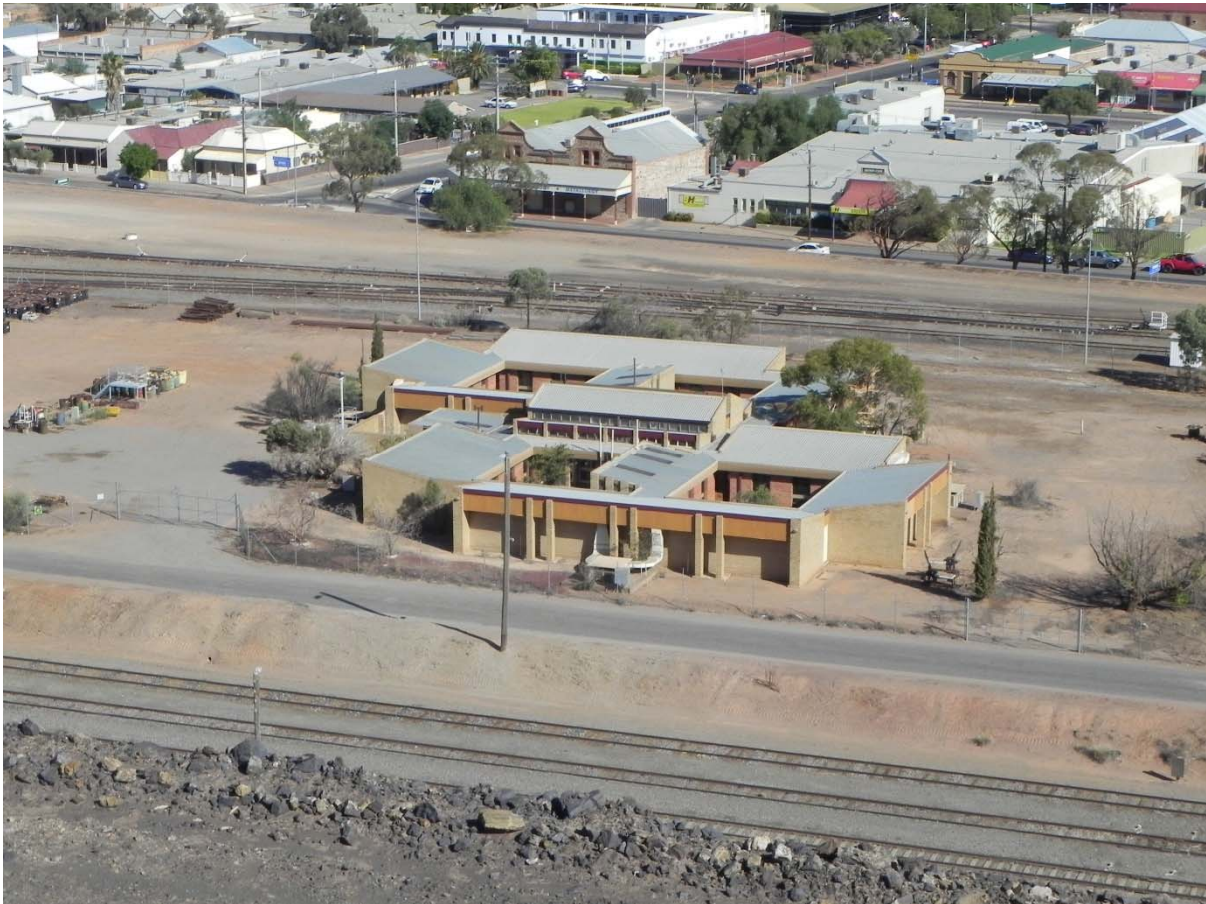
*In 1969, \$35 million was spent on structures at Broken Hill in conjunction with the introduction of the uniform, standard gauge rail service across Australia. The station building was extended, the platform straightened and lengthened, a new large goods shed and a new, joint locomotive depot were built to serve New South Wales, South Australian and Silverton Tramway locomotives in their new role of shunting the mines. The image here shows the combined rest house to accompany the new locomotive depot. It is not the interesting design, nor the appropriate colour of the bricks that are most striking aspect of the project. It is the commitment to care for the railway staff that is the key message derived from an examination of the building. Even in 1969, people in powerful positions acted in a caring manner to ensure staff were well-rested and at no expense to them when they were a long distance from their homes. Image by Gary Hughes on 5<sup>th</sup> March 2019.*

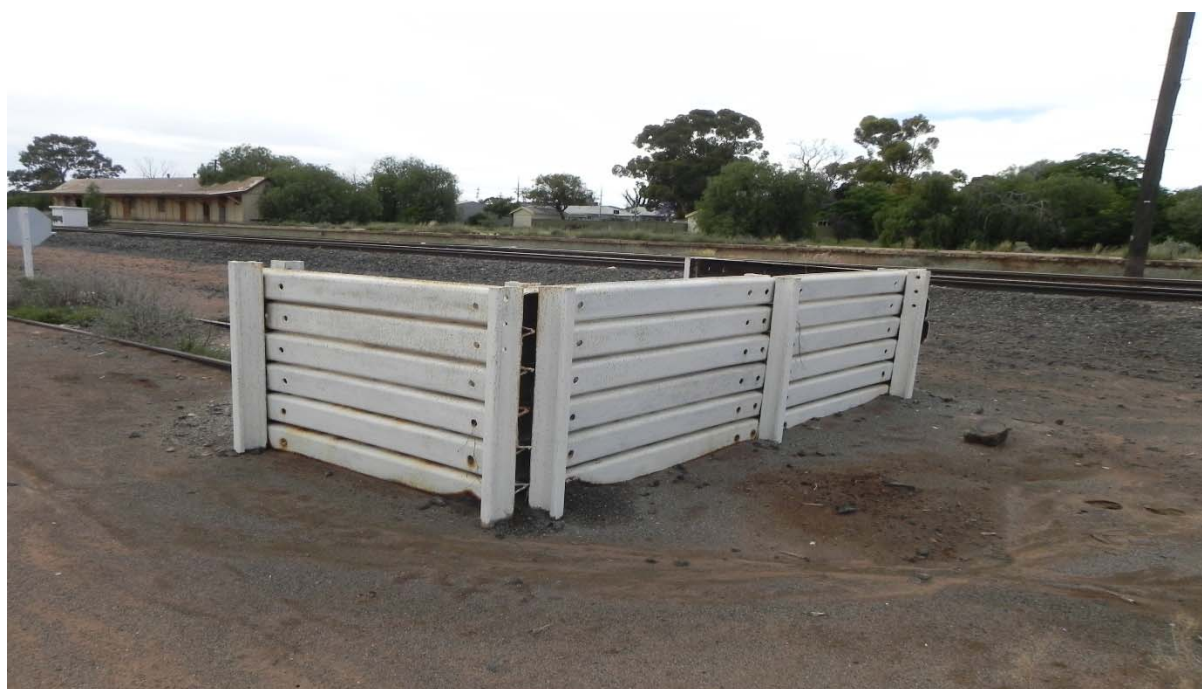
*The ash stop terminates a siding adjacent to the Iodide Street level crossing of the main line. Like many places on the NSW rail system, steam locomotive ashes have been used as buffers to prevent vehicles leaving the rails in sidings, especially in places as this where there is a nearby road. What makes this no ordinary ash stop is the recycled use of steel sleepers, which had been laid in the 1950s as an experiment. Unfortunately, they had to be removed because they were unstable in the sandy soil conditions. Old rails have been used for the posts. The NSW Railways is perhaps the oldest recycler in the State and was re-using materials for approximately 130 years from 1855 to 1985. The ash stop is a relic of the culture of the railway organisation and is evidence that the railway staff in Broken Hill actively participated in the recycling philosophy. The 1919 station building is in the distance. Image by Gary Hughes looking towards Sydney on 6<sup>th</sup> December 2010.*

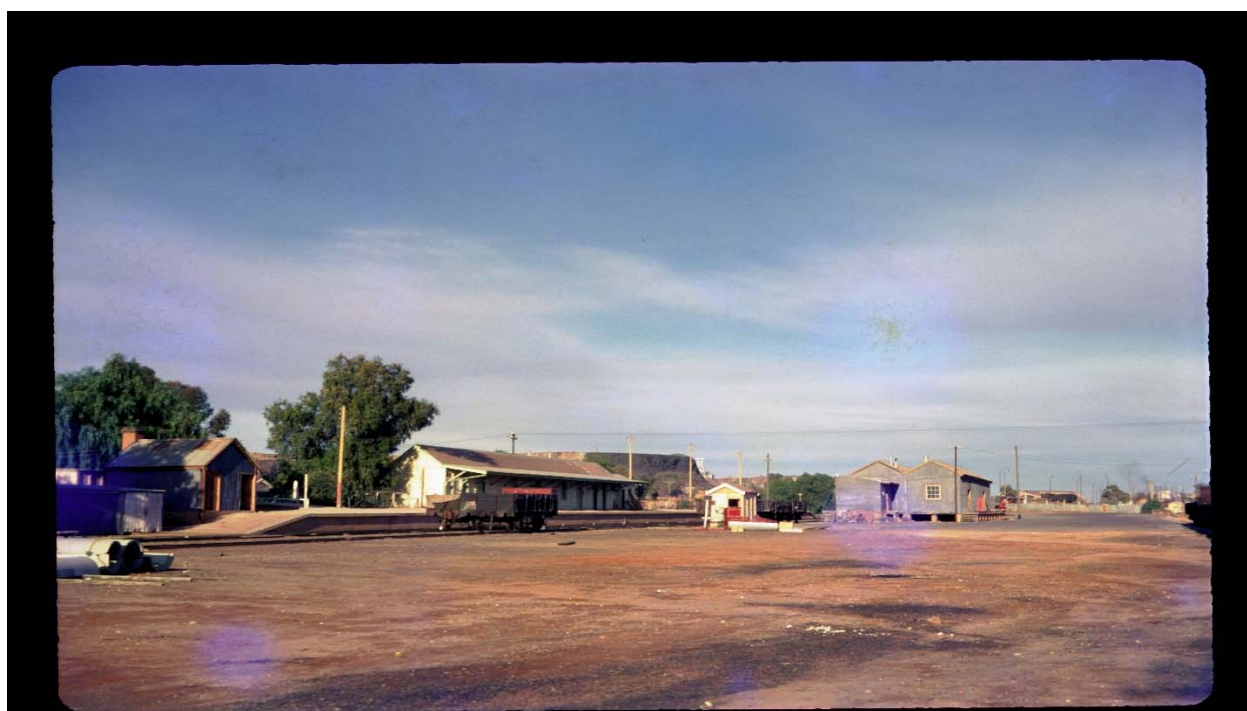
*The first Broken Hill station site in 1962. The different roof colour at the far end of the platform building denotes the addition of the ladies' waiting room and toilet in 1927. The roof of the building at the end closer to the camera also shows the addition (for an enlargement of the parcels office), but it is masked by the shadow of the tree. The 1942 signal box at the western end (right-hand side) of the platform building exists, having been renamed Broken Hill Yard Box in 1957. It closed in 1970. At the extreme eastern end of the platform (left-hand side), there is a corrugated iron shed belonging to per way staff. Note that only the timber work has been painted. Behind that structure was the male toilet. The goods shed has an unusual design of double-gable roof. This was a very rare roof style on the NSW Railways, the only other examples being at Camden and Taralga. Note the absence of urban development. The station site was on the fringe of the city. Image No. 064652, ARHS Resource Centre.*

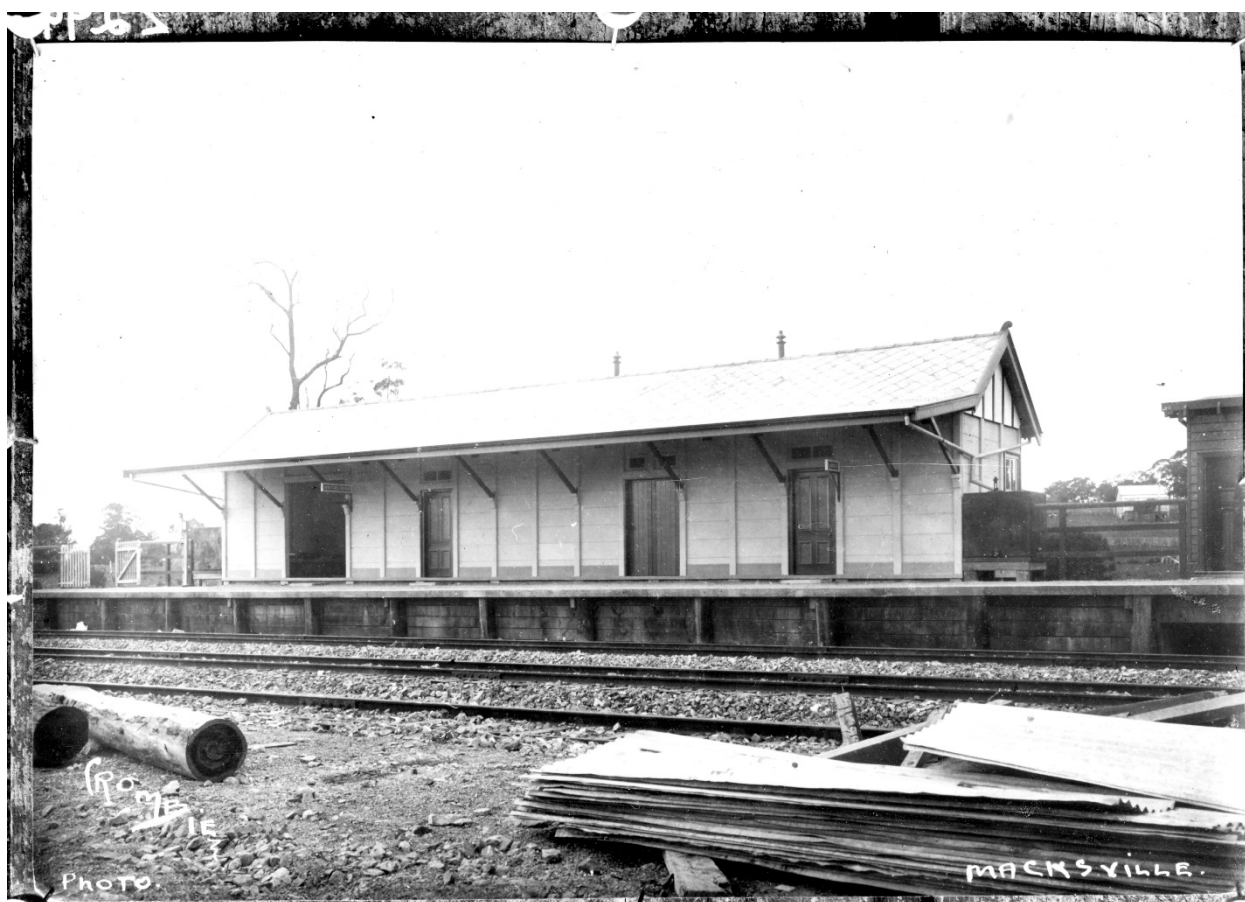
Concrete unit buildings of similar size to that at Broken Hill were erected at Macksville, Bombala, Ballina, Eugowra, Rankins Springs and Hillston. These were all puny places of much lower importance than Broken Hill. The photograph shows the example at Macksville, which is extant. One interesting aspect is the timber platform wall, which was applied to all other examples apart from the one at Broken Hill. Why? Was the experimentation with concrete poured in situ part of an intended insult to the city? No doubt many Broken Hillites thought that way. Image No. 007758, ARHS Resource Centre.

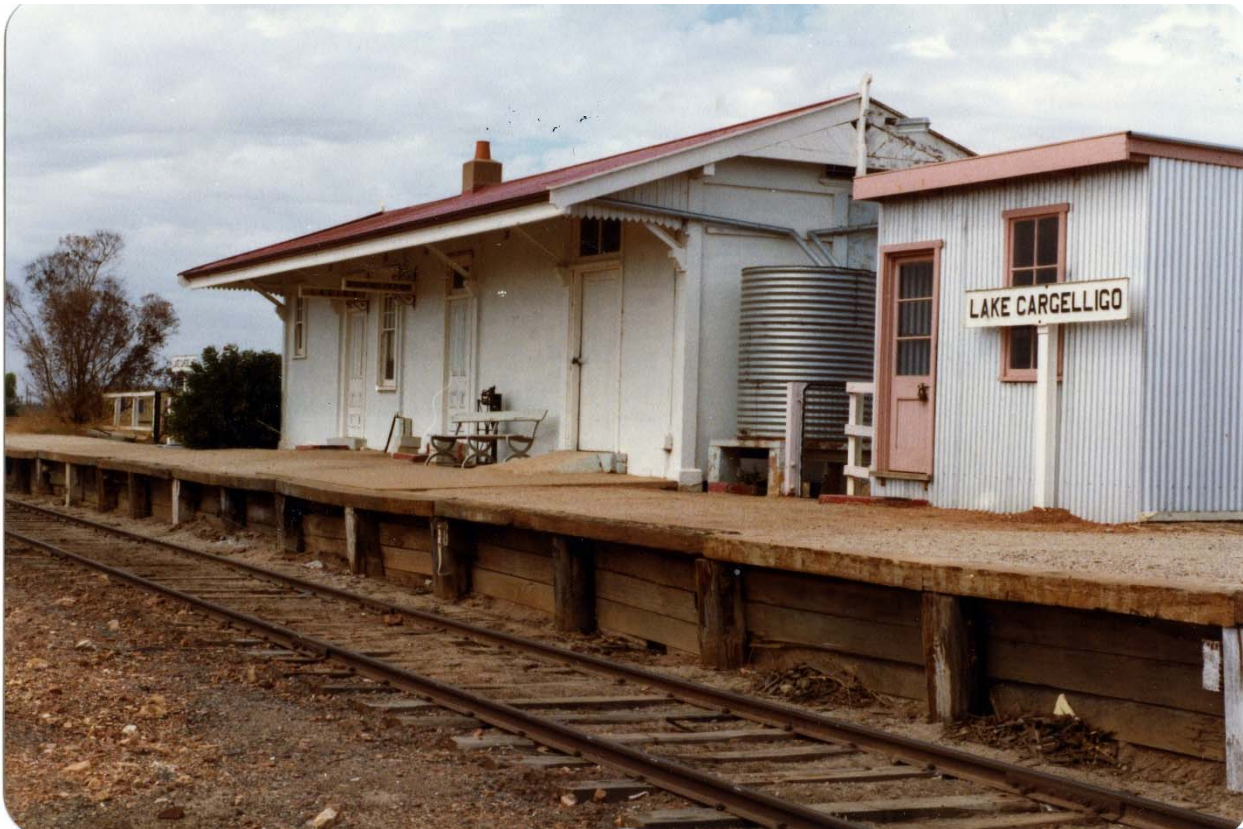
*The prototype for the introduction of concrete unit platform buildings was built at Lake Cargelligo in 1918, the year after the line opened to that centre. It was a one-off experiment and the following features were not provided on subsequent examples, including the Broken Hill building: rendered external walls; brick chimney; extension of roof rafters to form a platform awning; gables formed by timber boards; finials on gables; high-level corbels to support the awning braces and six-panel external doors. Photographed by Ray Parr in 1982. Image No. 017540, ARHS Resource Centre.*

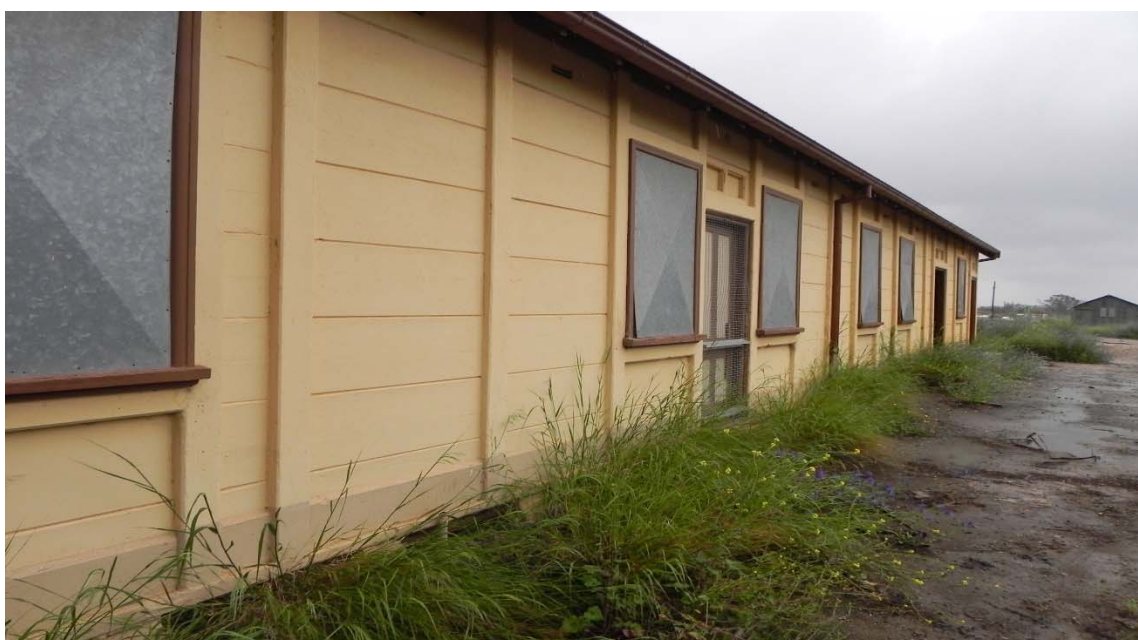
*The large-sized concrete units forming the walls featured a profile at their top edge that was not repeated on other concrete station buildings. Later units of this large size had flush joints. This type of concrete construction is often referred to as post-and-panel work. Note the four-panel door marking the pedestrian entry, a door style that was different to the prototype at Lake Cargelligo. There is a plinth at the bottom of the wall which has been painted a different colour. The use of plinths was questionable on a building where expenditure was minimised. They played no functional role. Image by Gary Hughes on 15<sup>th</sup> October 2010.*

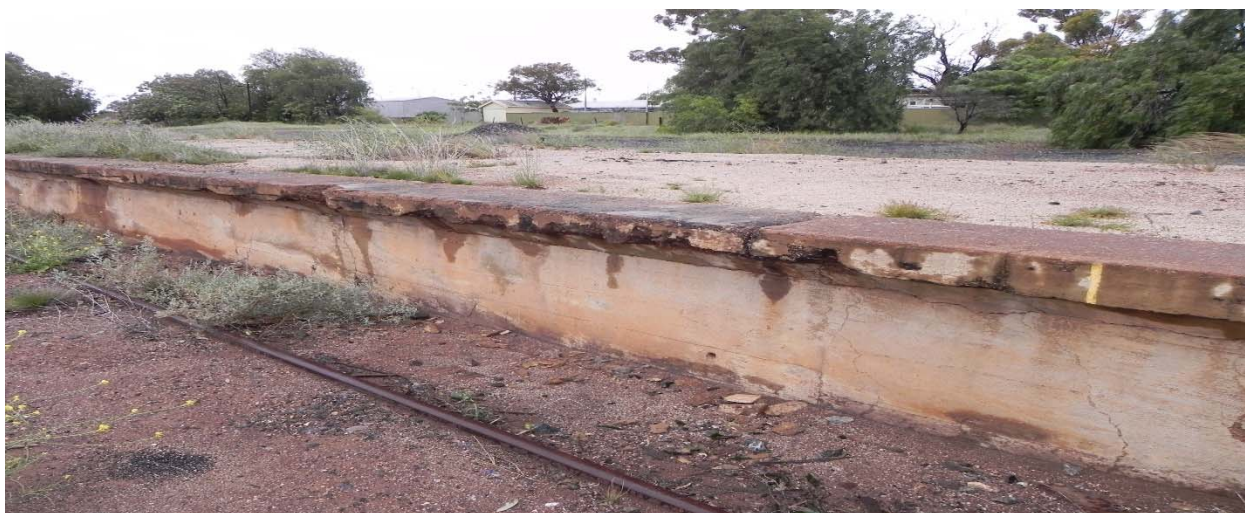
*This image shows the faint diagonal outline of the edge of the ramp at the western end that marks the end of the 1919 platform and the start of the 1927 extension. The mass concrete wall was poured off formwork and was experimental when built in 1919. Why punish poor Broken Hill further after the insult of a disgraceful platform building? The unusual profile under the coping was never repeated after 1919. Image by Gary Hughes on 15<sup>th</sup> October 2010.*

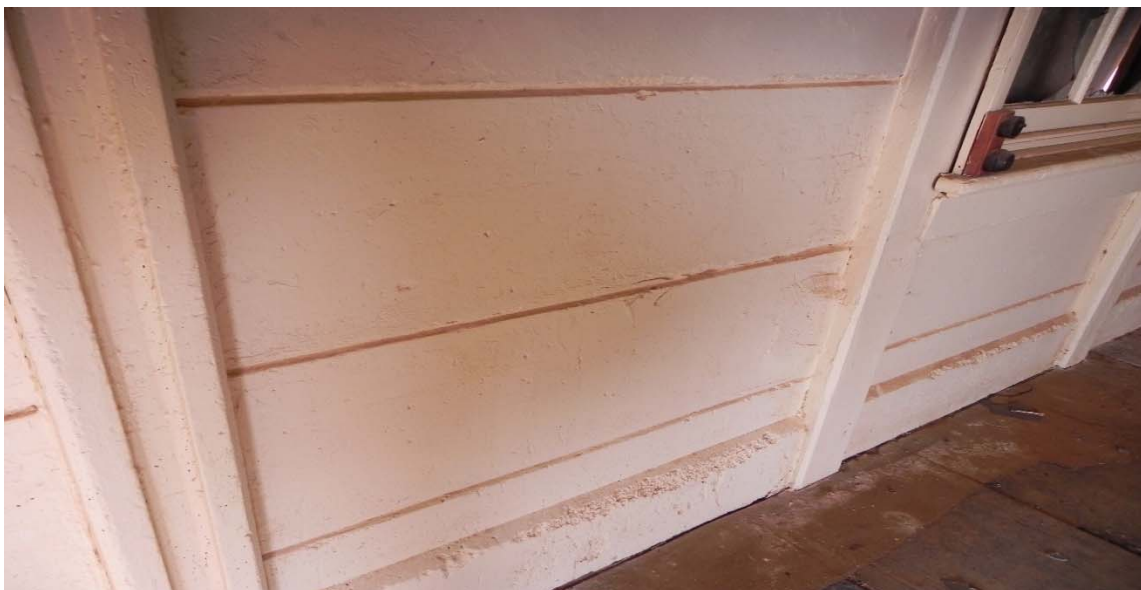
*What do the concrete units look like on the inside? Just the same as the external surface, with the unusual profile of the top edge. What about the pink colour? Should one expect to see natural colours, such as browns and greens? It is all about time. From 1950, the NSW Railways started to change its building colour policy and it was Broken Hill's turn in 1954. The pastel pink was introduced widely from the 1950s and was accompanied by pastel green and pastel blue. Note the plinth at the base of the wall. Image by Gary Hughes on 6<sup>th</sup> December 2010.*

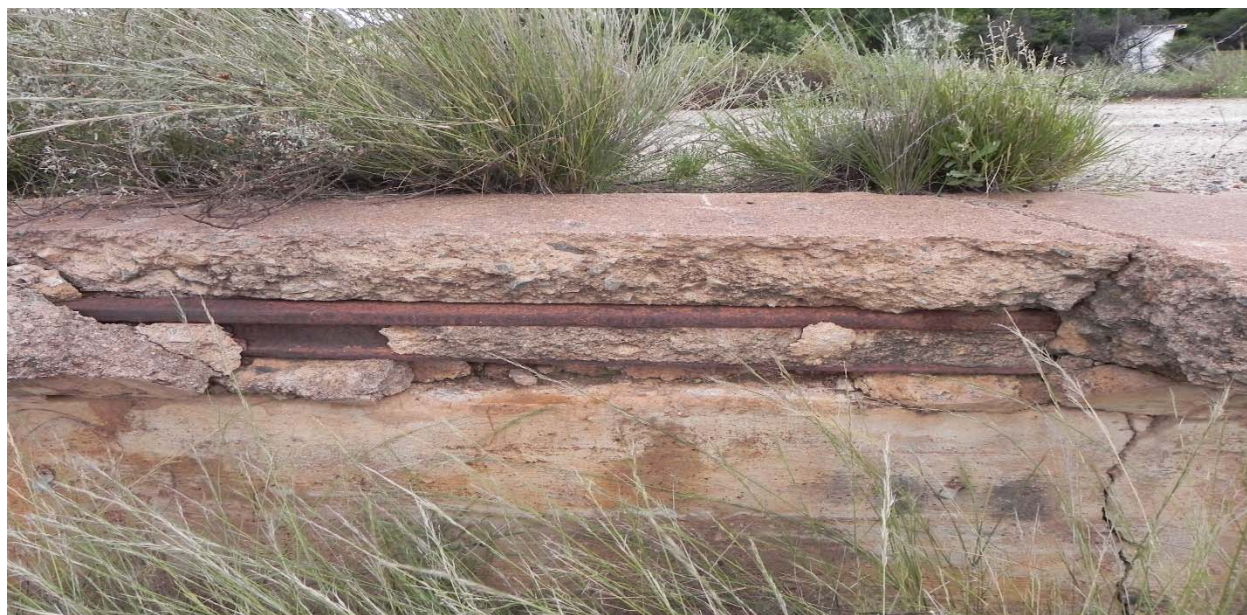
*The colour of the concrete indicates that local materials were utilised. Also, old rails were used to build the platform frame. Old rails continued to be used for platform construction up until the 1980s. They became very popular in the 1950s when a standard type of platform was introduced, known as the Cowan type, as that was the first location where the prototype was located. The platforms were open-fronted (i.e. no earth fill) using a frame of old rails with front and back cross bracing and a reinforced concrete deck. Image by Gary Hughes on 23<sup>rd</sup> March 2011.*

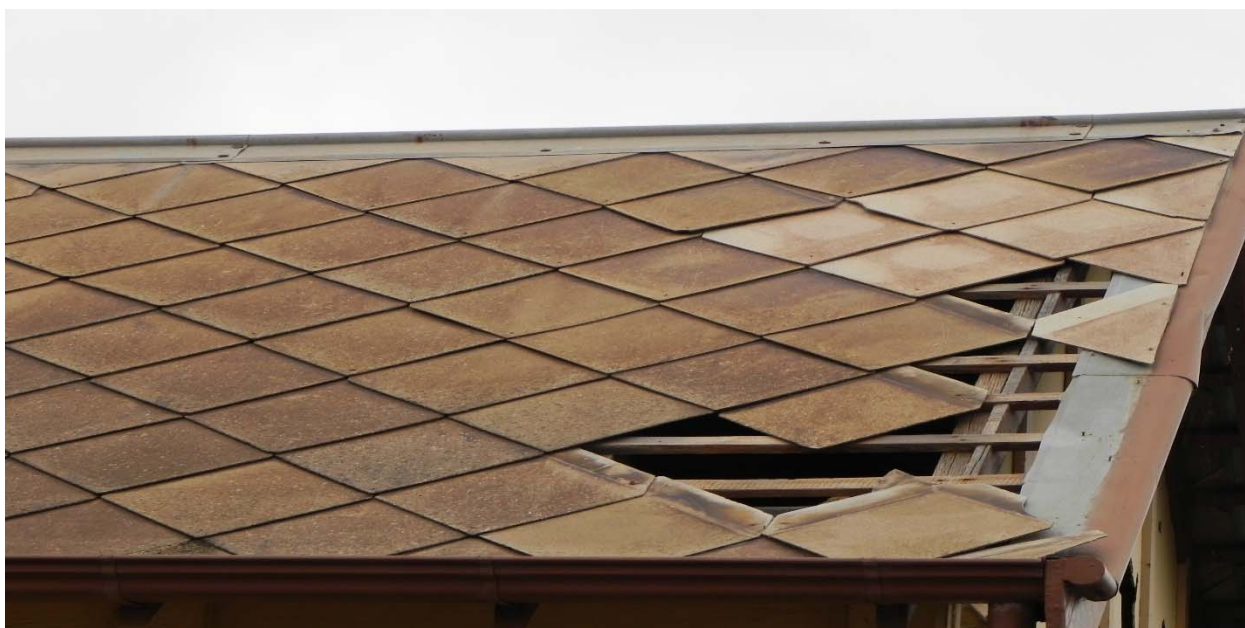
*This image by Gary Hughes on 23<sup>rd</sup> March 2011 shows what the Department called “asbestos cement slates”. That was a contradiction in terms, but it broadly defined the size of the sheets. They were set in the diamond pattern. This product was used for the initial examples of concrete structures but, after the mid-1920s, large corrugated asbestos cement sheets were used in lieu of the small individual “slates”.*

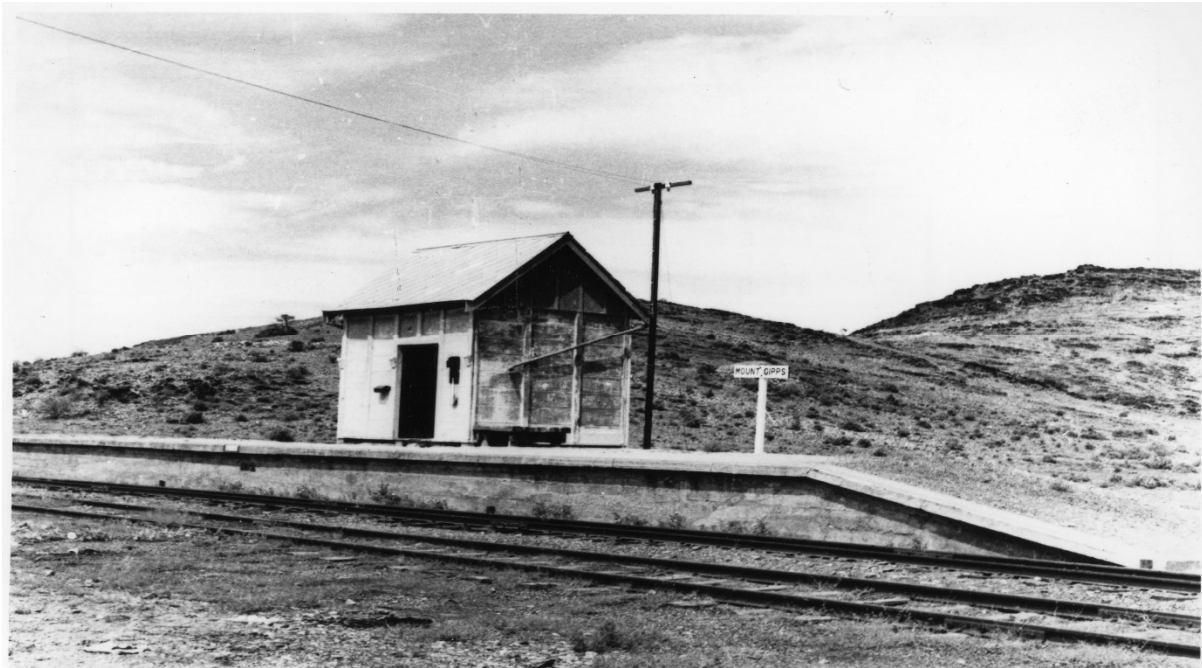
*Mount Gipps station in about 1970 showing the “shelter shed”. On the left of the open-front is a small container in which messages were placed for the local track gang. On the right-hand side, is the round disc to alert trains to stop at the station. The three corbels to support a future platform awning are visible on the vertical posts. The rainwater tank has been removed, probably stolen, but the timber stand remains. The telegraph pole indicates that a telephone is located inside the shed. The surviving residence is located to the left on the Sydney side of the station a little less than a kilometre distant. While the goods loop is extant, the Department of Public Works siding closest to the camera has been removed. Image No. 034697, ARHS Resource Centre.*

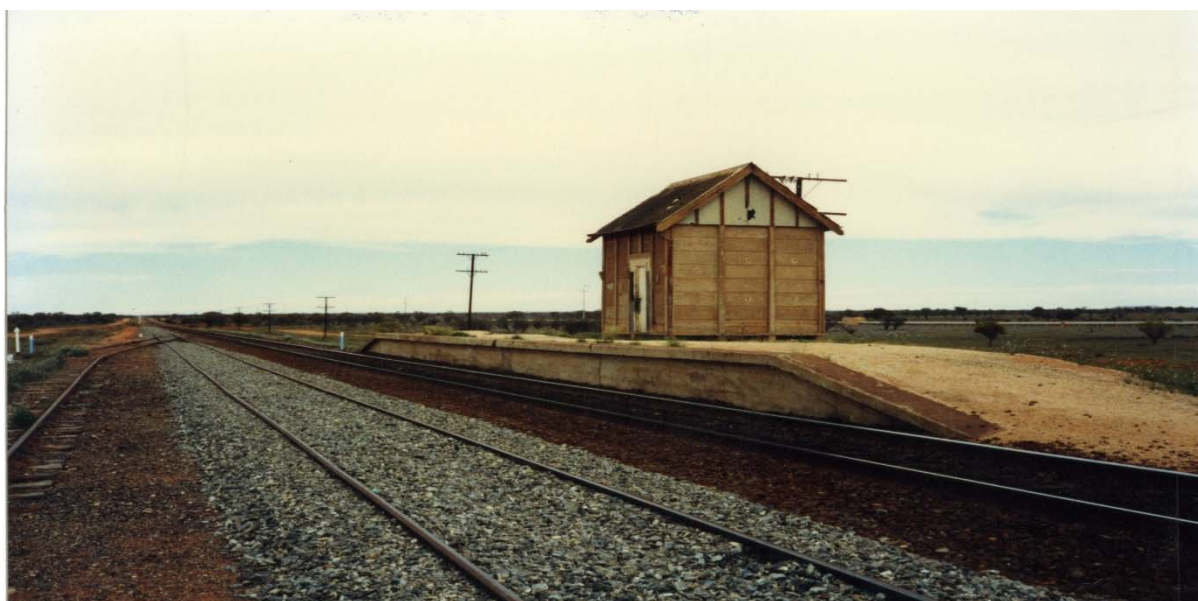
*This is Box Tank, but the image enhances the interpretation of the same type of structure that was at Mount Gipps. The external concrete walls have been painted in the traditional colours of the New South Wales Railways, a palette which lasted from 1855 to 1951. The walls have been painted in the colour of mid-stone while the timberwork, as seen on the roof gables was painted in dark-stone. As was intended, the asbestos cement sheets on the gables were unpainted. The original white colour of the asbestos cement slates on the roof has turned black because of the incessant deposit of locomotive smoke and dirt from the occasional rain shower. It appears that a door has been fitted to the opening into the shelter shed. Once again, the corbels to support a future platform awning are visible. The 100 feet long platform, the absence of a fence at the rear of the platform, the 15 feet long ramps, graded at 1 in 20, and the station building at The Gorge were the same. Graham Harper tells us that the well-ballasted loop line was provided in 1941 which could be opened and closed as required. In addition to a traffic officer to take charge of the operation, an officer from Signals and Telegraph Branch had to attend the opening/closure to provide the correct key for the procedure. The Box Tank loop was taken out of use altogether on 26<sup>th</sup> February 1952, but was re-opened on 1<sup>st</sup> September 1965 as the same type of loop with the same operating procedures as the 1941 effort. Finally, in 1986, it was taken out of use for the last time, along with the goods siding. Undated image No. 027881a, ARHS Resource Centre.*

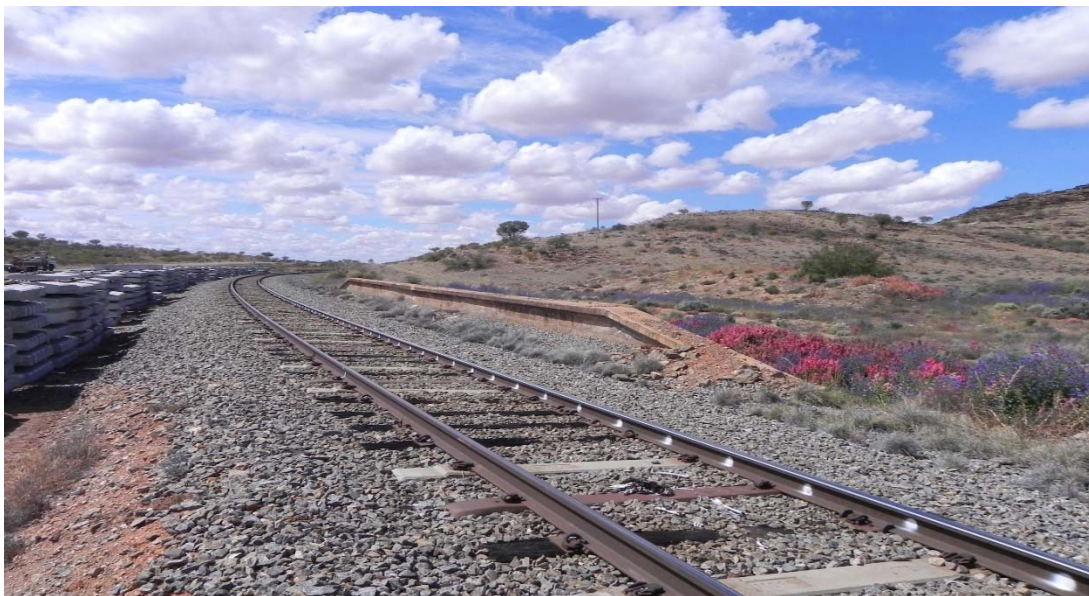
*The platform wall at Mount Gipps facing towards Sydney. The track has been re-aligned away from the 1919-built platform wall. The construction of the wall by the use of mass concrete poured in situ off timber formwork was an experiment and not later repeated with the construction of other concrete unit station buildings. Note the steel sleepers under the rails, which were about to be replaced. Image by Gary Hughes on 12<sup>th</sup> October 2010.*

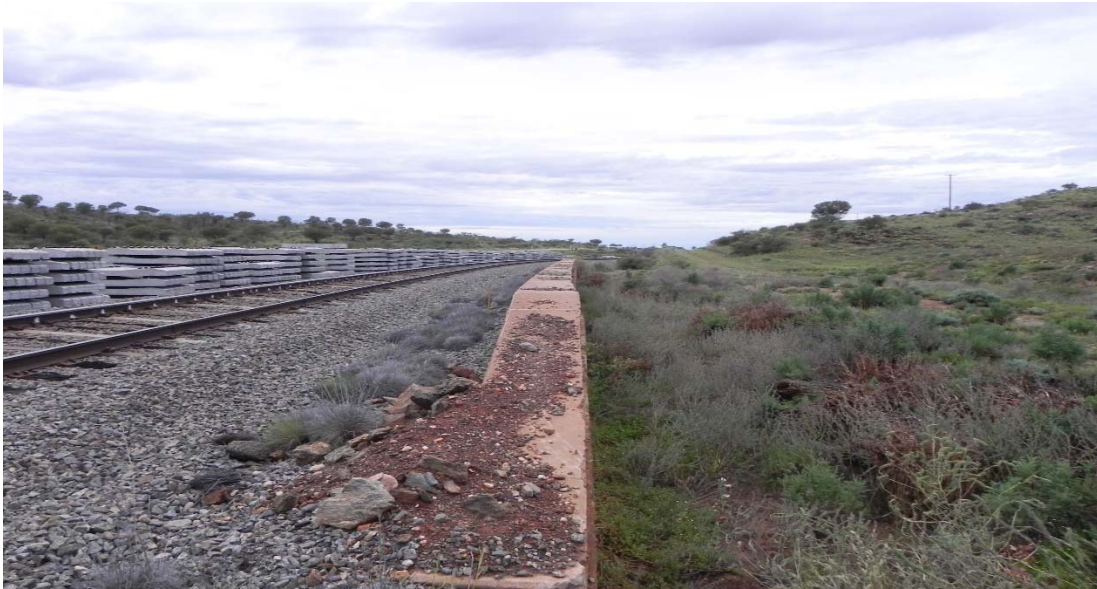
*Was the platform at Mount Gipps on a curve? Yes, but of the slightest radius. Image by Gary Hughes on 12<sup>th</sup> October 2010.*

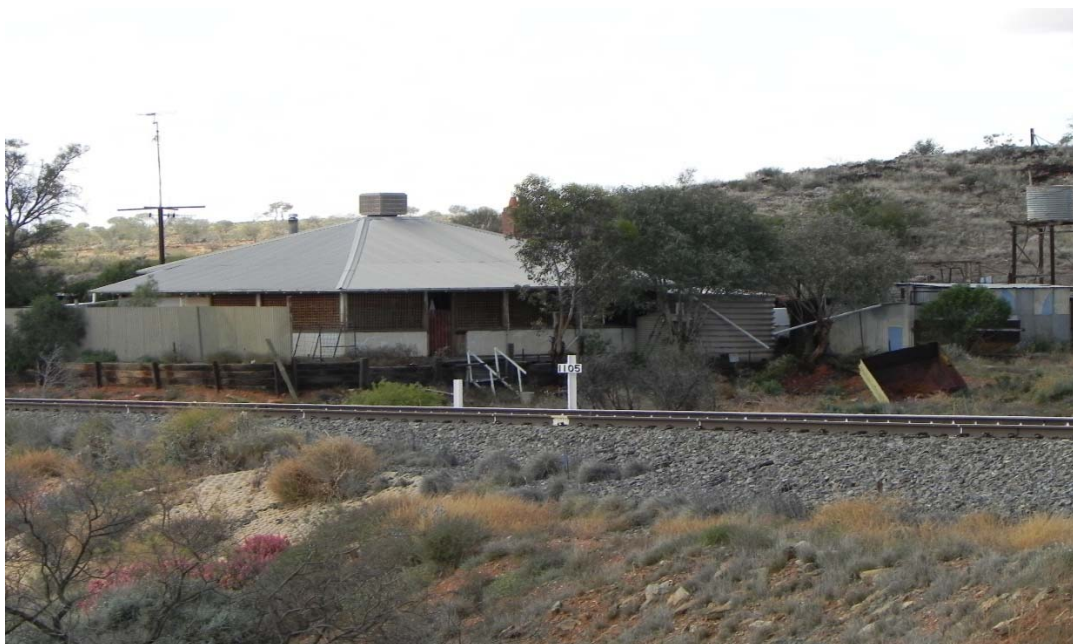
*This is the remaining one of three residences built in 1953 for members of the track gang. The design features were: low-pitched hipped roof; wide verandahs on three sides; weatherboards fitted to external walls to the height of the window sills and asbestos cement sheets above the sills & three rainwater tanks. Image by Gary Hughes on 12<sup>th</sup> October 2010.*

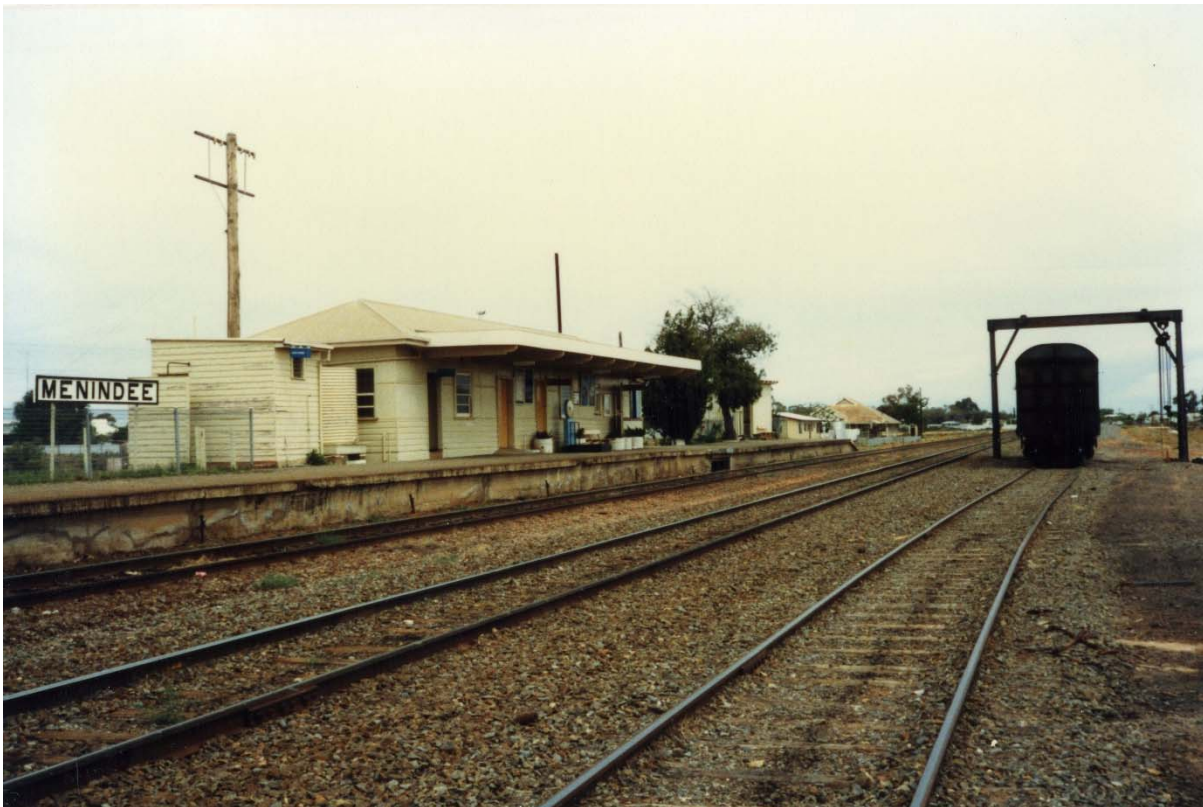
*This was the Menindee station which existed prior to the establishment of Countrylink in 1989. The main building is mostly in original condition, with the weatherboards terminating at window sill height and asbestos cement sheets above. The provision of detached male toilets on platforms was a 1959 feature. It was part of a programme in the late 1950s and 1960s to eliminate the smelly, off-platform male toilets on many minor lines since Adam was a boy. Although undated, the photograph was taken in or after 1985 as two residences are shown at the right, just beyond the platform. The one closer to the camera was built in 1985 as a “transportable house” and the residence further away (with the dominant roof) was erected in 1946, being the first official residence where the external walls were completely covered with asbestos cement sheets. Before 1944, there was an interlocking frame on the platform where the gap in the platform wall is located. With the construction of the existing building, the frame was enclosed in the Station Master’s office. It is unknown whether a signal box protected the pre-1944 frame. Paul Horder in 2013 photographed under the building at the Broken Hill end. He discovered that the original frame was still on its original mass concrete foundation with 1940s-vintage piers supporting timber floor beams to the right. Have you seen other places where the Department has used orange paint? Of course, you have. The use of orange became popular in the 1960s and 1970s for platform seats and replaced the traditional green hue for platform furniture. Photograph by G. Dorman and is image No. 027880b, ARHS Resource Centre.*

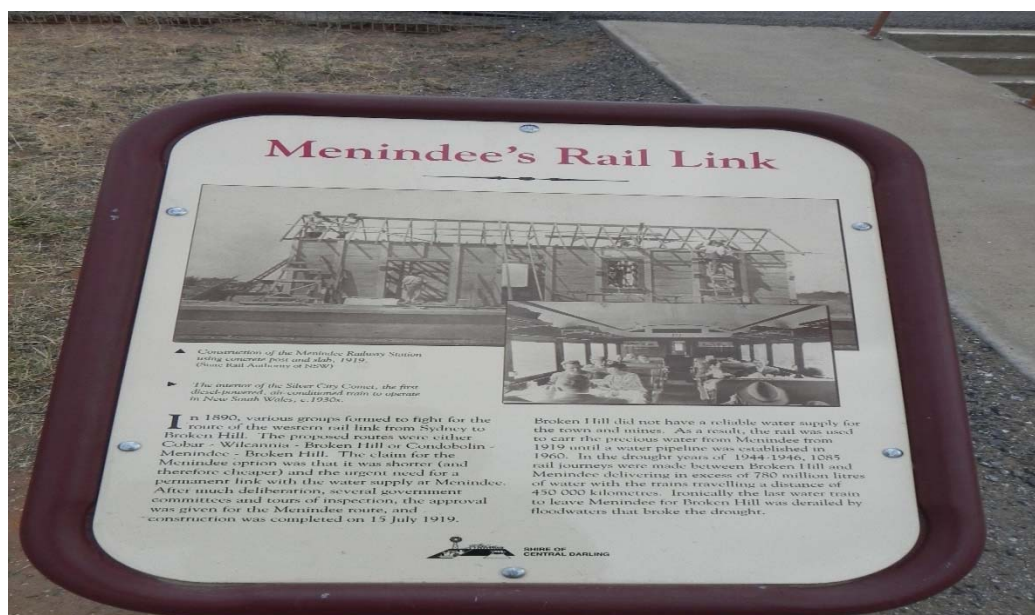
*Gary Hughes took an image of the information plaque at the station on 25<sup>th</sup> October 2013 which shows construction of the concrete unit building in 1919. It was only the provision of the roof system that was the main item requiring the attention of a number of tradesmen. The doors and windows were standard sizes and were usually pre-made in Sydney workshops and delivered to the worksite. Whether that occurred in the case of buildings on the Menindee-Broken Hill line is unknown.*

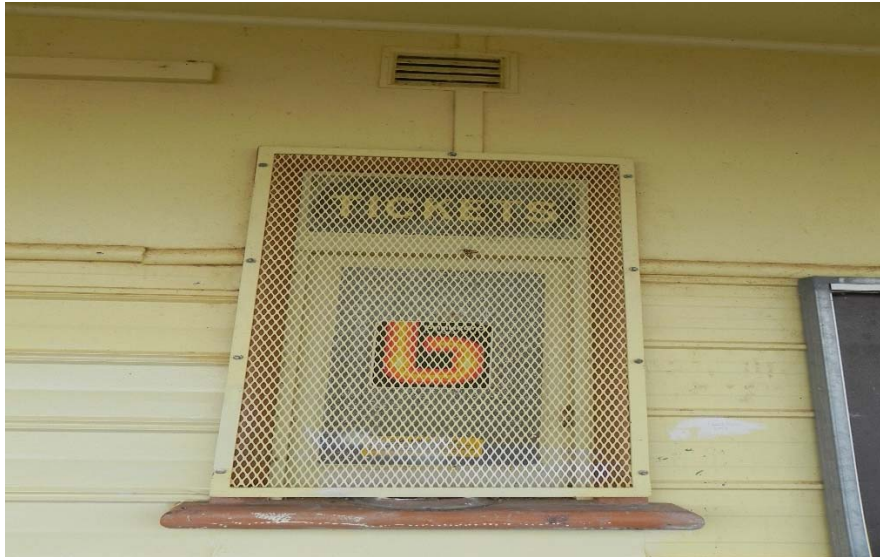
*The ticket window faced the platform in the 1944 building – a highly-irregular practice for the NSW Railways before 1930. The change took place starting with buildings on the then new East Hills line in 1931. The two different wall materials in the Menindee structure are obvious. The use of the “Bankcard” sign suggests that it had been a long time since coaching business was conducted through the ticket window. Worthy of mention is the vertical cover strip between the adjoining asbestos cement sheets. Their use was under-emphasised compared with the cover strips for the horizontal joints. Photograph by Gary Hughes on 13<sup>th</sup> October 2010.*

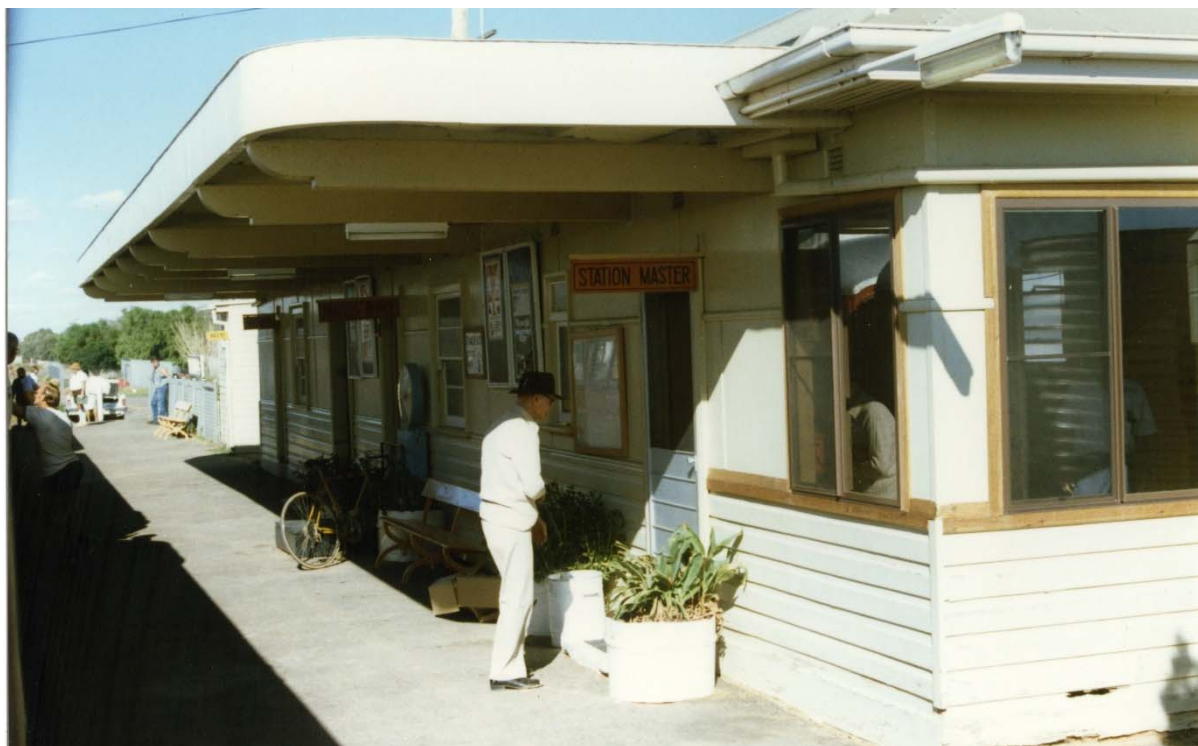
*This photograph, taken by G. Dorman on 18<sup>th</sup> March 1985 shows some structural changes to the 1944 building, notably the metal door to the Station Master's office and the new, metal-framed windows. The room tablets (i.e. small signs) were metal. A new platform scale is in service. The underneath of the platform awning, known as the soffit, is unlined. The ticket window is located immediately on the left side of the man. The platform seat appears to have been in that position since the station opening in 1919. Its base is formed by a set of inverted steel "U" brackets. It contrasts with the new style of platform seats provided with the 1957 Broken Hill station. Image No. 027880a, ARHS Resource Centre.*

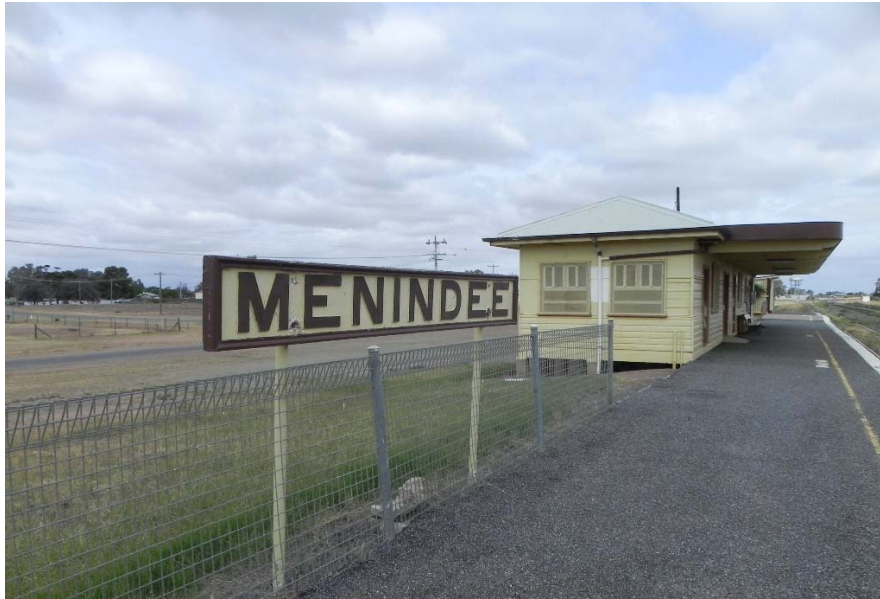
*Gary Hughes took this photograph on 2<sup>nd</sup> June 2017. The original weatherboards are those below the window sills. The replacement of the original asbestos cement sheets above the sill level with aluminium siding, though with a contoured profile, occurred sometime between 1985 and 2000. Note the colour scheme applied to the station nameboard. Surely, the paint scheme is incorrect and should be black and white? No. starting in 1951, the traditional colours used by the Department started to change and the use of creams, browns and yellows were widely used. Thus, the choice of paint colours is probably authentic. The galvanised, roll-top fence was installed in the 1960s. Fencing was originally provided at only the Sydney end of the platform and consisted of a single rail.*

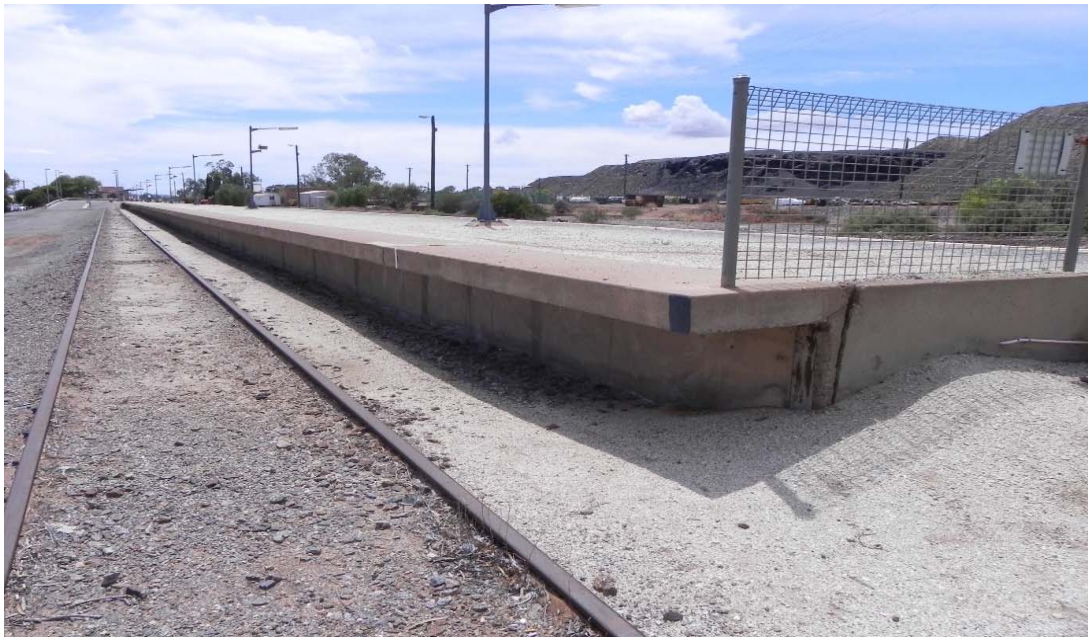
*Several facets of the 1969 and 1970 changes associated with the uniform gauge opening were architecturally harmful to the station building. However, there was one aspect that demonstrated some good thinking had taken place. When the platform was extended in the direction of Adelaide, the platform was formed to serve a back platform road under the name of a “Platform Shunting Neck”. By the alignment of the track to serve the back platform, provision was made to allow easy cross-platform changes between New South Wales and South Australian passenger trains. While such thinking was most admirable, the back platform was rarely used for cross-platform passenger transfers. As is seen in another image, South Australian trains used the main platform. Image by Gary Hughes on 6<sup>th</sup> December 2010.*

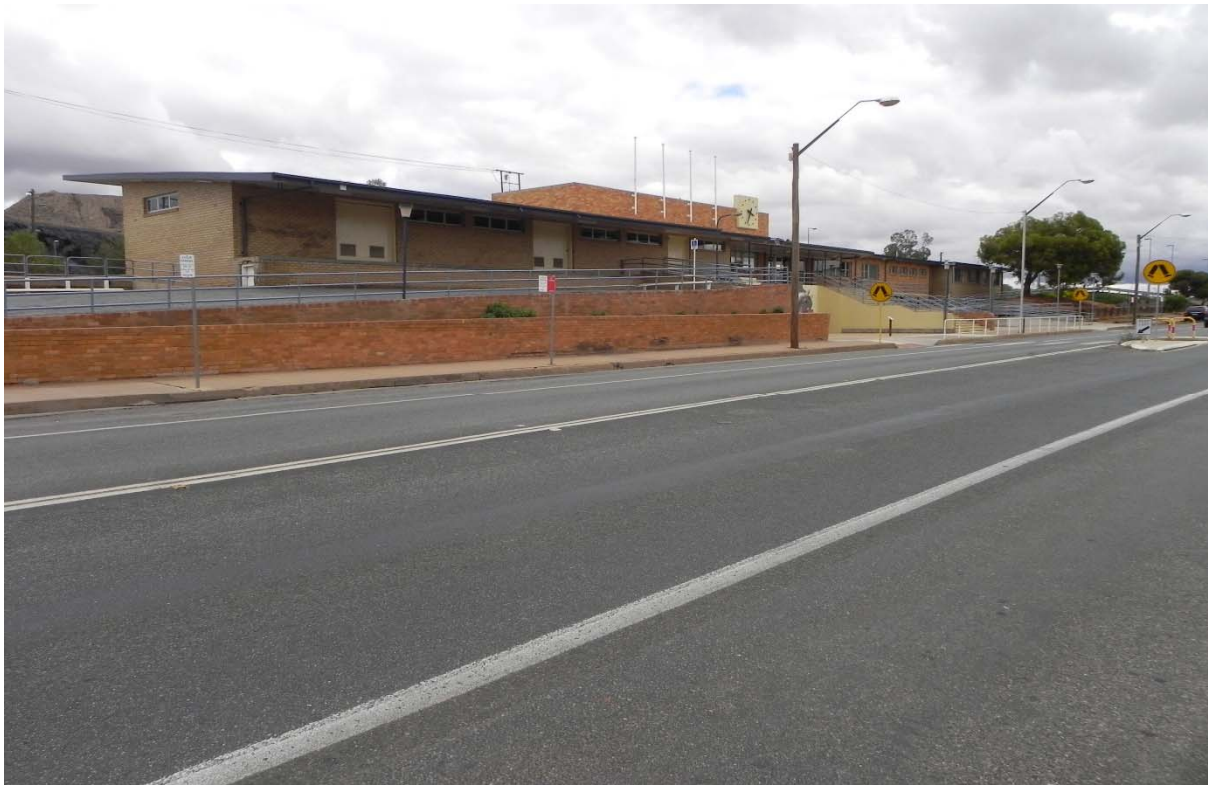
*This image by Gary Hughes on 13<sup>th</sup> October 2010 shows the same colour bricks used in the ramp retaining walls as were applied to the 1957 building, confirming the existence of the ramp in the original design. Note how the blonde-coloured bricks used for the parcels extension have been extended beyond the roof pediment almost to the pedestrian entry. This addition went a long way to ruining the symmetry of the original structure. The elimination of the gardens facing Crystal Street is also notable.*

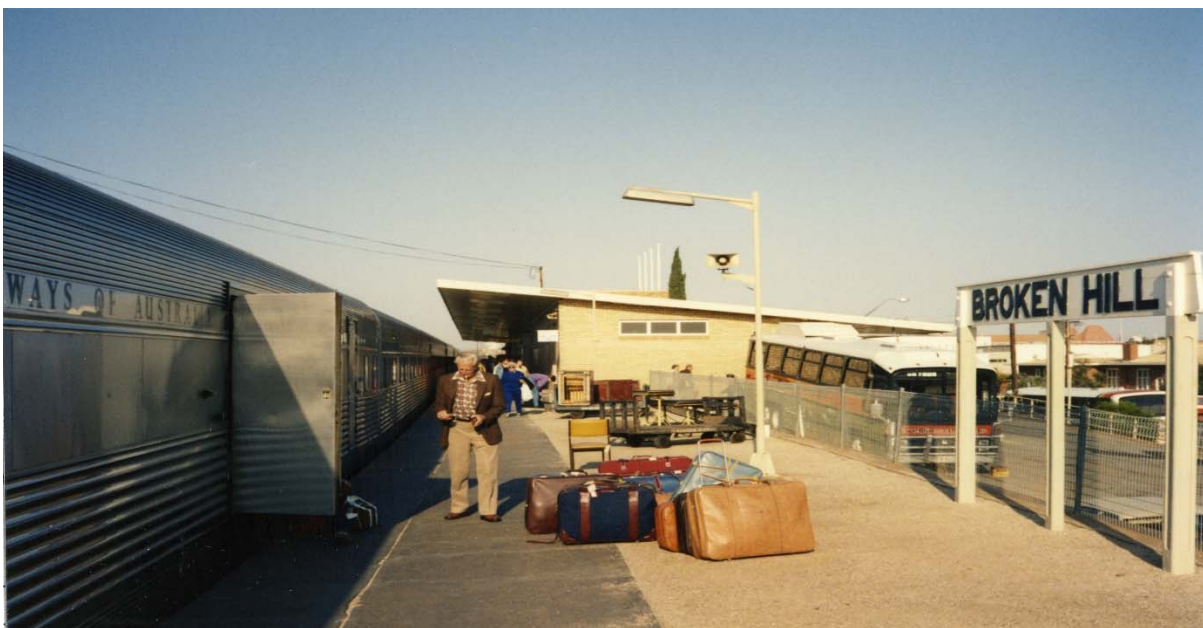
*The undated photograph above was taken by G. Dorman and shows some original and recent features of the station. In the original category is the station nameboard which is attractively shaped at the ends and is supported by three timber posts which have been elegantly fluted on all faces. It remains in position in 2019 – hopefully. When the building was extended in 1970, the original fencing at the rear of the platform was replaced by the role-top galvanised wire fencing, which was extremely popular with the Department of Railways. It did not need painting and did not rust. The one design blunder of the station was the 20 steps from Crystal Street to the entry foyer. The ramp on which the bus is located was provided in 1957 and has become the main access to the platform for both pedestrians and vehicles. The light standard is new and was erected as part of the 1970 “improvements”.*
