# RAILS TO THE BARRIER

## ESSAYS TO COMMEMORATE THE CENTENARY OF THE NSW RAILWAY SERVING BROKEN HILL.

Australian Railway Historical Society NSW Division. July 2019.

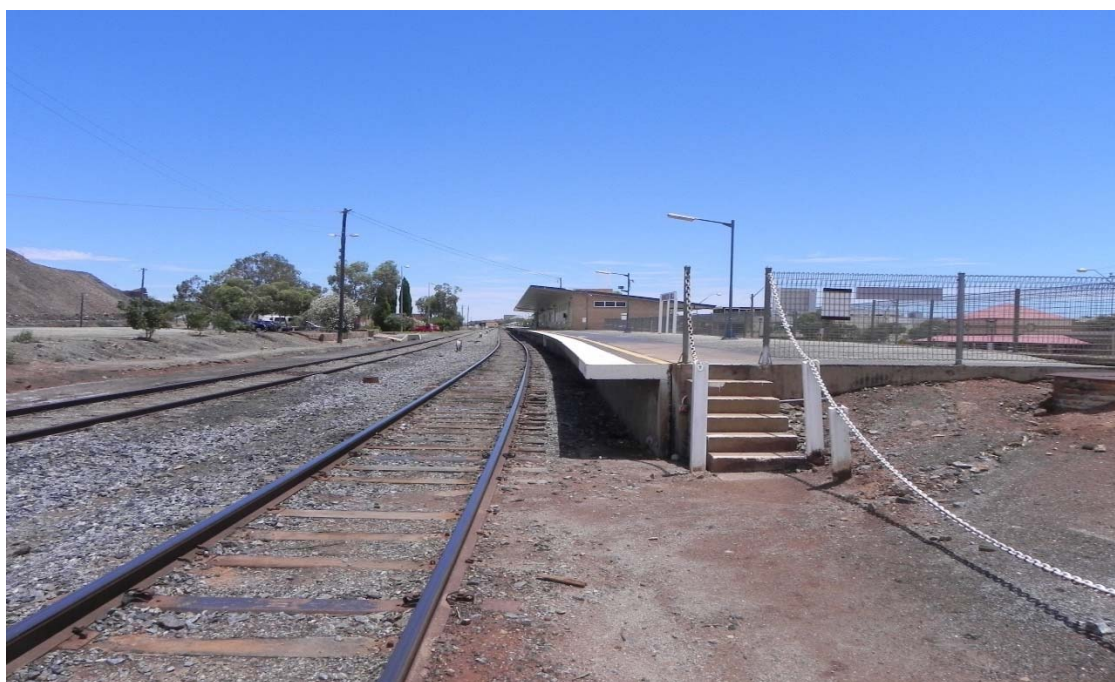
*When the station opened in 1957, the platform wall was an “S” shape. With the opening of the trans-Australia standard gauge line in January 1970, the curve at the Adelaide end was removed as part of the work to redesignate the former dead-end siding serving the platform as the main line. However, the curve at the Sydney end remains. The platform coping was cantilevered towards the track – a design feature introduced system-wide in the mid-1930s. Another modern feature employed at Broken Hill station was the elimination of ramps*

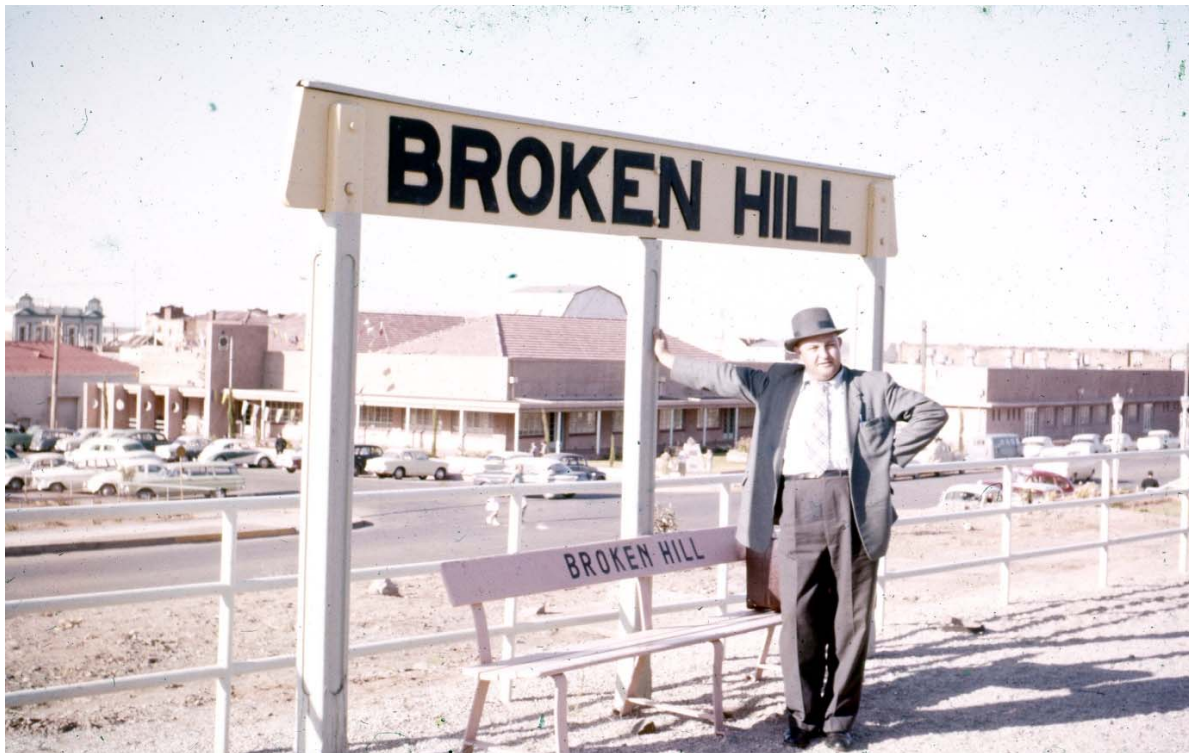
*There was only one station nameboard, which was located between the main building and the Sydney end of the platform. It was supported by three vertical timber supports which were nicely decorated with fluting on all sides. Originally, the station name was painted on an attractive, horizontal board but this was changed to metal letters at some time before 1984. The vertical posts are now nearly life-expired, and it should be no surprise at the time of the centenary visit (to the 1919 station) in July 2019 that the original nameboard has collapsed or has new support posts. Another interesting feature is the platform seat. Although the date of the introduction of this design of steel and timber seat is unknown, they were supplied to Broken Hill station upon opening in 1957 and it is possible that the occasion was the first installation of the new platform furniture. The design of the seat contrasts to those placed on the platforms at the 1919 Broken Hill station and at Menindee station. The three-rail pipe fence is original and Broken Hill was the first time the product was employed on the NSW rail system. This undated photograph by Ken Bowen is No. 170529 in the ARHS Resource Centre.*

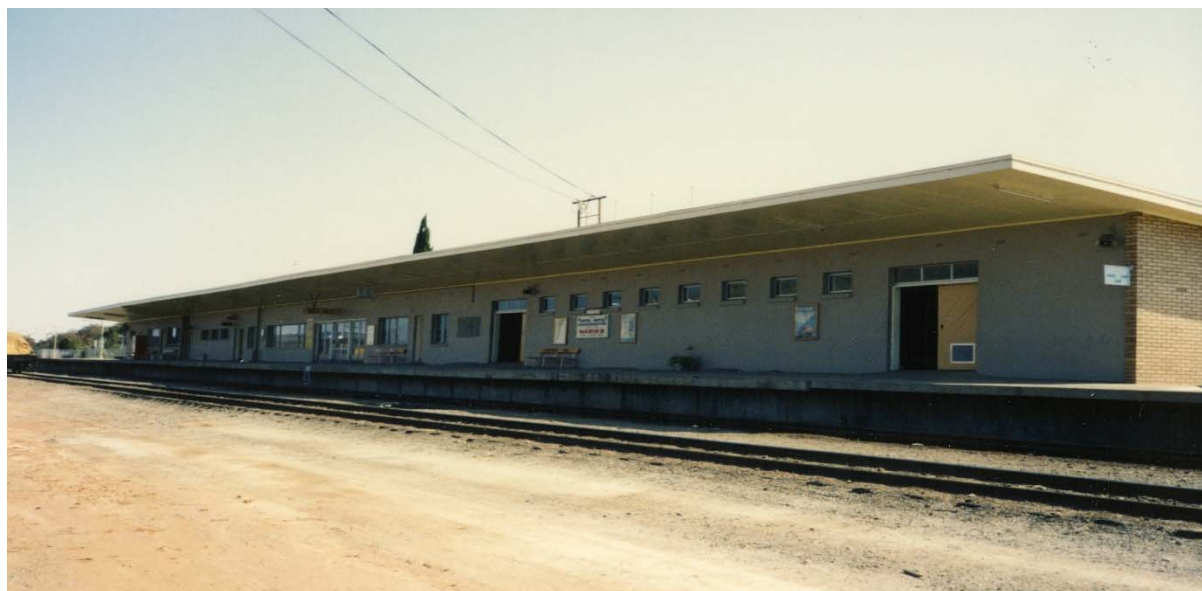
*This undated photograph by G. Dorman well shows the size of the expanded building. The high-level windows on the right-hand side denote the parcels office. The pedestrian entry and waiting room is located where the large windows are positioned towards the middle of the structure. When the 1957 building was extended in late 1969 and early 1970, the demolition of the original signal box and parcels office at the Sydney end were required and, on the platform side of the structure, the Department decided to render the entire wall to cover the use of different coloured bricks, except for the new extension at the Adelaide end, which remained as face brickwork. The original platform seats are in position, but their original green paint has been covered by the almost-universal use of orange colour in the 1970s. Image No. 027889b, Resource Centre.*

The enlarged (existing) railway station was opened as part of the \$35 million improvements at Broken Hill on 29th November 1969 by Prime Minister John Gorton to commemorate the completion of the standard gauge line across Australia.<sup>156</sup> There is an obelisk in the station forecourt to celebrate the event. The 1957 building was significantly enlarged at the time with a humongous parcels office at the Sydney end which enveloped the former signal box. The extension at the Silverton end contained rooms designated for “operators, teleprinter, ladies’ rest room and plant room. The building in 2019 retains the footprint of the 1969 changes. The 1969 extension at the Silverton end are now empty. The building enlargement was carried out by Keith D. Morris and Sons, which was a large construction contractor based in Sydney and Brisbane.<sup>157</sup>

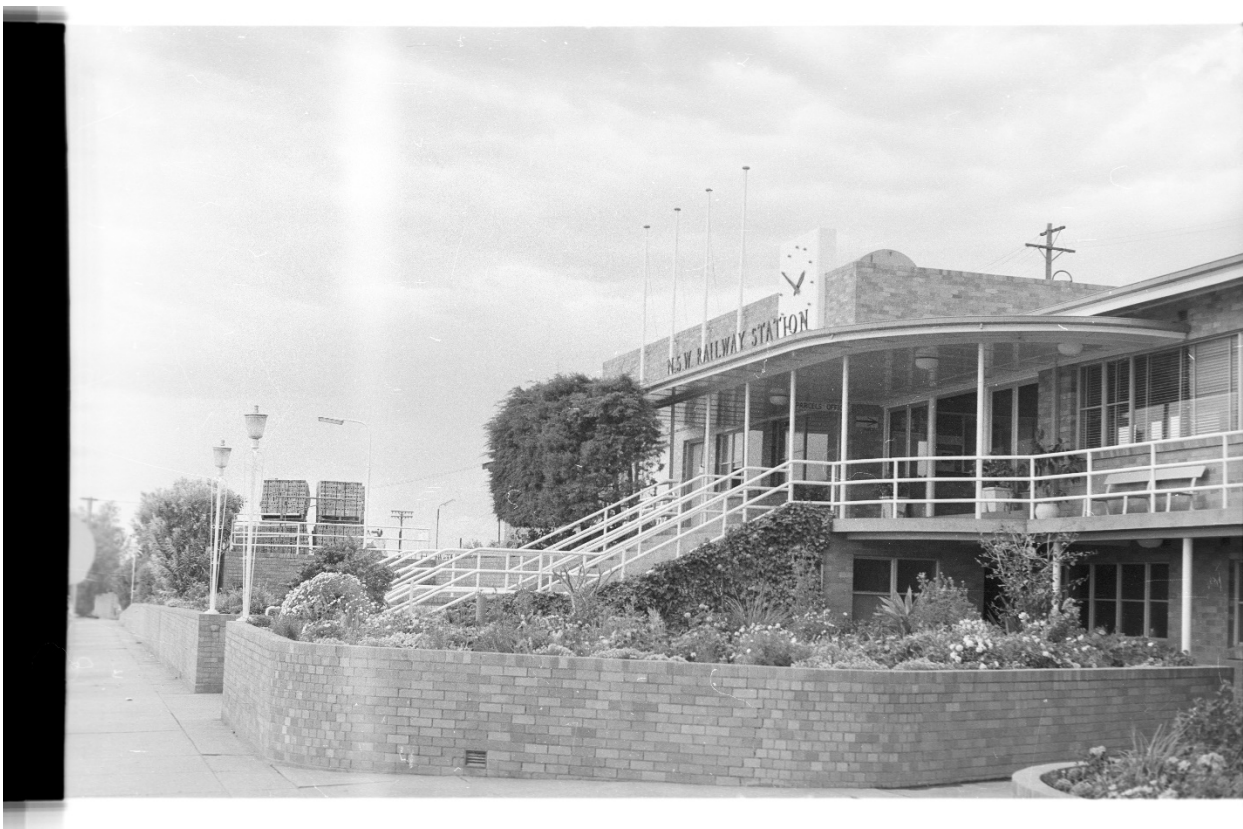
*This photograph was taken by Alex Grunbach in October 1969. The pallets of bricks on the left stand ready to extend the building at both ends for the January 1970 opening of the trans-Australia standard gauge line. The station looks magnificent in its original, 1957 form. Plants and shrubs are used on both sides of the stepway and attractive brick walls act as a retaining barriers. Elegant lamp-standards strike an imposing view at the bottom of the steps. The title of the building, "NSW Railway Station" adorns the top of the awning. A lovely feature of the design was the subtle use of curves in the brickwork facing Crystal Street. This was utilised at the bottom of the steps and to form the corners of the garden walls. Just visible behind the roof pediment is the metal radio disc used for transmission of official messages. The building was about to experience its first act of architectural brutality with the building extensions. Image No. 204406, ARHS Resource Centre.*

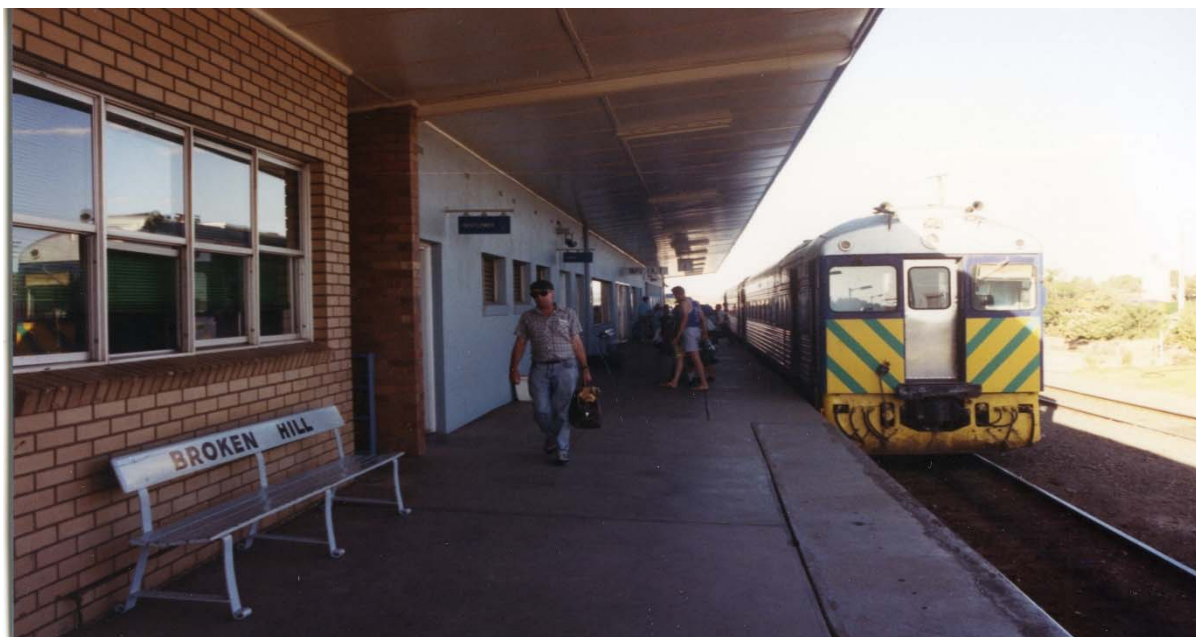
*This photograph taken after 1970 shows the building extension at the Adelaide end, which has been left unpainted. The windows at the head of the railway worker are, importantly, those of the male toilet. The remainder of the building wall on the platform side has been rendered and painted to hide the mutilation associated with the extension of the parcels office at the Sydney end. It appears that some blue paint was left over from the wall painting and was applied to the platform seat. Undated photograph by N Hatcher and is No. 139256 in the ARHS Resource Centre.*

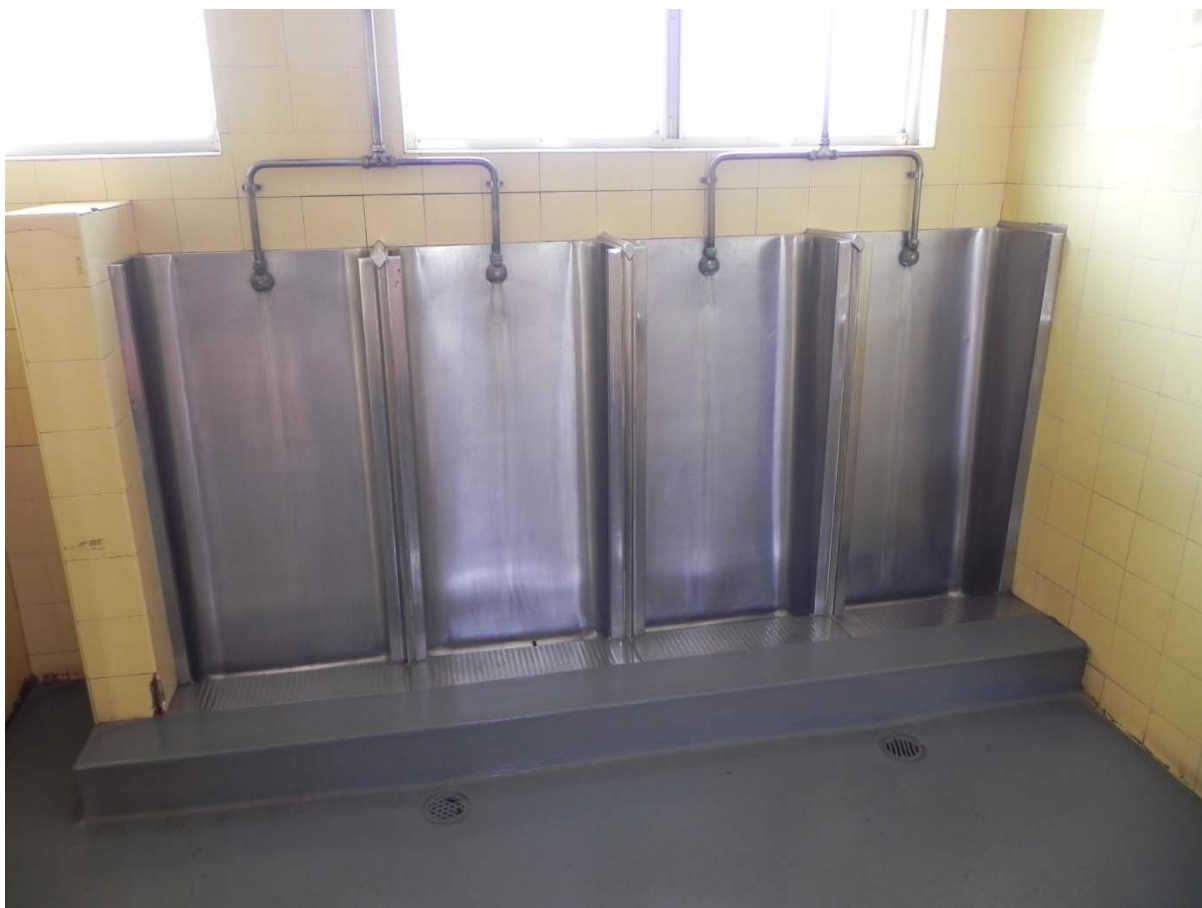
*There are many notable features that demonstrate that the 1957 station was modern not only in terms of its overall design, but in regard to many fixtures, such as the waiting room furniture, the station nameboard, the clock and the light standards. One other remarkable attribute was the stainless steel urinal. This was the first installation of stainless steel urinal on the NSW railway system. Of course, stainless steel has been in rampant use in men's railway comfort facilities for over 60 years but flat stainless steel has been the favoured product for the rear wall for a long time. The urinal at Broken Hill marks the transition from the use of porcelain with individual stalls not only by the continued use of individual stalls but the continued use of the standard stall width of two feet. By 1960, individual stalls had disappeared. Image by Gary Hughes on 12<sup>th</sup> October 2010.*

- The position at the end of Chloride Street, allowing lengthy vistas towards the station,
- Over the counter ticket sales (as opposed to the sale of tickets through a small ticket window),
- Part two-storey appearance,
- Roof parapet encompassing a clock and four flag poles,
- Integrated gardens on the street elevation,
- Metal-framed windows,
- The first use of moulded plywood seats in the general waiting room,
- The first provision of a table in the general waiting room,
- The first use of concrete bricks [for the internal skin], &
- The first use of stainless steel for the urinal in the men's toilet,

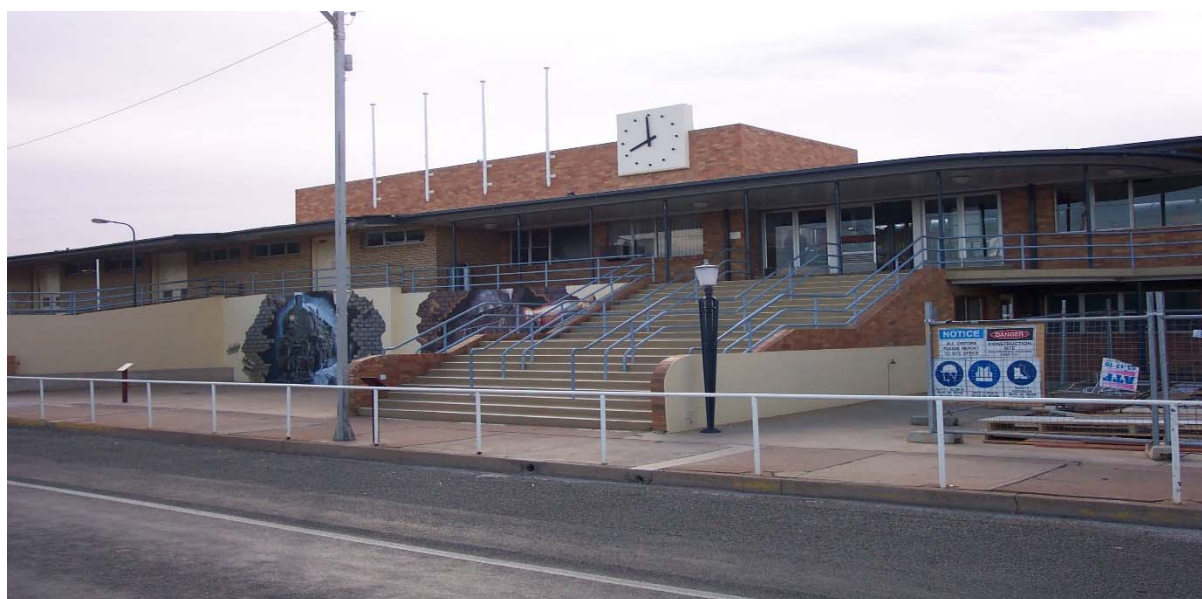
*When the parcels office was expanded in 1970, the project required the demolition of all that part of the walls on the Sydney side of the ticket office, identified by the second flag staff from the right. The difference in the colour of the bricks is obvious. Why, if the joint between the 1957 and 1970 components was considered so ugly on the platform side to require rendering, was not the Crystal Street side of the structure also rendered and painted? Note that the title of the structure, "NSW Railway Station", above the awning at the top of the stairs has been removed. That was probably done after the inauguration of the standard gauge services in January 1970 as there was, from that time, no need to differentiate between the Sulphide Street station and the Crystal Street station. The rounded brickwork at the bottom of the stepway survived, though the retaining wall enclosing the garden has been eliminated to make way for the disabled access ramp. Words cannot describe the insensitivity of the railway authority for allowing the mutilation of the building with the two murals depicting some fantasy scenes not associated with the New South Wales Railways. It is hard to think that*

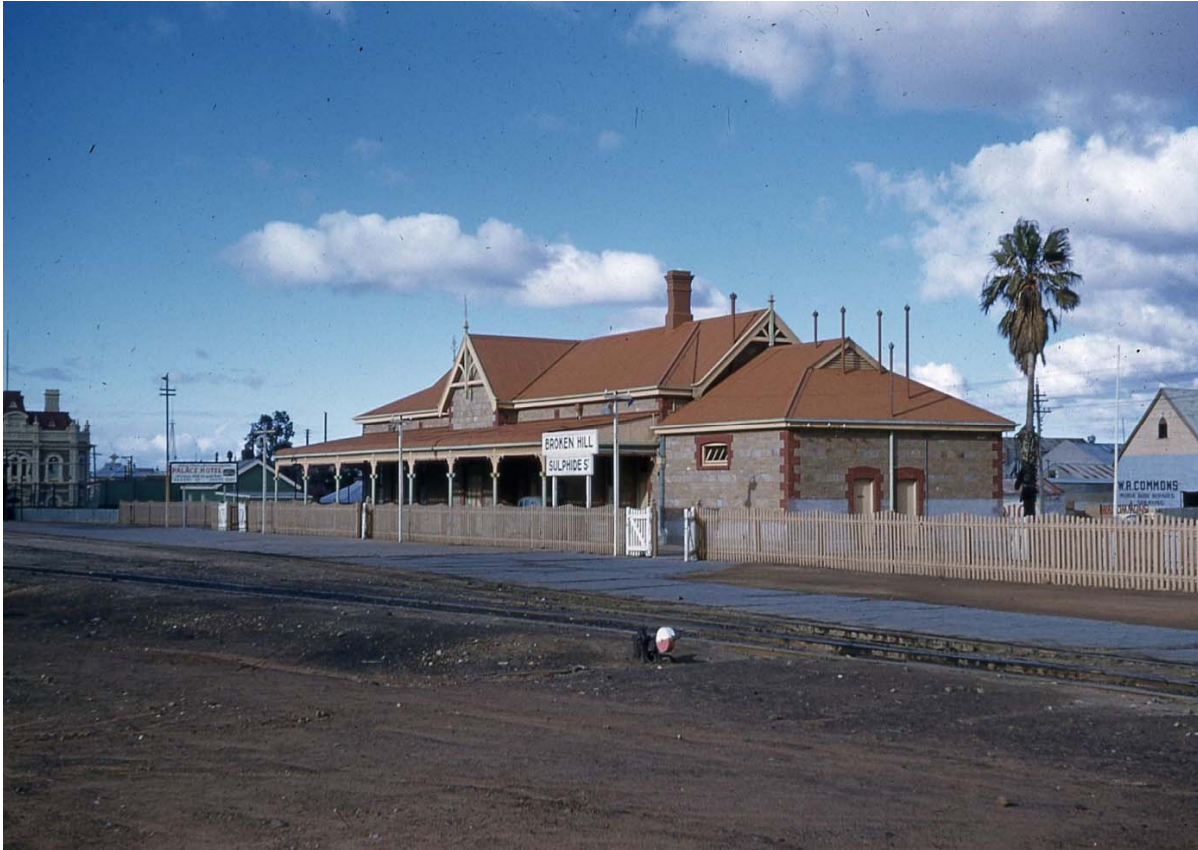
*This photograph was taken by Gary Hughes in 1960. The fencing, installed when the building was erected in 1905, visible in the photograph was only a fragment of the 780 feet of similar-styled fencing that Broken Hill resident, Cliff Old, stated “completely enclosed the train while at the station with a view to efficient ticket collecting”.<sup>161</sup> The fencing was extended across the tracks with gates so that fare evaders could not scamper away. The concave profile of the fence is unusual – at least on the NSW Government Railway system. The locally-sourced stone is a pleasant colour, but the design was about 20 years out of date when the building opened in 1905.*

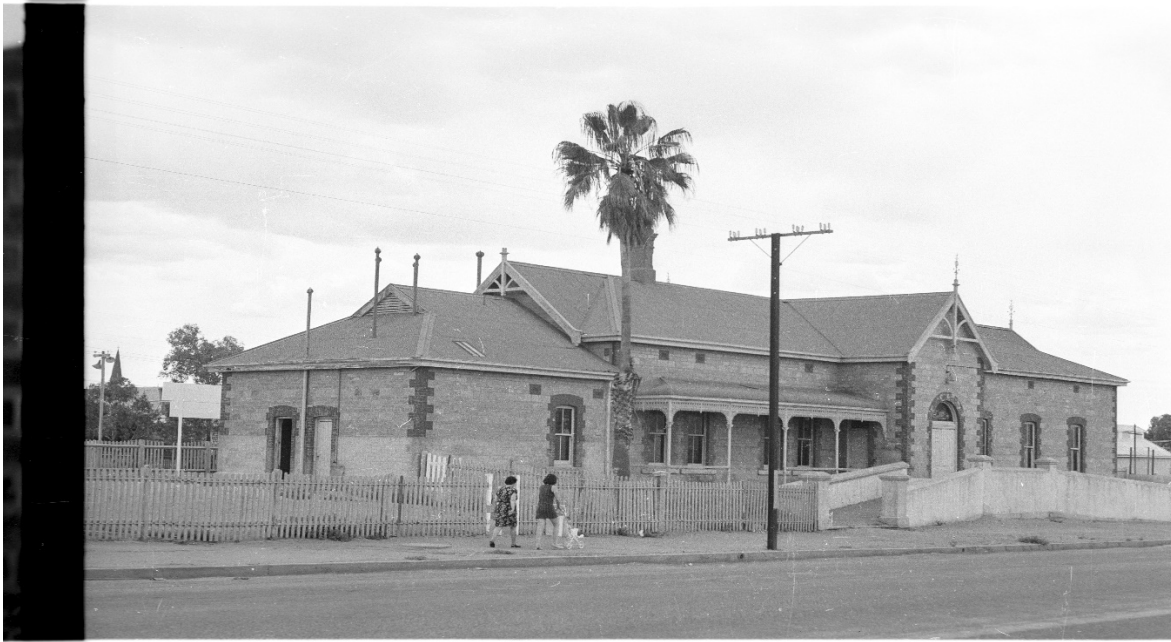
*This 1969 photograph by Alex Grunbach shows the building from the Silverton end. Note the asymmetrical appearance and the unusual (in NSW Railways) concave roofed awning. The existence of the ventilator pipes at the western end indicates the location of both male and female toilets. The open door leads to the male toilet. The closed door was a store. In classical railway practice, the entry to the female toilet is nowhere near the entry to the male toilet and is positioned around the corner facing the rail lines. Note the palm tree, which were found at many railway installations. Image No.204402, ARHS Resource Centre.*
