CARLTON RAILWAY STATION

A PLACE OF ARCHITECTURAL SIGNIFICANCE IN THE HISTORY OF N.S.W. RAILWAY STATION BUILDINGS

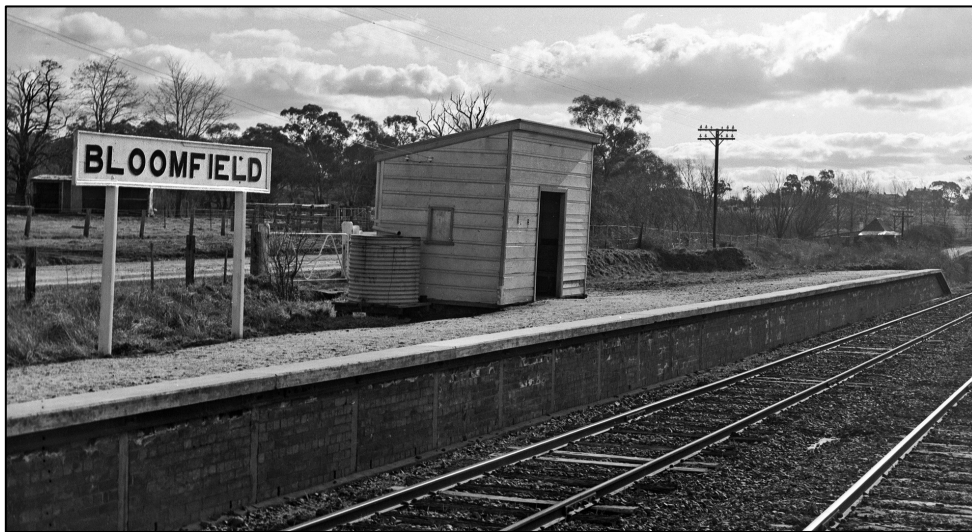
*Although plans do not survive of the first building or buildings at Carlton station, the above photograph of Bloomfield near Orange, which opened in 1891, is typical of the simple form of waiting shed provided universally at small stations throughout the network up until 1891. Carlton station no doubt received similar, low-cost facilities. **SOURCE:** Facebook.*

Although no plans survive, the first station building was described (in the singular form despite the line being duplicated at the time of the opening) as a waiting shed measuring 8 feet by 10 feet. It must have been void of a platform awning as one inch of water regularly pooled on the floor of the shed when it rained. Moreover, it was claimed that the heat was “unbearable” in Summer and lacked protection from the cold, bleak southerly winds in Winter.¹¹

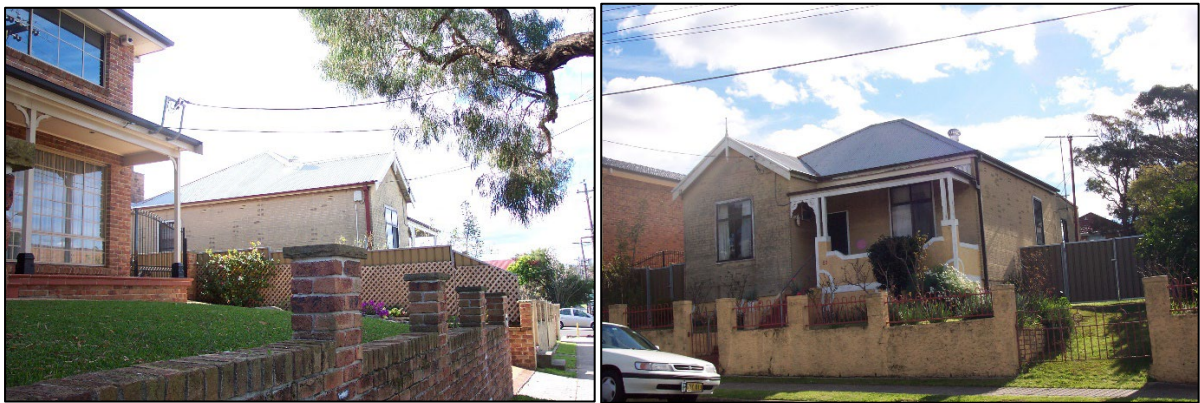
These are images of a similarly designed residence provided in 1902 for the Station Master at Mortdale.

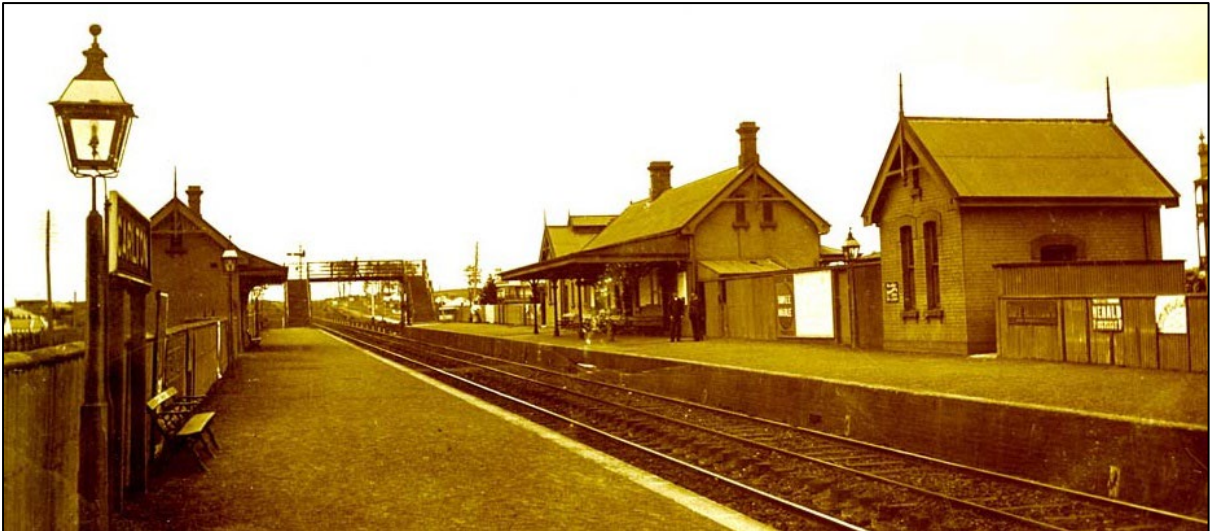
*This photograph looks south and shows the first footbridge built in 1896. It was erected at the southern end of the platforms. On the left or southbound platform is the smaller waiting shed with its narrow platform awning. What is obvious is the absence of vertical posts supporting the awning, which was propped up by small brackets cantilevered from the building wall. Nearest the camera on the right side is the lamp room, which was demolished in 1945. The corrugated iron fencing at the rear of both platforms detracted significantly from the pleasure of watching trains swish by. **SOURCE:** Photograph No. 510063, ARHS Railway Archives.*

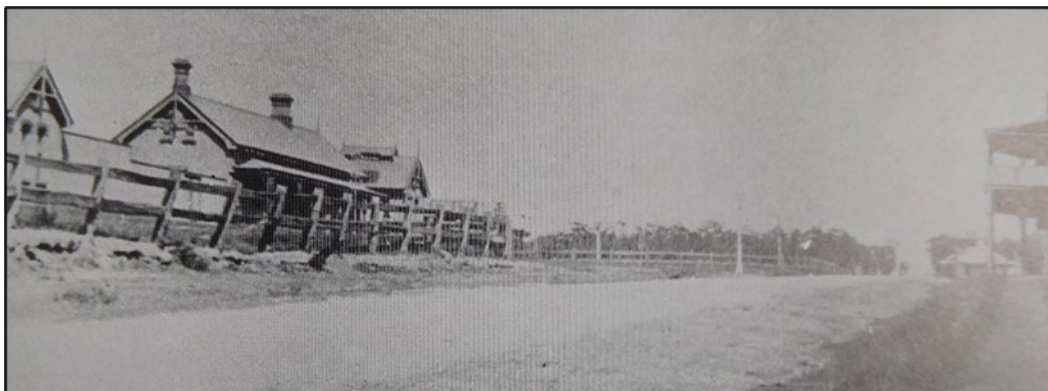
*The photographer is looking south. This is the only known photograph of the road elevation of the 1890 building on the northbound platform. On the road elevation, there was no porch to mark the pedestrian entry/exit but that point was expressed by a stepway. A narrow verandah stretched the full length of the centre component. The fencing marking the boundary of railway property is very cheap, two rail timber fence. **SOURCE:** J. Lawrence, *Pictorial Memories – St George, Alexandria, Kingsclear Books, 1996, p. 97**

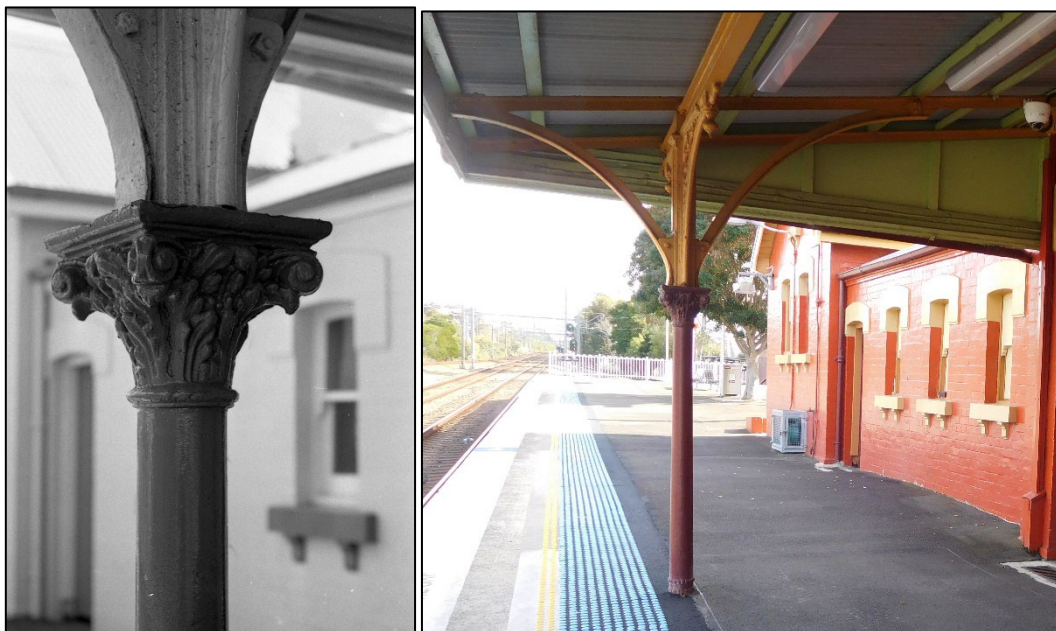
These two pictures show the extent of decorations on the awning posts on the present platform No. 2. For a start, the columns are not fluted – a feature applied to many stations in the 1880s. One nice touch was the Corinthian influenced capitals provided on the awning posts. However, the cast ironwork for the awning brackets was approved only for one plane, namely that which could be observed from trains. The same decoration has been omitted from the braces extended across the platform springing from the capitals. It was the omission of the transverse decorative brackets that was adopted for the very first building on an island platform that totally dismissed the need for awning posts. That major event occurred at Raglan in 1891. Hence,

Carlton and the five stations listed above were the last structures erected on the New South Wales railway system with the platform awnings being supported by vertical posts. There was one dominant element of the design that identified the structure as being approved after John Whitton's retirement in 1889. That single feature was the provision of three female toilet closets between the main building and the male toilet pavilion.

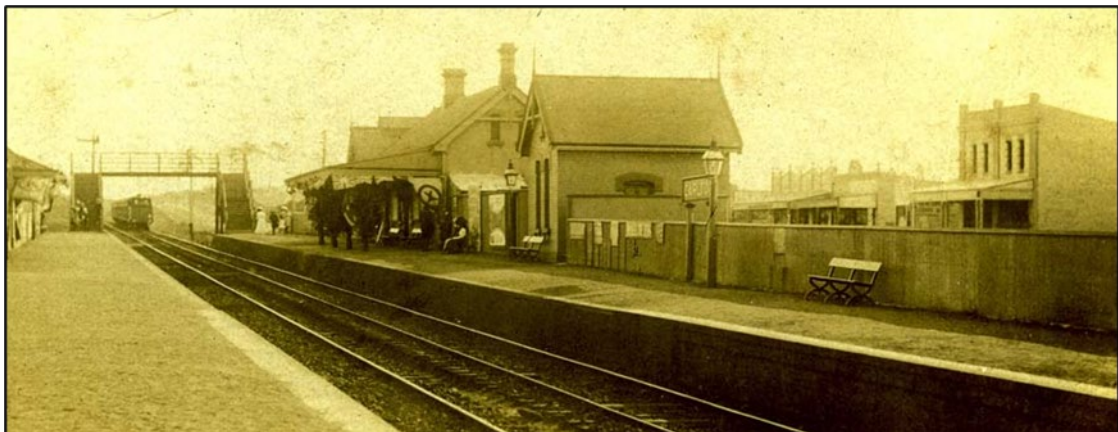
*The above photograph was taken between 1896 and 1912 and shows the main building on the northbound platform. Although it was the larger structure at the station, the building was small relative to most other station platform structures when the line from Illawarra Junction to Hurstville opened in 1884, the exception being the recreational styled waiting sheds at Tempe. Not only were the buildings smaller at Carlton, but corrugated iron sheets were also utilised to form the fences at the rear of the platforms rather than timber fencing used at other stations to Hurstville. Both the smaller sized buildings and the cheaper fencing reflected a degree of financial restraint. **SOURCE:** Photograph No. 510062, ARHS Railway Archives.*

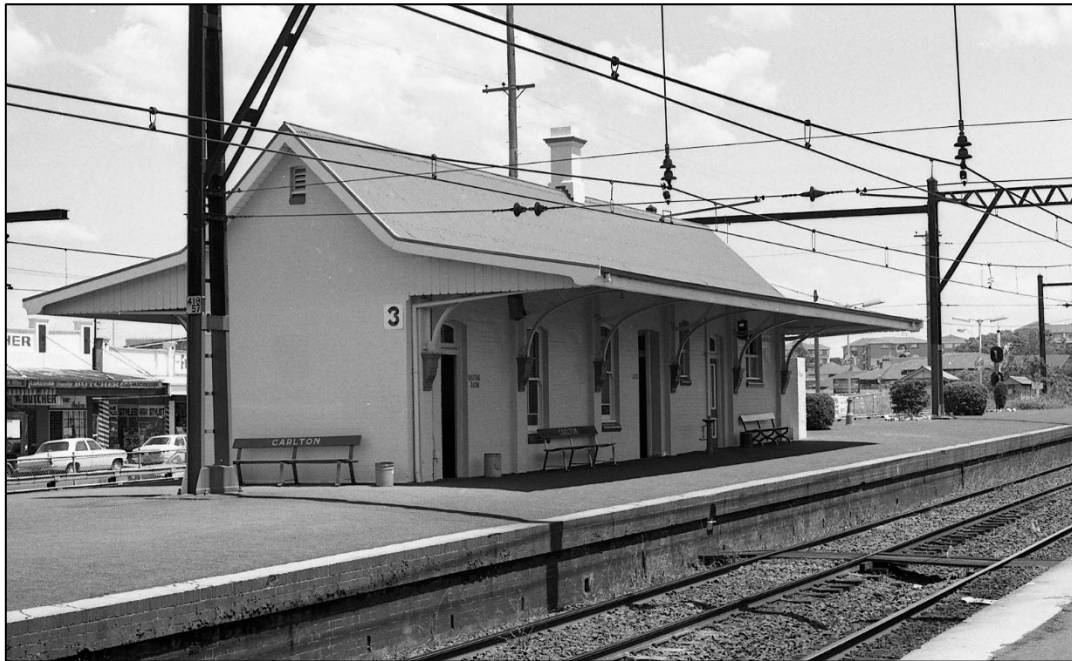
This photograph, taken on 11th February 1978, shows the 1890 building with the additional length and alterations to accommodate track quadruplication in 1924. The location of the first

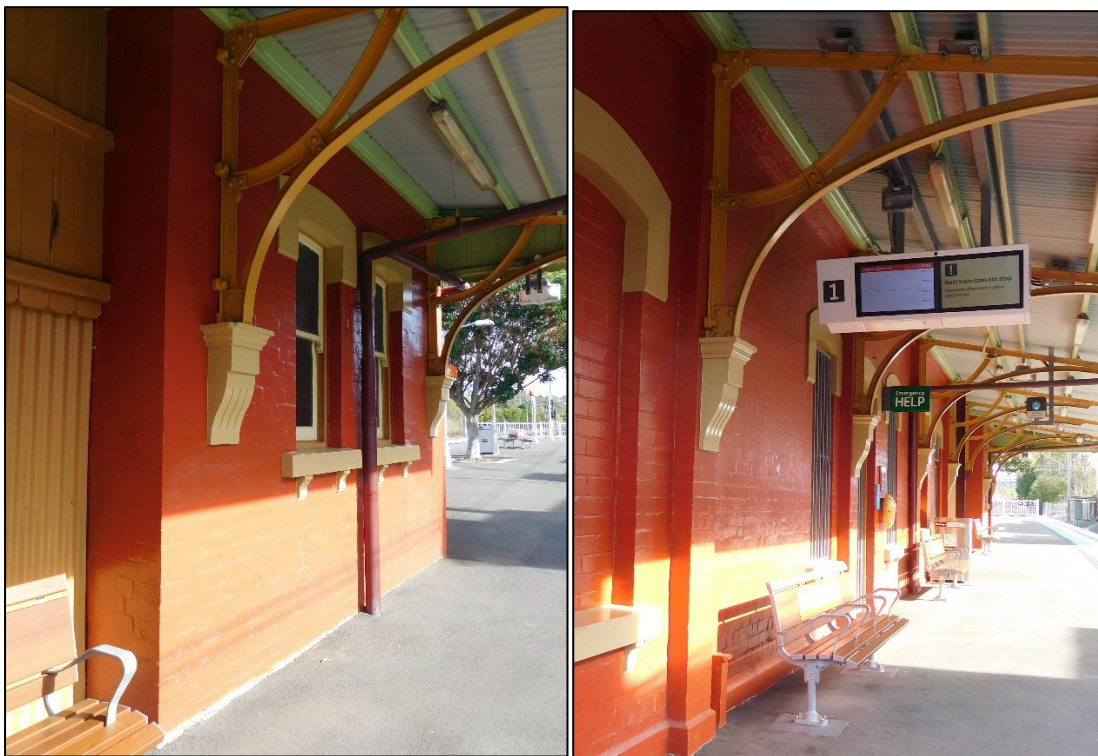
These two images show a very unusual feature of the Carlton buildings. In 1924, the Railway Department approved the application of what it called “standard awning brackets” to support the new platform awnings. The brackets sat on what were known as corbels, which are the cream painted elements shown in the above pictures. In those instances where the brackets were to be added to existing brick walls, the usual practice was to directly affix the corbels and the brackets to the existing brick walls. The picture on the left shows the standard treatment. However, the standard treatment was not universally applied to the Carlton buildings and, instead, engaged brick piers were erected and the corbels and brackets were secured to the piers – not the walls. That presentation is shown in the picture on the right. As far as is known,

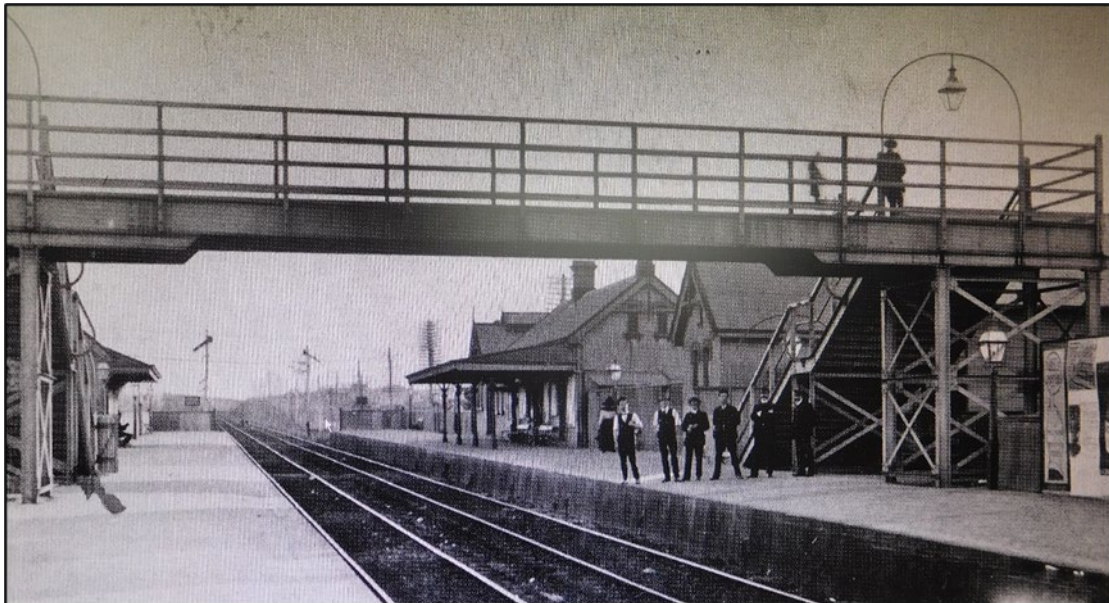
*The second footbridge at Carlton station was erected in 1924 as a part of the track quadruplication works. It was placed at the northern end of the platforms and the first footbridge at the southern end was removed. While the decks of both the first and the second footbridges were supported by metal beams, the second bridge was of a slightly different design to the first footbridge, being classified as a haunched beam. **SOURCE:** NSWRTM, Roundhouse, August 2015, p. 35.*

A replacement footbridge was erected at the northern end in its present position in 1912. When the second bridge was approved in 1911, it was one of the first examples of footbridges to use a concrete deck. One time railway engineer, Dr Don Fraser, describes the structure as a “double RSJ haunch over trestles”.²¹ The structure was fabricated from steel imported from England. When the plan was issued on 20th April

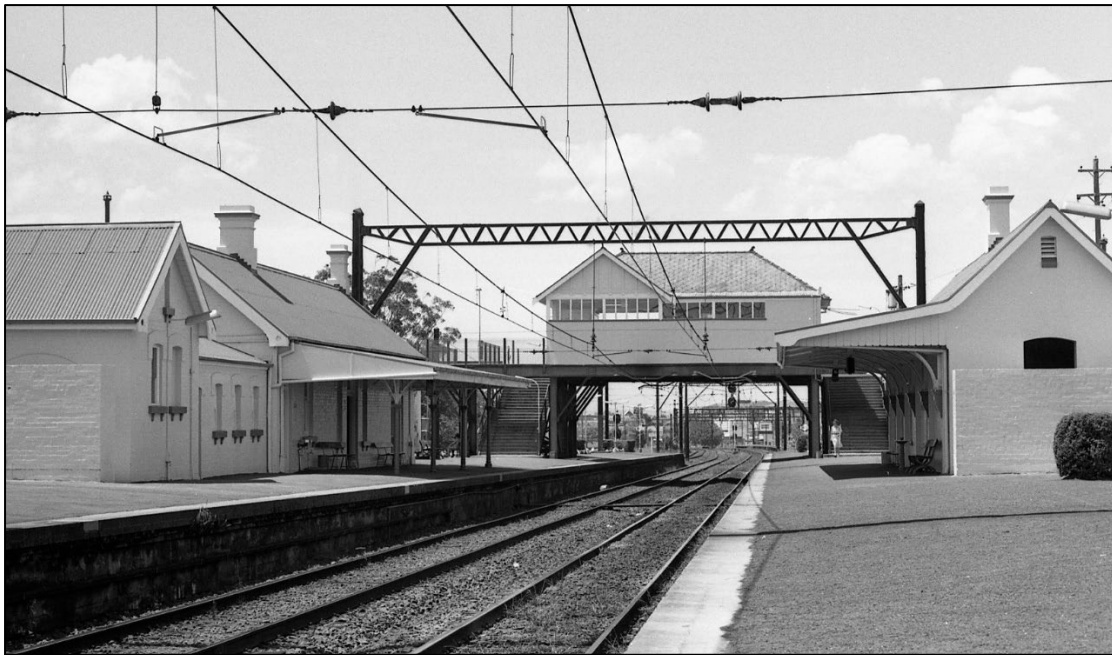
The photographer is facing towards Sydney on 11th February 1978. The overhead booking and parcels office appears much larger than it was. The extensive roof provided the illusion. The roof was covered with asbestos cement “slates” with terracotta ridging and finials. The Railway ticket department deployed two roof designs. The more visually engaging design involved the use of what was known as a Dutch gable where the ends of roofs featured a combination of hips and gables. This style was applied to Arncliffe and Rockdale and about 20 other locations. The second design was much plainer in appearance and could feature a simple gabled or a simple hipped roof, as at Carlton. When electrification was introduced in 1920s, the portal electrification structures were designed by engineers – not architects – who understood that a nice-looking, though pedestrian, structure engaged waiting passengers in a positive manner. At Carlton, this was reflected in the form of steel pyramidal caps at the top of the portal masts. They are faintly visible in the picture. Vandals destroyed the Carlton overhead booking and parcels office in 1978.

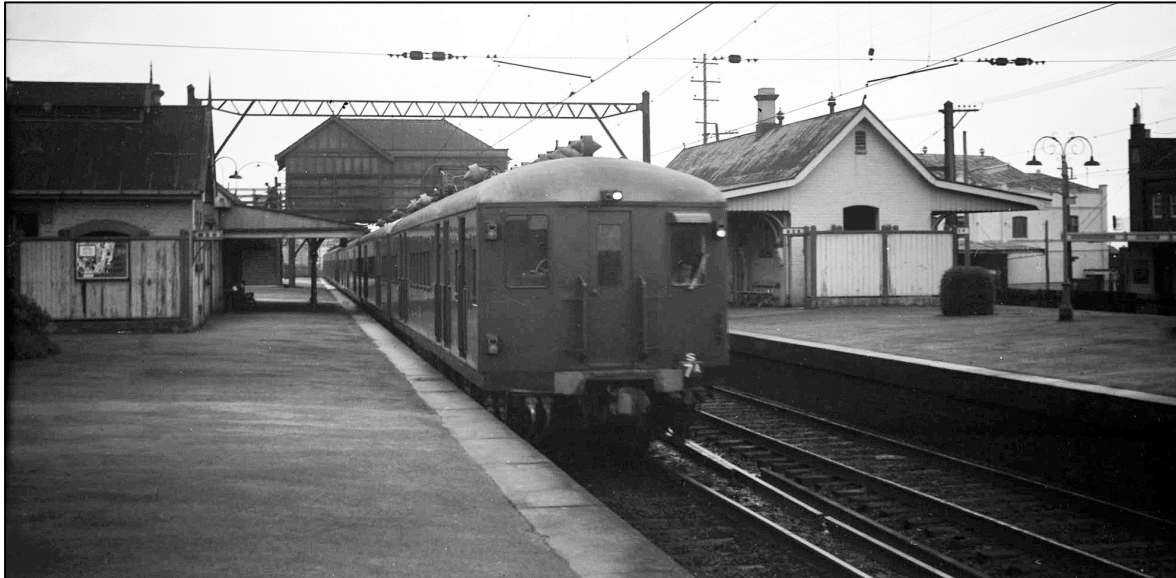
*Long time railway officer, Neil Munro, writes the caption for the above photograph. He writes: "The train in the photo is S7A+S7B on a limited stop service to Cronulla in 1962. It was not scheduled to stop at Carlton. These Commonwealth Engineering built trains with power operating doors were commonly referred to as '1955 cars' and as 'Sputniks'. The eighty cars did not commence to enter service till 1958 due to equipment supply delays and priority being given to the single-deck interurban sets which had commonality with many equipment parts. This would achieve major operational savings by having the interurban sets replace loco hauled commuter trains to Lithgow and to Gosford. The S sets were the first suburban trains with four-motor power cars and were authorised to run up to 115km/h where appropriate as against 80km/h for the previous types. In 1964, they became the first suburban sets to incorporate double-deck trailer cars, the single deck trailer cars cascading down to run with the earlier suburban fleet". Neal also provides details about the toilets, of which the timber privacy screen of the male toilet is visible. The screen utilised vertically set weatherboards, which was contrary to the traditional policy of setting the boards horizontally for building walls. The Railway Department made an exception for male privacy screens. Neil adds: "I have an impression that the men's toilet had the old black urinal with minor privacy screens and penny-in-the-slot cubicles. I cannot comment about the ladies' toilet. It was a rare occasion to join or alight from a train at Carlton on the Illawarra Mains (Platforms 3 & 4)".²⁶ **SOURCE:** Photograph No. 469945, ARHS Railway Archives*

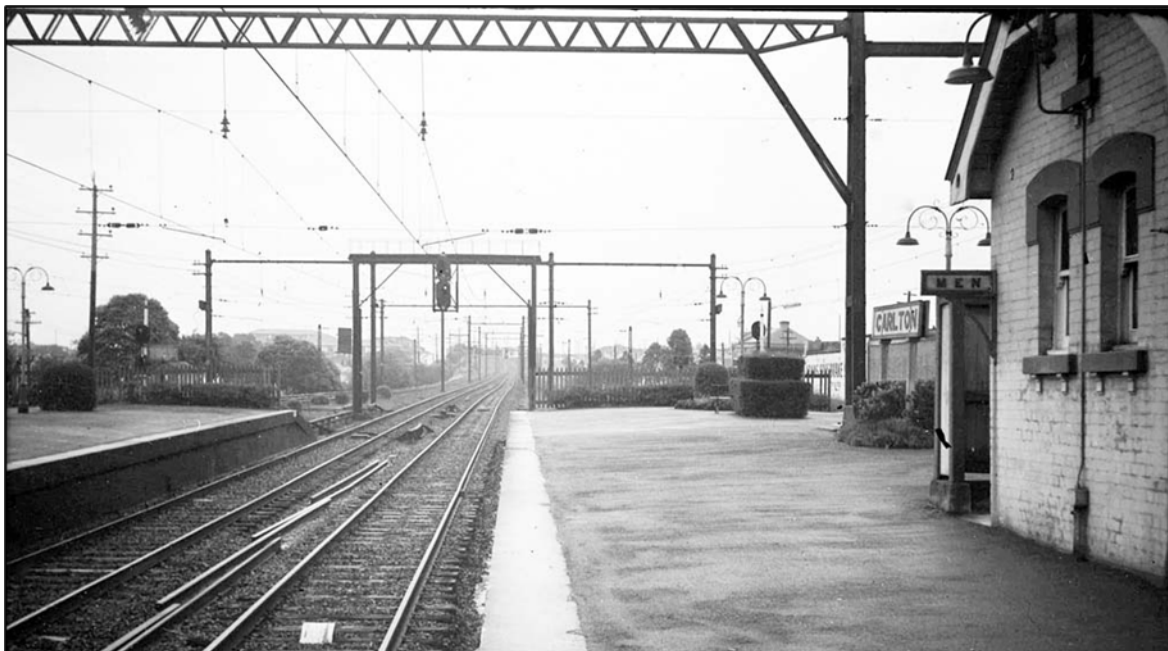
Neal Munro captured the photograph in 1962. Neal writes: “I lived at Carlton from 1948 till 1965. Oh, for Saturday afternoons at the Odeon cinema on the Down side at Carlton! The 57 class and 60 class roared through the station as they climbed the grade through Carlton. There were 32 and 36 class on commuter trains and 38 class on the expresses. Unfortunately, the absence of steam, the wonderful electric trolley buses and even the later Leyland double decker buses at Kogarah brings a tear, at the very least a big sigh, to what has gone. The demise of the good times is expressed in a 1960s song the words of which stated - once upon a time, the World was sweeter than we now know, but once upon a time never comes again”.²⁸ The Station Master’s house was relocated off the end of the platforms on the left side. The long period of nothingness was mirrored in the poor condition of the male toilet on platform Nos. 1 and 2. SOURCE: Photograph No. 469944, ARHS Railway Archives.

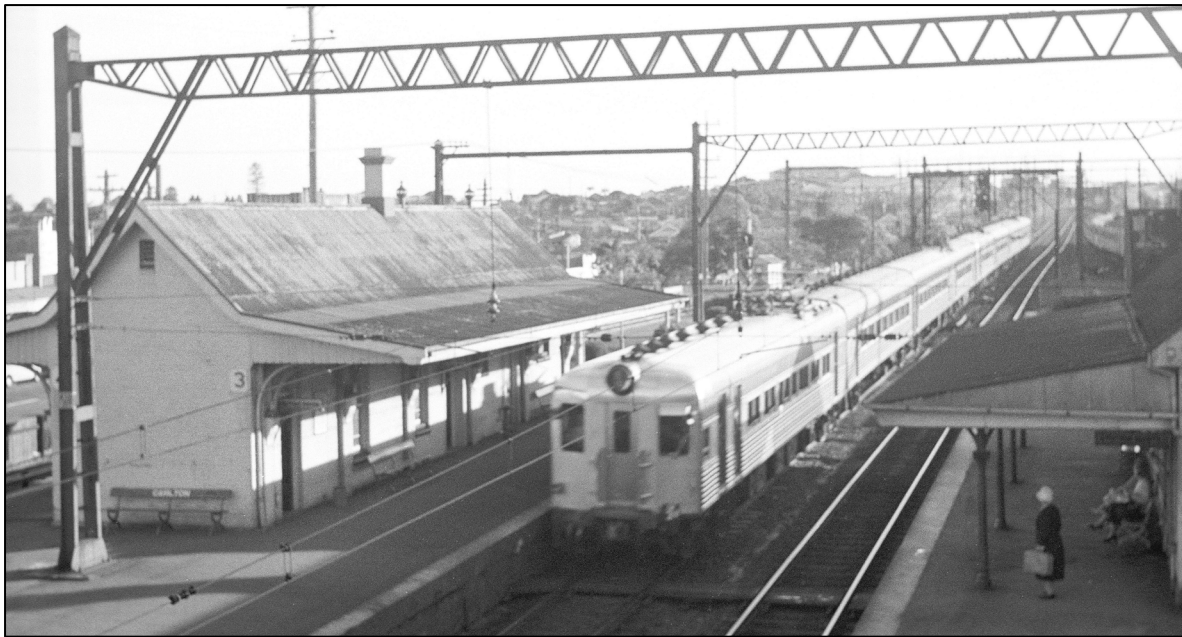
Photographer, Neal Munro, writes: In the early 1960's Flemington Depot was becoming congested, partly due to the increasing length of night trains to Melbourne and Brisbane with their new air-conditioned sleeping cars and the Spirit of Progress consists. The suburban fleet had also expanded with the single deck S-sets for the Penrith electrification and the single deck interurban fleet. ACDEP Eveleigh was on the distant horizon but adjustments had to be made with the maintenance of emu trains at Flemington. A re-shuffle of some suburban sets to Mortdale, Punchbowl and Hornsby was carried out. In addition, minor servicing of interurban emu trains such as cleaning and brake adjustment was carried out on some sets at Mortdale. The eight-carriage U-set in the photo taken in 1962 has been attended to at Mortdale and is proceeding empty cars to Central to commence an afternoon commuter service. It was to be another twenty years before these single deck U-sets became a regular sight on the Illawarra Line.³⁰**SOURCE:** Photograph No. 461167, ARHS Railway Archives.

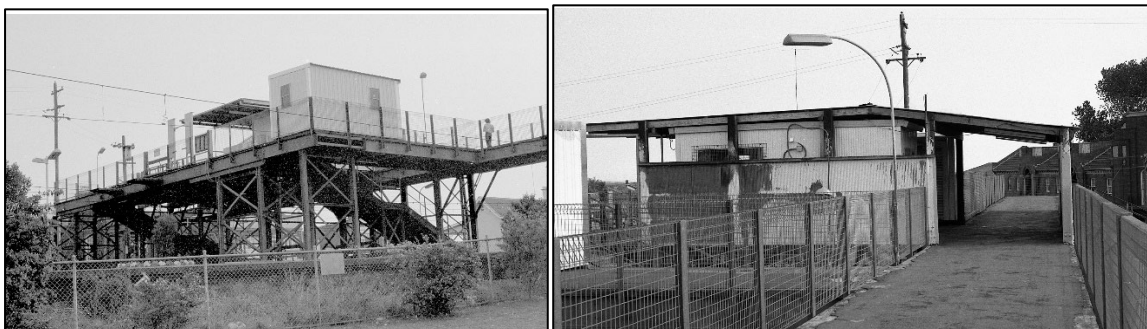
These photographs taken on 25th November 1979 show the temporary use of two portable buildings following the fire.

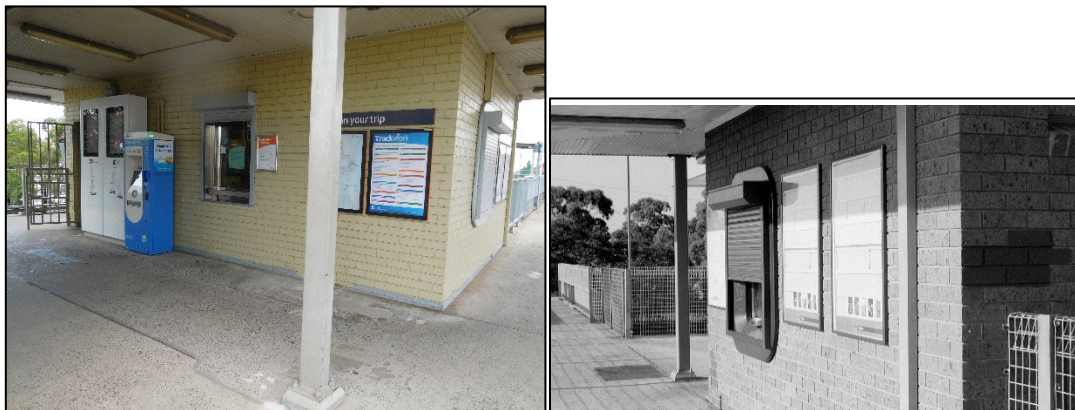
These two photographs were taken on 30th December 1995. On the left is the ticket office window and on the right parcels office window. While the fibreglass surround of the ticket window has been replaced with a new CityRail bullet-proof aperture, the similar feature around

were fitted at ceiling height except for the ticket and parcels windows which were expressed with fibreglass surrounds very similar to what had been applied in the same year to the ticket windows on the Eastern Suburbs Railway. The conventional ticket collection system was expressed by the use of welded swing gates with pipe barriers to control passengers leaving the station. A new style of glass in the ticket windows was fitted with a different arrangement of holes to that applied earlier in 1979 to similar alterations to booking offices at Flemington and Telopea.

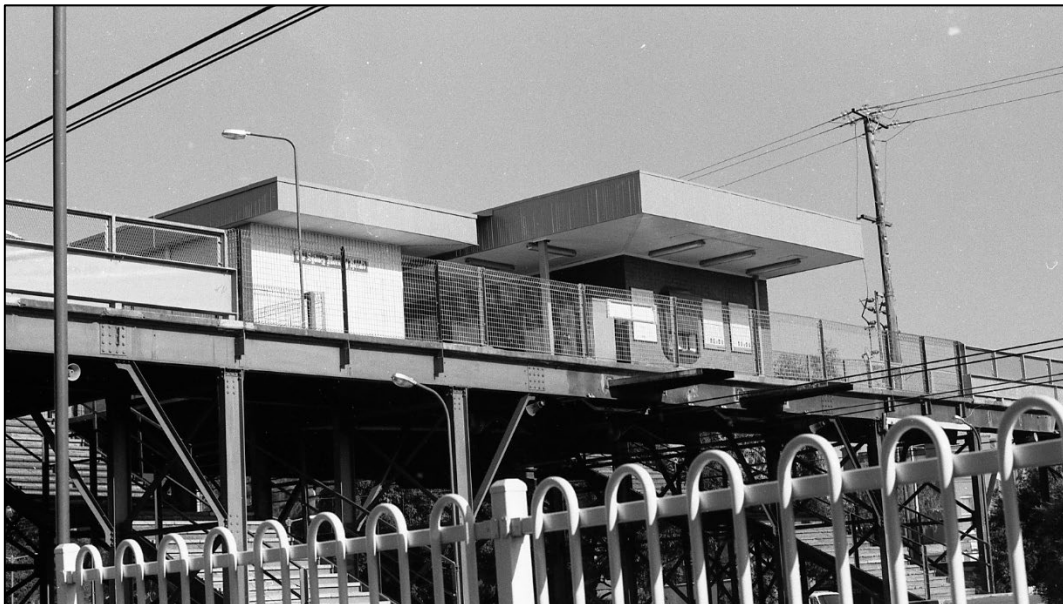
Taken from platform Nos. 1 and 2 looking north, the dominant feature of this 1995 photograph is the indescribable architectural style, which featured a near flat roof concealed by wide fascias. The architecture and the materials were a direct copy of what was occurring in the private sector for commercial buildings. The design held sway in the Way and Works Branch in the 1960s, 1970s and 1980s because of its low cost. Facing the footbridge is the parcels window and the structure opposite the ticket office is the newsagency.

Doug Neil included a parcels counter protected by a roller shutter. Although there was no defined space for the Station Master, the staff did receive their own toilet, as well as a pie warmer, hot water urn and stainless steel sink. The structure was face brick with raked mortar. The near-flat Lysaght Colorbond Klip-Lock roof was concealed by a wide, “Panelrib” fascia with vertical ribbing. As usual, aluminium framed windows

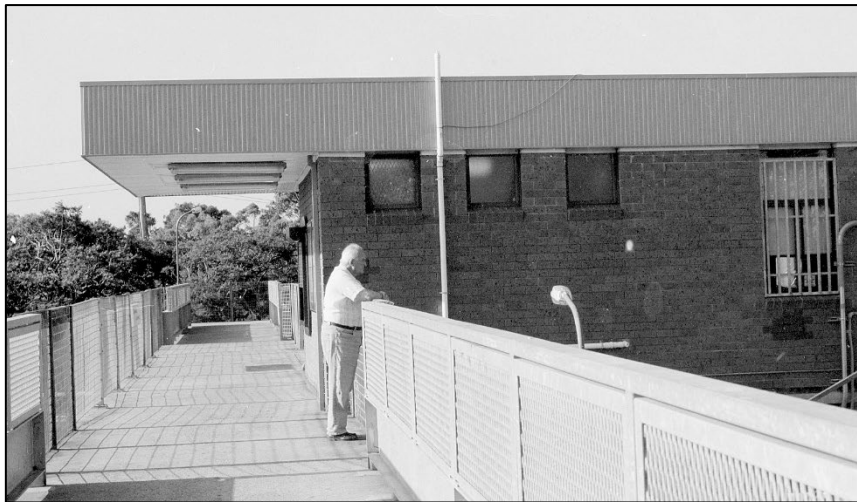
This photograph shows the clinical simplicity of the design, namely a box with a flat lid. There is no architectural term that describes the features. The man leaning on the fence was the author's father and our Carlton visit was the last time he accompanied me on a station visit before his death in 1996.

The decision in 1979 to build a replacement overhead ticket/parcels office in brickwork was very significant. The New South Wales Railways had exclusively used non-masonry building products, particularly timber and asbestos cement sheets, for all overhead booking/parcels offices for the previous 80 years. The last brick overhead booking/parcels office approved was at Strathfield in 1899 and, unfortunately, either the supporting substructure was inadequately designed or the load of the brick building on top of it was excessive for the supporting structure. Whatever was the source of the problem, the New South Wales Railways provided additional supports for the overhead building.

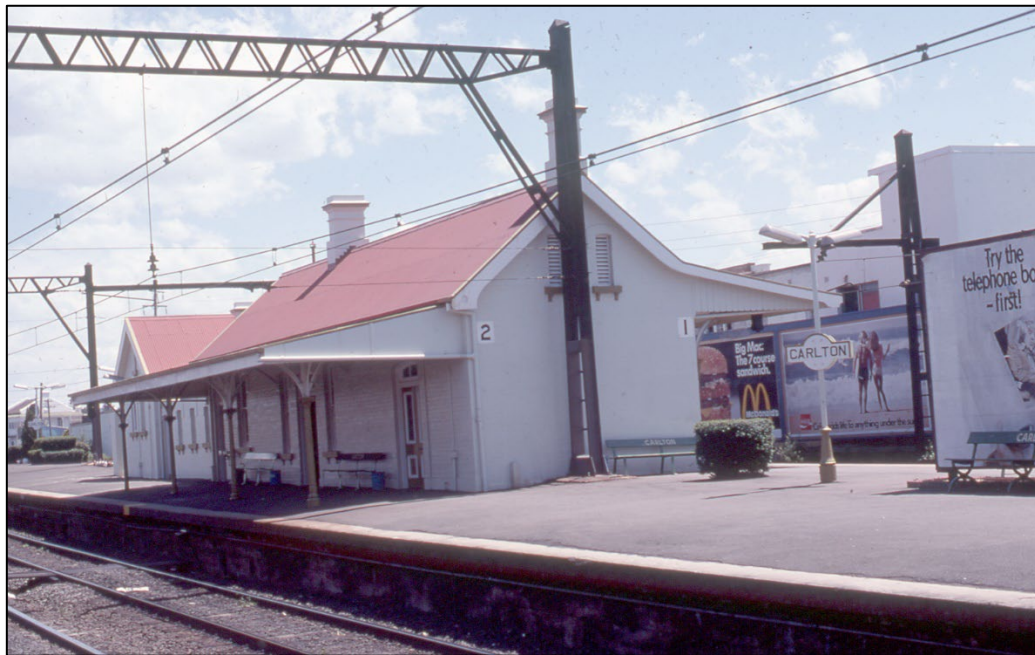
It is 11th February 1978 and the building at Carlton reflects the colours of the time – pastel blue on the building, green platform seats with yellow script, small blue rubbish bins and black and white circle-and-bar station nameboards. It was a time when vegetation on the platform was officially viewed as a positive feature.

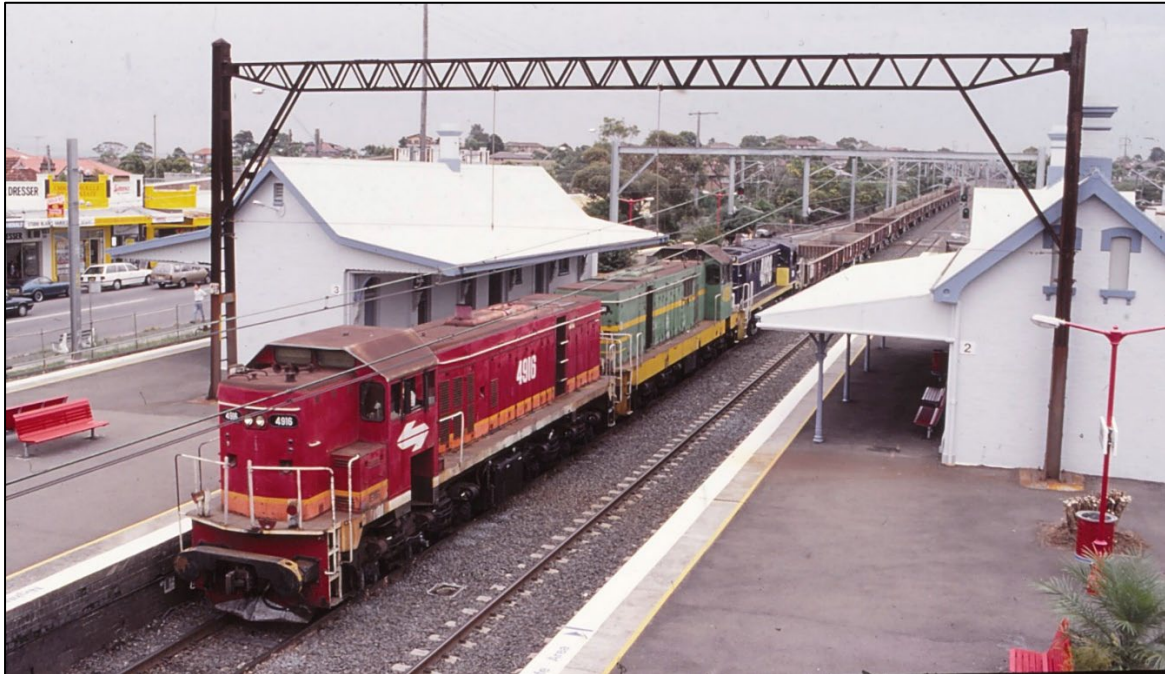
Photographer, Chris Sim, captured the essence of CityRail in 1995 with the red platform reds, rubbish bins, red lamp standards. CityRail also chose to repaint the platform buildings in a shade of off-white with lilac trim. The application of paint repeated the policy of painting the platform buildings, which had existed at Carlton for 70 years at that time. Therefore, the painting of the bricks was not a sin in that case. Note that the pyramidal cap is still affixed to the top of the overhead electrification portal stanchion on the left.

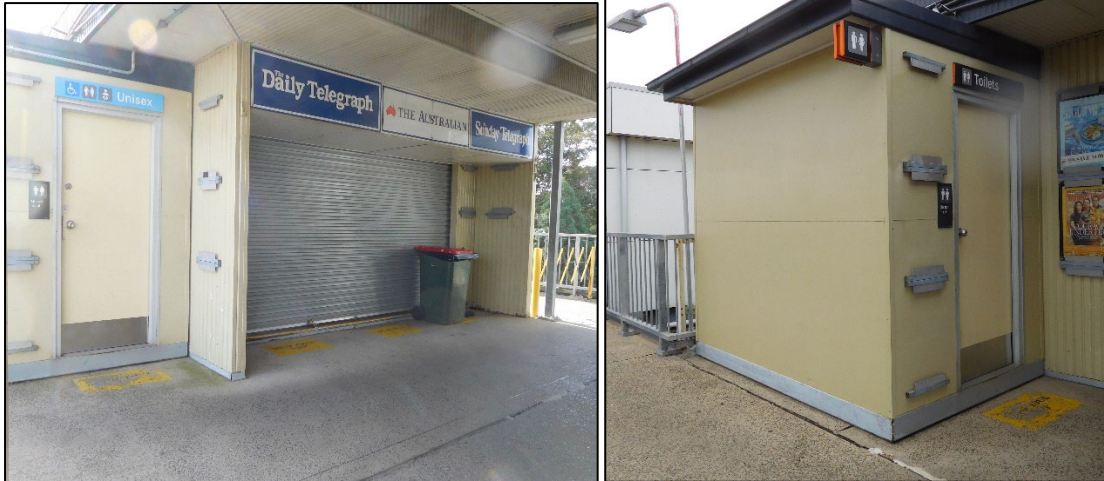
These two images show the (now closed) newsagency on the left and the unisex toilet on the right. They have been painted in the same shade of baby poo as the ticket office. Taken on 20th January 2020.

It was possibly at that time or thereabouts that CityRail erected the pre-fabricated, portable, uni-sex toilet adjacent to the newsagency on the overhead footbridge opposite the booking office. It is known to have been erected prior to 2004.

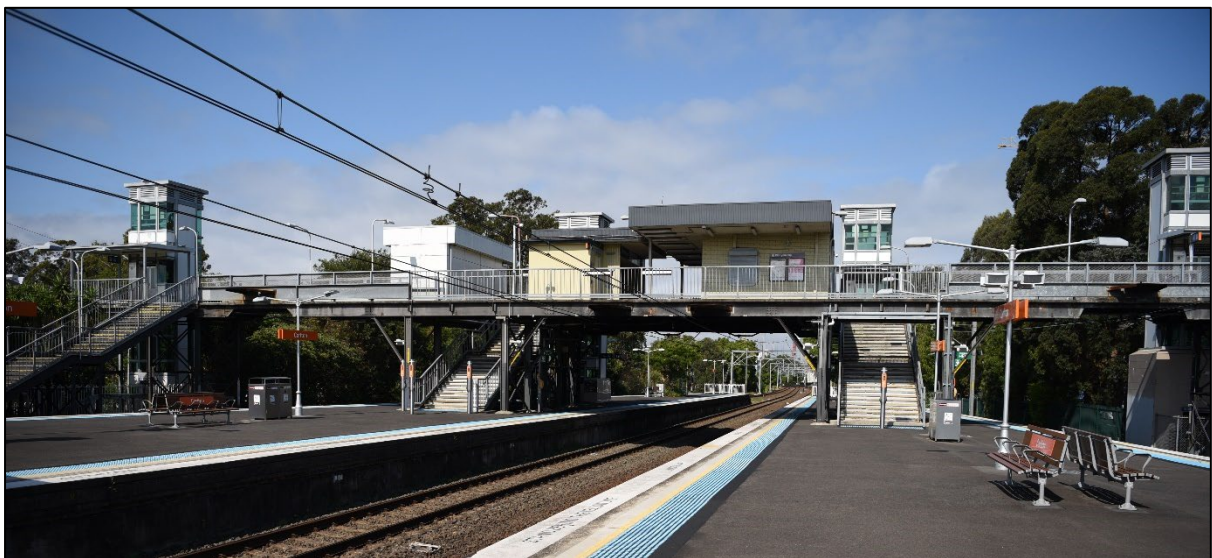
*Treads on the stepway to the platforms were renewed in 2023, but the replacement programme has not yet extended to the stairs which reach beyond the railway boundary. Railway observer, John Stebbing, took this image on 9th January 2024 looking north. The key identifier of the time period is the trademark orange nameboards on the platform seats and light standards. The system-wide introduction of the orange and white nameboards started in the first year of the establishment of Sydney Trains in 2014. Ten years later, the orange paint is fading when exposed to direct sunlight and the plastic-like covering is peeling. A similar problem affects the yellow safety strip adjacent to the platform copings. However, not every item at Carlton station which was painted in the colours of the former CityRail has been eliminated. Overall, the walls of the buildings on the footbridge have not yet been repainted the current colours of Sydney Trains, namely dark grey and black and reflect the more energetic spirit of CityRail. Also, the white, loop top fencing survives at the ends of the platforms. **SOURCE:** John Stebbing.*

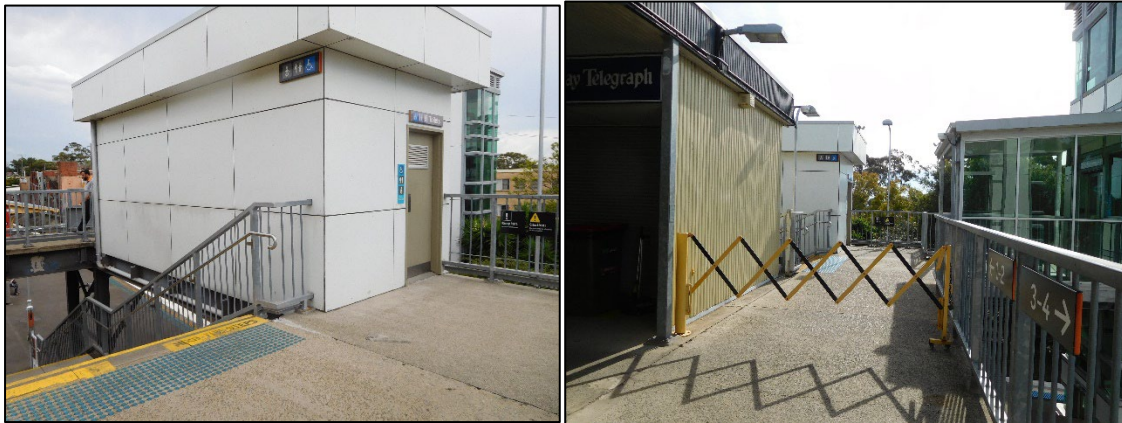
On the left is the 2008 built combined lift and store room. The store room has a door in the rear wall. The surface coating on the wall is already delaminating. Current station policy restricts access to the facility when all stopping trains operate from platform Nos. 3 and 4.

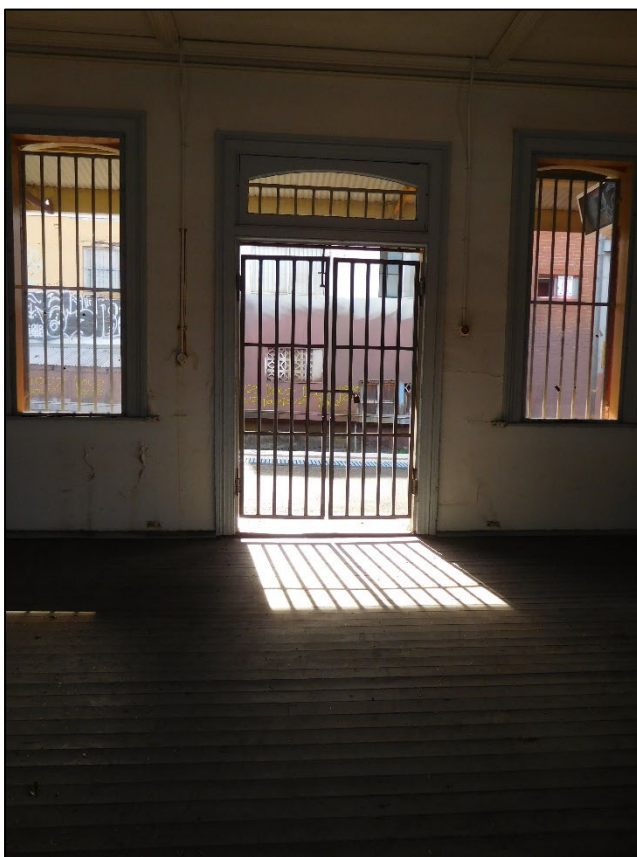
The closure of platform level waiting rooms is a policy that commenced in the 1980s in an attempt to stop the then rampant vandalism and graffiti. All subsequent administrations have continued the policy to some degree. This is the case at Carlton. The photographer is standing on platform No. 2 and its facing into the former general waiting room to platform No. 1 the date is 15th July 2023.

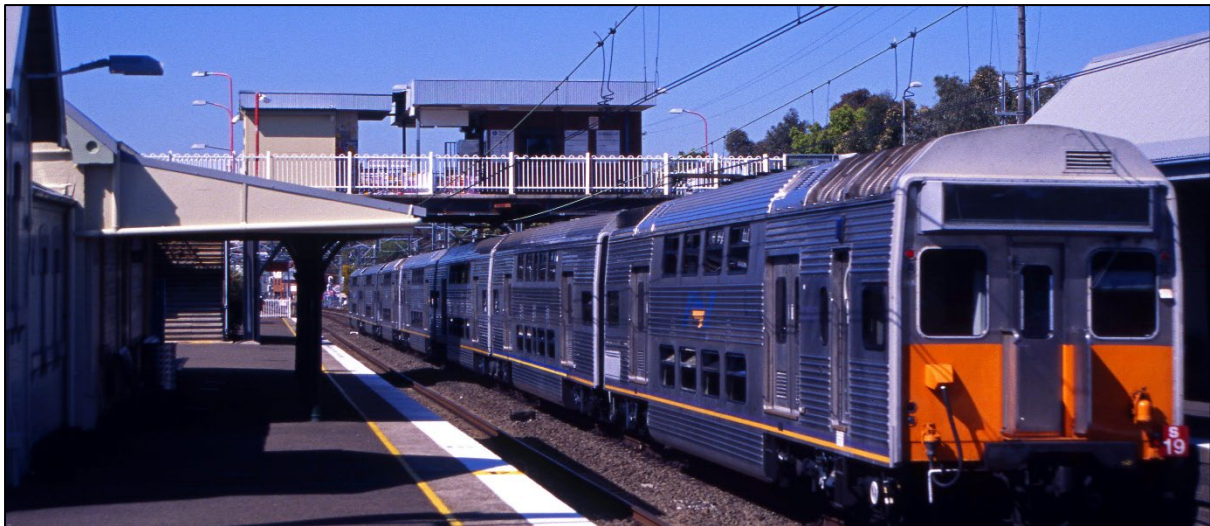
SOURCE: Image No. 458006, ARHS Railway Archives.

Neil Munro writes the caption to accompany his image above. He says: “The train was travelling very fast and moving away from the camera. In such circumstances, it is always difficult to judge the precise moment to capture the best image when milli-seconds are involved. The train was a limited-stop CityRail service from Cronulla was moving fast on the downhill run from Hurstville to Rockdale as it rockets through Platform No. 3 at Carlton on the Up Illawarra Main line on the 21st of September 2004. The train consists of a three-car S set leading a four-car S19, all seven cars being non-airconditioned carriages built by Goninan in Newcastle. While the heritage platform buildings are still extant, the former commodious booking office on the station footbridge has been replaced by a much less imposing structure. The parcels office has gone and no longer are there multiple ticket windows for the Monday morning commuter rush or to reserve a seat or sleeping berth on services to NSW and interstate destinations. The large and imposing advertising hoardings along the fence line have been removed and Station Masters would soon become an endangered species”.³³

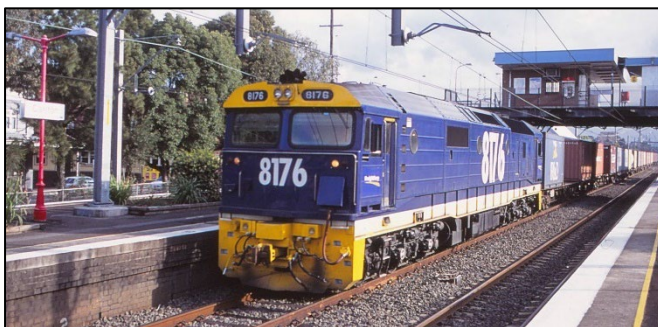
Chris Sim took this photograph in 1997. He is standing at the northern end of platform Nos. 1 and 2. Yes. The red painted light standard is gone. So too has the gardens on platform Nos. 3 and 4. It is sad to think that Sydney Trains cannot support the planting of gardens as a means creating a better station environment.
