STUART TOWN RAILWAY STATION

PERHAPS THE MOST PUZZLING SET OF STATION STRUCTURES ON THE NSW RAILWAY SYSTEM

THE SIGNIFICANCE OF STUART TOWN PLATFORM BUILDING

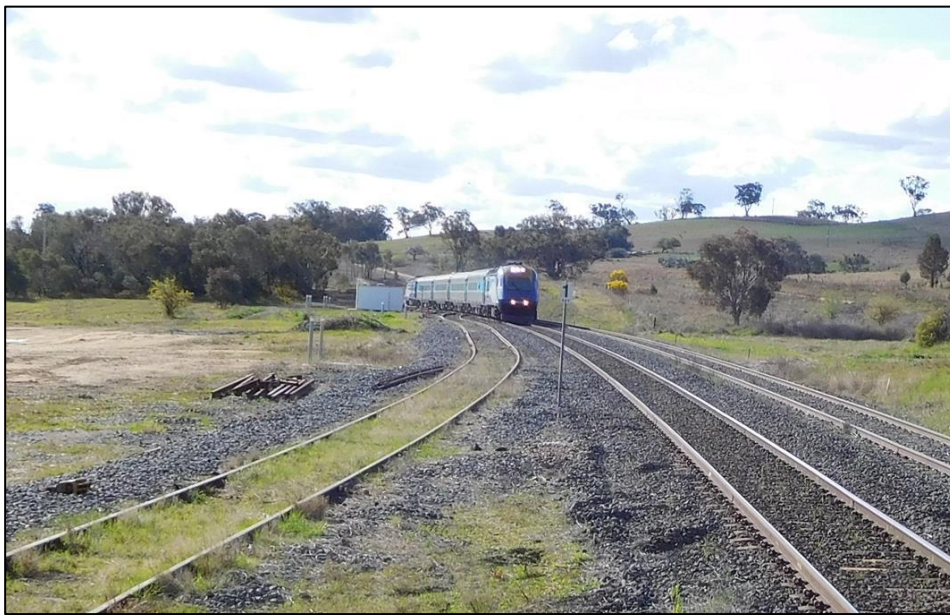
The Central West XPT comes into view from Wellington and passes over the points leading to the dock siding. The main interlocking frame at Stuart Town was located adjacent to the points after Frame “A” on the platform was removed. The white building was a staff hut in which the electric staff instruments were located following their transfer from the ticket office in the platform building. The post with the numeral, 1, tells the XPT Driver the stopping location so that her/his train clears the Liddell Street level crossing. The train will stop at the 379.5-kilometre post on the platform. The date is 14th September 2022.

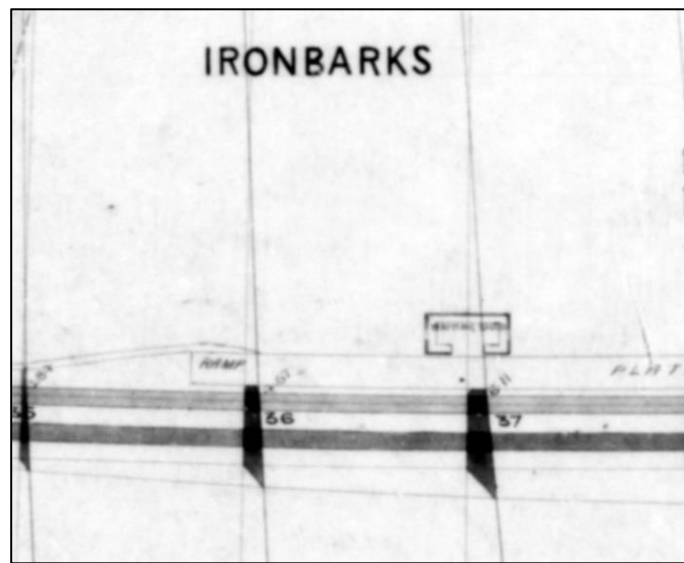
In addition to the plan issued in August 1879, a second plan was produced in May 1880, shown above in part, which displays exactly the outline of the same building as expressed in the 1879 plan. John Whitton initialled the May 1880 plan “JW” and he wrote the date 15th May 1880 on it. By his signature, it is clear that Whitton proposed to erect a waiting shed but, given that he dated the plan only 15 days before the station opened, he had no intention of erecting the structure.

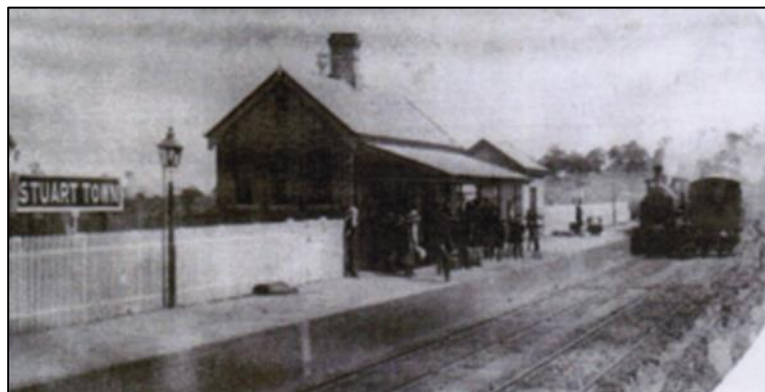
The above photograph shows the building at Stuart Town at an unknown time but probably after 1890. There are no known plans explaining the development of the structure. The building at Stuart Town never expanded further than that shown in the photograph. Rather than add rooms to an existing building, the Railways Department would provide small, stand-alone structures at smaller stations. As well as the brick building in the middle of the foregoing picture, there is a gabled roof out of shed towards the far end and, in between the main building and the out of shed, there was a lamp room with a semi-circular shape roof. SOURCE: N. King, There's No Railway There Anymore, privately published, no details, p. 34.

Overall, the structure is 47 feet 6 inches long by 12 feet 5 inches wide, both external, according to a 1984 official plan. The room at the eastern end was the ladies' waiting room and toilet, being 16 feet 4 inches long. In the centre was the general waiting room with a length of 9 feet 10 inches and, at the western end, was the ticket/parcels office for the station officer with a length of 14 feet 9 inches. It may be observed that the room dimensions add up to about 40 feet and not 47 feet. The official measurements do not correspond with on-site measurements taken on two occasions – in 1979 and in 2022 – which both approximated the length at about 45 feet.

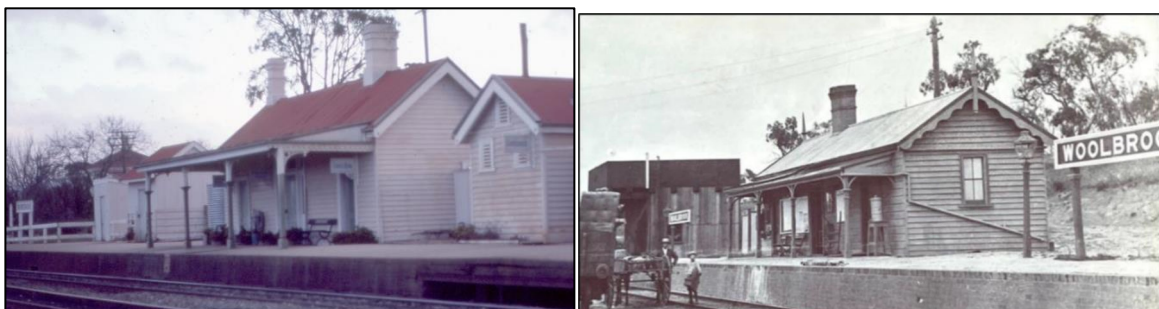
Presented above are photographs of buildings provided for what the Railway Department classified as a third class station. On the left is the mini three room building that John Whitton approved in 1885 for Borenore when the line was extended between Orange and Molong. Whitton's station design policy, which he introduced in 1880, provided for a standard footprint in three lengths – 37 feet, 55 feet and 70-80 feet. These buildings were called standard roadside design by a later administration. The photograph on the left shows the smallest of the three standard sizes. The building contained three rooms, namely a ticket office, a general waiting room and a ladies' waiting room. In the case of the smallest standard building, there was one semi-detached pavilion which contained both the male and female toilets and was connected to the main building by narrow passage through which women moved between their waiting room and their toilet without being observed by men. Virtually every major element of the standard roadside design was fixed. The photograph was taken on 7th August 1978.

Woolbrook station opened in 1881 and shown on the right. It got its permanent platform building in 1885. The structure was 54 feet long. It was the product of the Engineer for Existing Lines, George Cowdery, and conformed to a design that his predecessor, William Mason had introduced in 1876. The overall design feature was the lack of architectural attractiveness. Whereas Whitton's standard roadside design was pleasing in design, Cowdery's equivalent structure was a purely low-cost, utilitarian affair and unappealing. Another standout feature of Cowdery's work was his absolute abandonment of standardisation. In all examples, virtually every aspect changed. This was most obvious in the absence of a toilet pavilion. At nearly every one of Cowdery's third class buildings, the male toilet was erected in a different position while the ladies' closet was placed either at the rear or side of their waiting room. Other strange aspects of the Woolbrook structure include the ornate barges on the gables, the lattice work in the spandrels and the window in the end wall. With only one chimney, some people waiting for trains probably froze to death or decided that the pain associated with freezing was not worth the effort of train travel.

Although primary evidence to support the involvement of Mason and Cowdery is limited, a photographic comparison of what Whitton and Mason/Cowdery were approving in the early 1880s helps to identify the origin of the design of the Stuart Town building. The photographs below show the building approved by Whitton at Borenore in 1885 and at Woolbrook by Cowdery also in 1885.

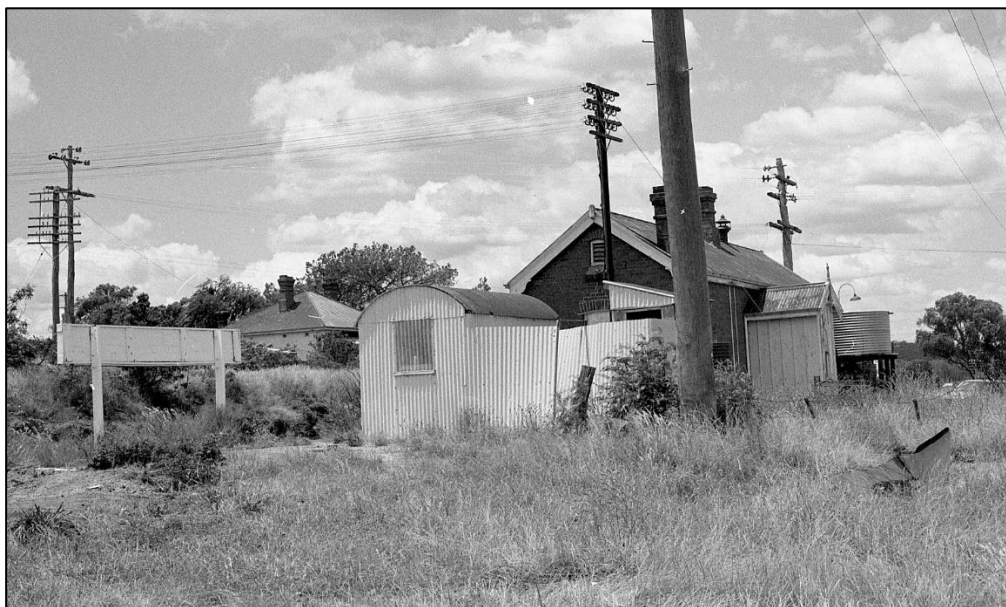
One of the standout features of third-class buildings erected on existing lines was the random location of male toilets. This photograph of Stuart Town taken on 24th January 1979 shows the small male toilet located between the main brick building and the corrugated iron lamp shed. Its location at the rear of the platform was supposed to provide a discrete location. Additional discretion was provided by the placement of twin rainwater tanks that were located on the road approach to the building, but these tanks had been demolished at the time of the photograph.

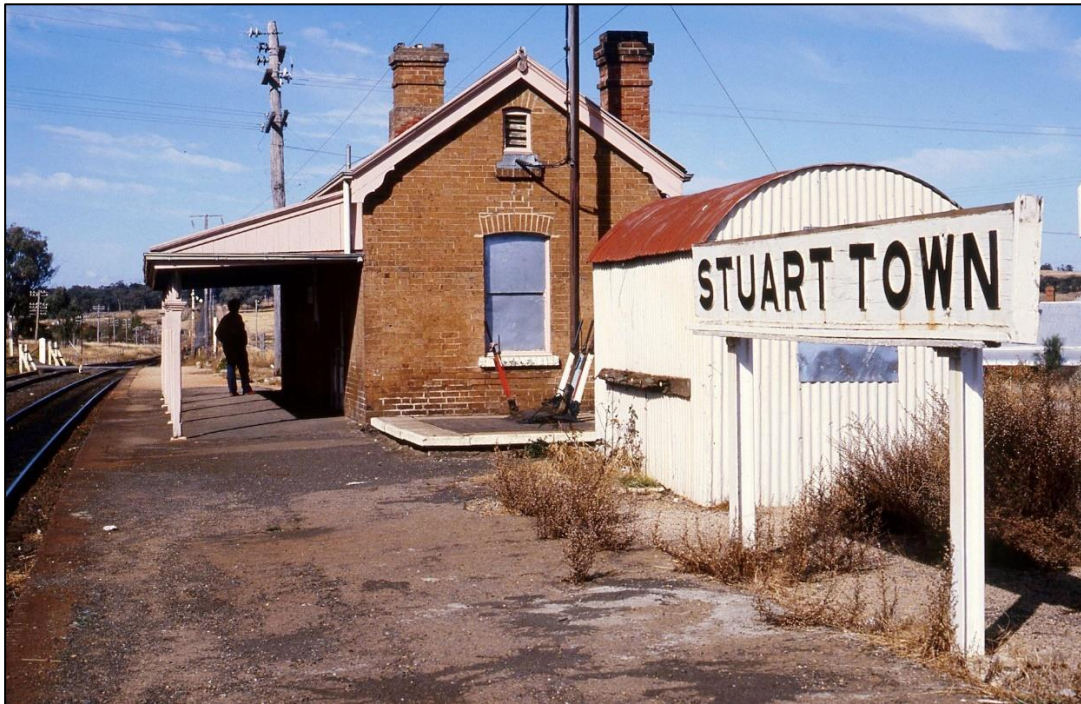
*Of the three other similarly designed buildings in the regional area (i.e., Mullion Creek, Euchareena and Maryvale), only that at Stuart Town has survived and its preservation is only due to the strong and ongoing political pressure from the local community. The above photograph of Stuart Town was taken about eight years after the Public Transport Commission withdrew the officer from the station. When the photograph was taken in 1984, the Liddell Street/Wellington Road level crossing immediately east of the station operated under “open type” conditions without any protection for motor vehicles apart from standard “stop” signs. The Down Home signal has been “pulled off” by the reversal (i.e., movement) of lever No. 2 in the interlocking frame. Three red coloured buckets to fight fires used to hang from the horizontal length of timber fixed to the wall of the lamp room but they were removed once the staff had been purged from the station in 1976. The silhouette of Signalling and Safeworking Historian, Graham Harper, is visible in the Stuart Town photograph. **SOURCE:** Lyn Harper.*

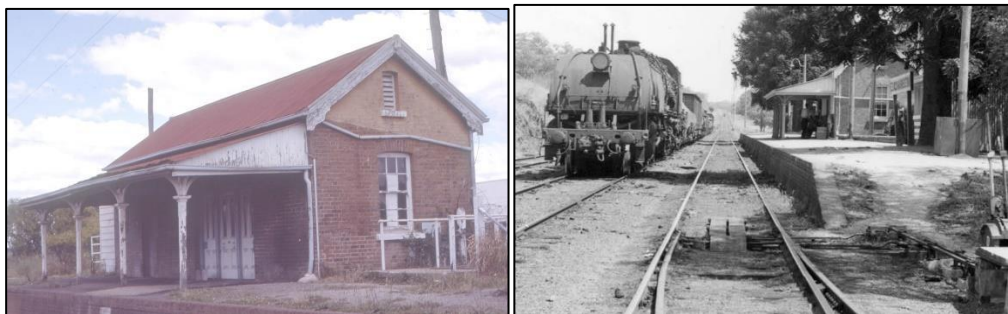
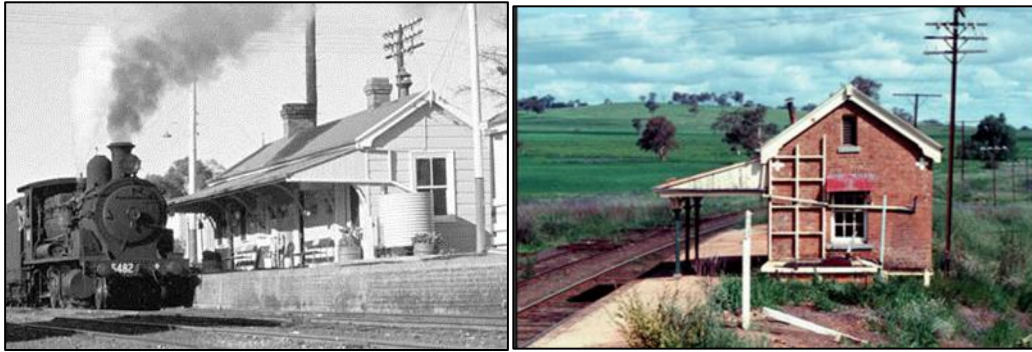
The four photographs show Mullion Creek on 8th June 1968 at the top left, Euchareena on the top right, Mumbil is on the bottom left and Maryvale on the bottom right. The physical similarity of the buildings at Euchareena, Mullion Creek and Maryvale is clear. All three were erected in brickwork but Mumbil was constructed of a timber frame with weatherboard cladding of a later time than its 1885 opening. **SOURCES:** Ken Winney photograph of Euchareena No. 112472 taken in February 1964. For Mumbil, photograph No. 461704 and for Maryvale photograph No. 59188 all from the ARHS Railway Archives.

The building at Stuart Town displays a similar appearance to the buildings at Mullion Creek, Euchareena and Maryvale and is approximately the same length as the building at Mullion Creek and Euchareena but not at Maryvale, which was shorter and was possibly the only station where the original building dimensions, 26 feet by 13 feet 6 inches both external, were not altered. Post-opening plans refer to the Maryvale structure as an office. The physical development of these buildings and the layouts of their subsidiary structures, such as, waiting rooms, toilets and lamp rooms, were different, which was a characteristic of third-class buildings on existing lines. Mumbil was opened five years after Stuart Town and was a much larger, timber building with a cantilevered platform awning. In other words, the Mumbil building was dissimilar to the others mentioned.

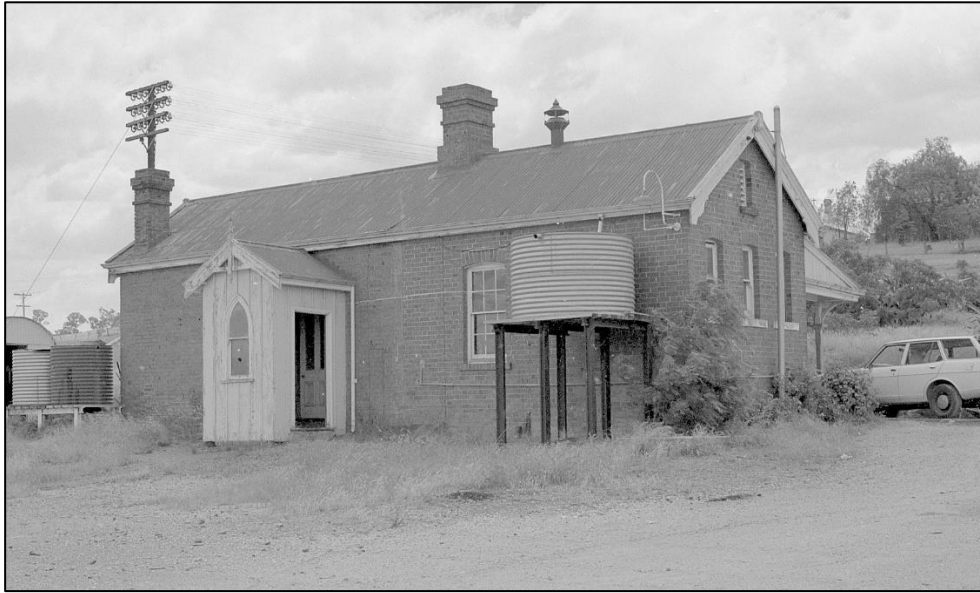
This photograph taken on 24th January 1979 shows several items of interest. Just to the left of the window in the brick wall is a vertical line that marks the addition of the ladies' waiting room to the other two internal spaces. A mixture of adjectives is essential to describe the porched entry – cute, incompatible and unusual – all in a fake Gothic Revival fashion. Porched entry through the rear of platform buildings was a status sign in most cases, but it is hard to see that the idea worked successfully at Stuart Town. It is hypothesised that the porch was added in 1890. The unusual location of the single chimney that evacuated smoke and gases from the fireplace in the Station Master's office suggests that it was provided after the construction of the building and possibly replaced a cast-iron stove which had a metal flue penetrating the rear wall. On the left side are two rainwater tanks on stands which provided some visual protection for the unattractive, corrugated iron male toilet. The erection of rainwater tanks above ground was very rare before 1890.

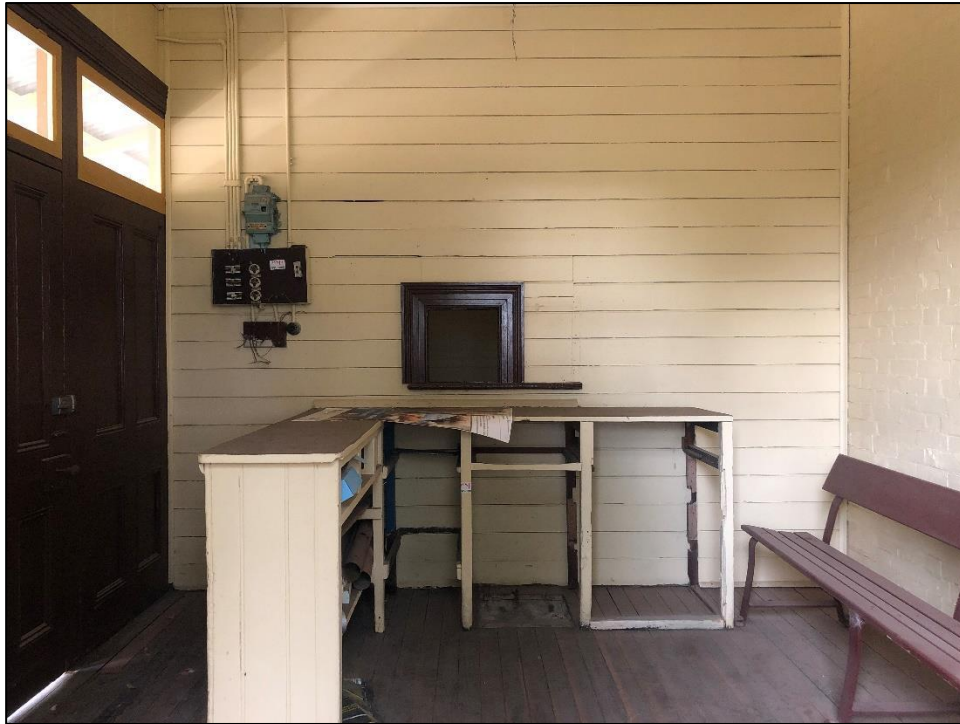
Although the external walls are formed of solid nine-inch brickwork, the internal wall between the ticket/parcels office and the general waiting room is formed by a timber frame covered with timber lining boards. Usually, the internal walls of brick buildings are formed by one the skin of bricks four and a half inches wide, but that is not the case at Stuart Town. The presence of the timber framed wall adds weight to the idea that, originally, the building was a single room with measurements either the same as the 1879 plan or different to the plan. Also of interest is the timber cover for the ticket window which slides horizontally against the traditional practice of covers sliding vertically. The “L”-shaped counter was designed to pass parcels between customers and staff. The image was taken by Bill Laidlaw on 23rd February 2024.

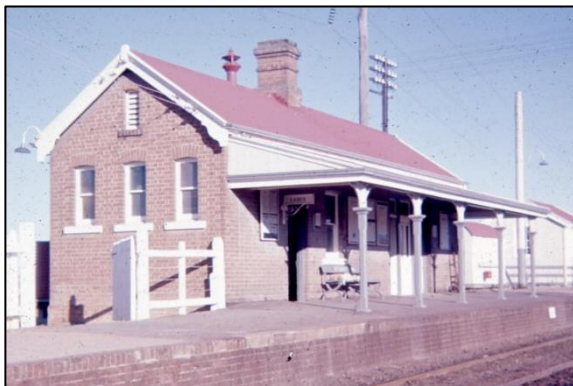
The railway staff painters had not long been at Stuart Town to paint all the timber work when this photograph was taken on 20th January 1967. The photograph shows the entry into the ladies’ waiting room and the three windows marking two closets and a hand washbasin. It was most unusual to see adequate toilet facilities provided for women. The photograph was taken three years before an additional

A septic system was installed at both the station toilets and at the Station Master’s residence on 21st January 1970. The opportunity was taken shortly afterwards to discontinue the use of the former detached male toilet block adjacent to the lamp room at the western end of the main building. A new male toilet was incorporated into the station building at the eastern end by truncating the size of the ladies’ waiting room. The work required a new opening for a door in the wall facing the platform and the new facility is identified by the door head being four courses of bricks lower than the other doors on that wall.

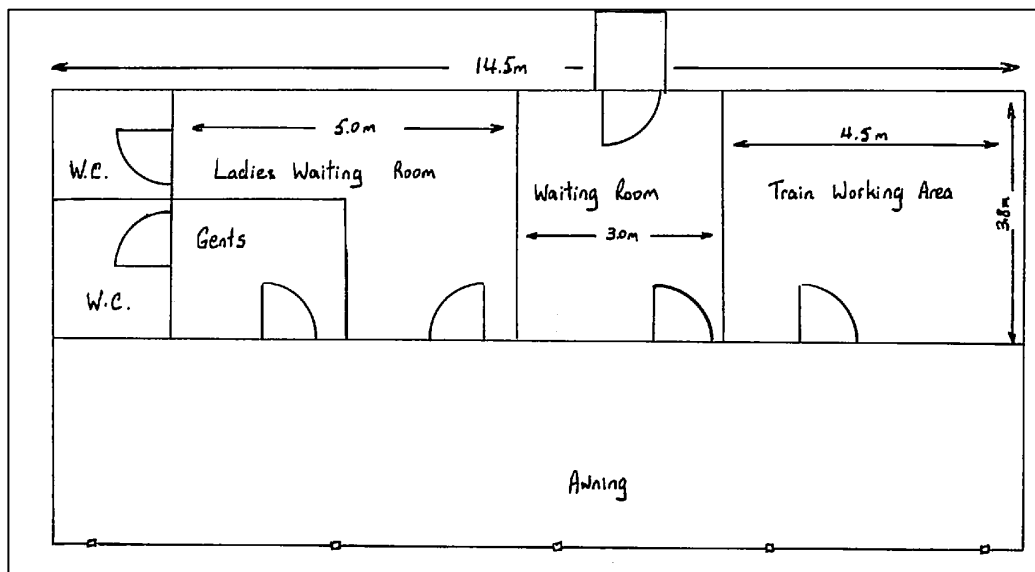
The above plan shows the layout of the building in April 1970 prior to the transfer of the male toilet into the main building. The following plan of the building in July 1970 was made after the provision of the new male toilet into part of the former ladies' waiting room.

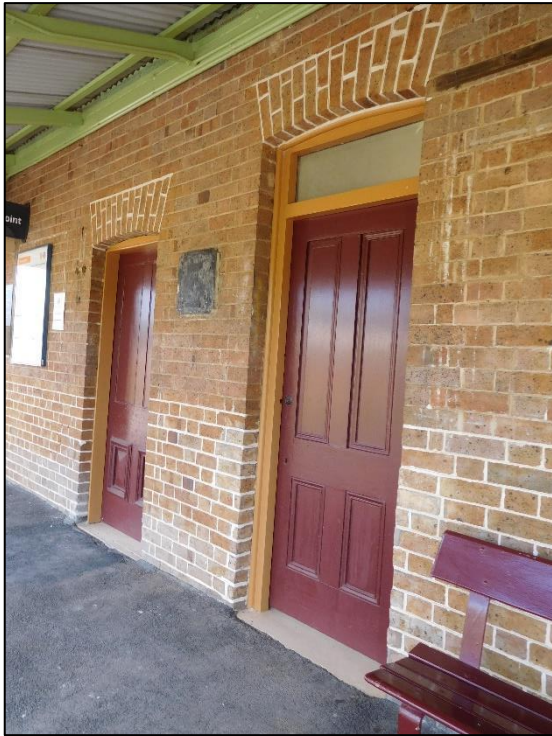
This image shows the impact on the building of the 1970 installation of the male toilet into part of the ladies' waiting room. The door on the right-hand side was the original door into their chamber while the door without the fanlight on the left-hand side provides access to the new male toilet. The omission of a fanlight for the new door opening is viewed as good conservation practice as a casual observer can determine the original door entry and the subsequent alteration. However, back in 1970, the omission of the fanlight was not made on conservation grounds but on a need to save money. Image taken on 14th September 2022.

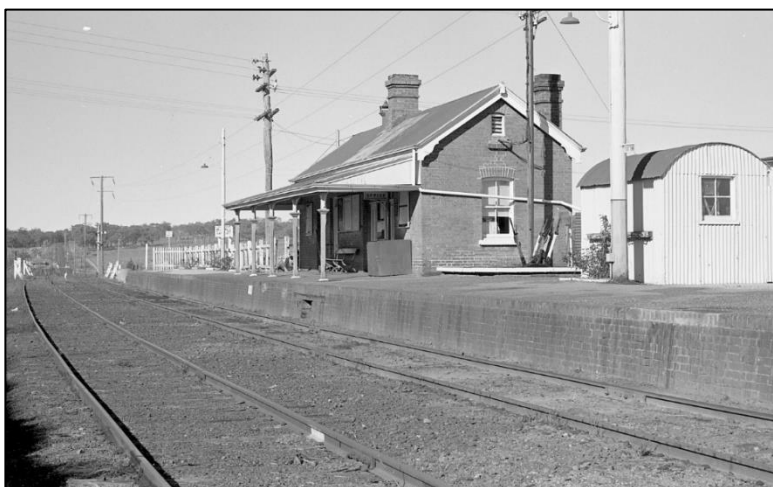
This photograph shows the building on 16th June 1975. A new addition to the platform is the steel box positioned outside the door of the Station Master's office. It was placed on the platform to facilitate the deposit of departmental correspondence and parcels when the station officer was not on duty. Other stations in the area also possessed these containers.

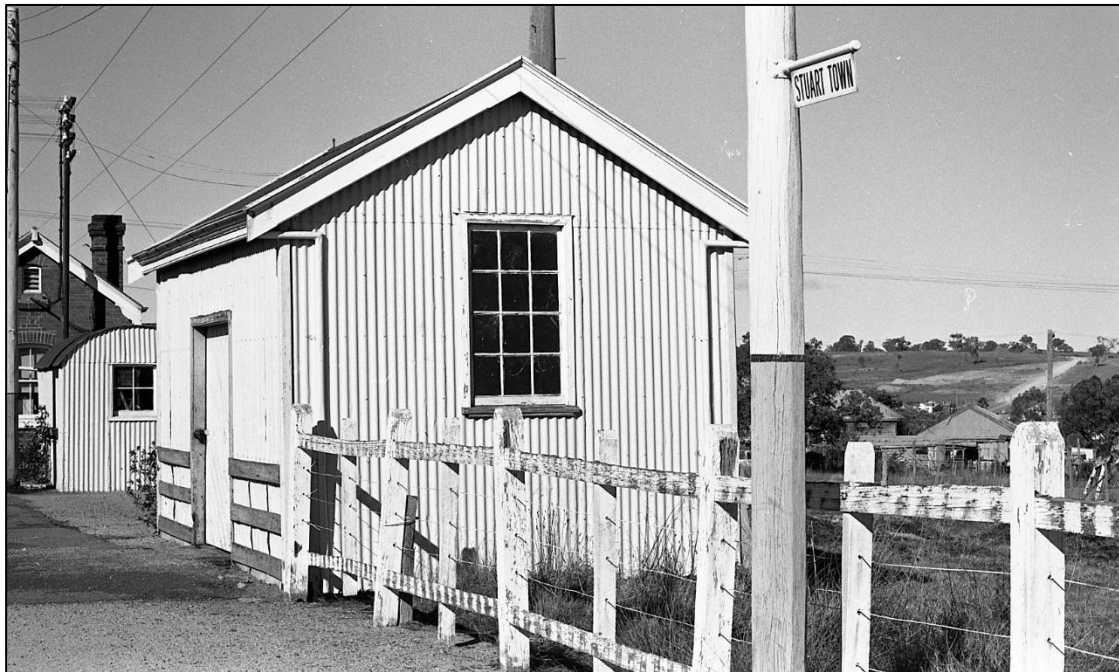
The above photograph, taken on 16th June 1975, shows the out of shed which was the third of three buildings on the platform. Out of sheds/rooms first appeared on the railway system in 1890 and followed the introduction by Chief Commissioner Eddy of the notion of second-class parcels. Prior to 1890, all parcels were conveyed by passenger train and kept in the office of the Station Master if there were not a dedicated parcels office. In order to reduce the cost of sending parcels, Eddy introduced a scheme whereby a lower tariff could be charged for those parcels conveyed by goods train and retained at their destination not in the safety of the Station Master's office but in less secure accommodation not under the direct supervision of the Station Master. In the photograph above, vertical boards have been placed against the corrugated iron wall sheets facing the platform to mitigate the damaged caused by the station Junior Porter banging the platform trolley into the building. Three other interesting other features are shown. The first is the strip of asphalt on the platform which terminates at the western end of the out of shed. In Departmental language, the bitumen on the platform surface of many stations, was called a barrow strip and its purpose was to facilitate the movement of

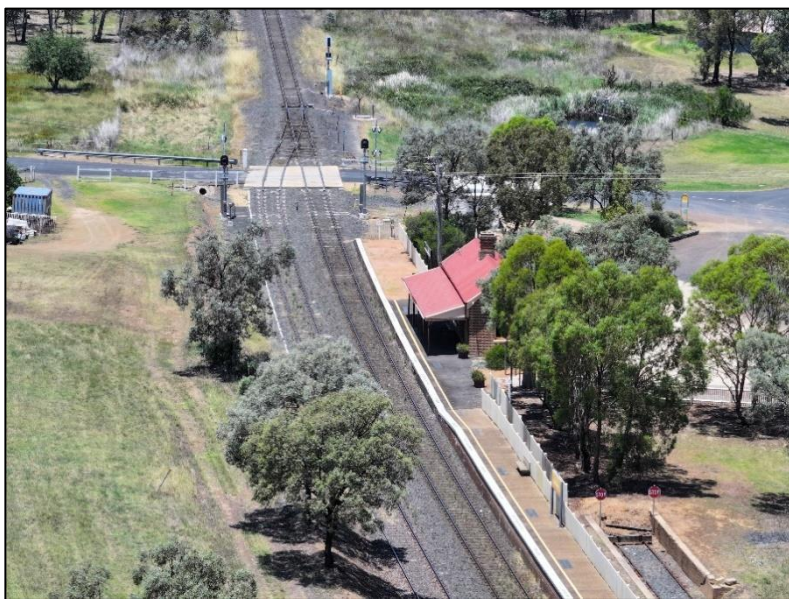
Unusual items at Stuart Town included double fencing along part of the platform and two “stop” signs at the end of the dock platform. James Dalton 9th December 2023

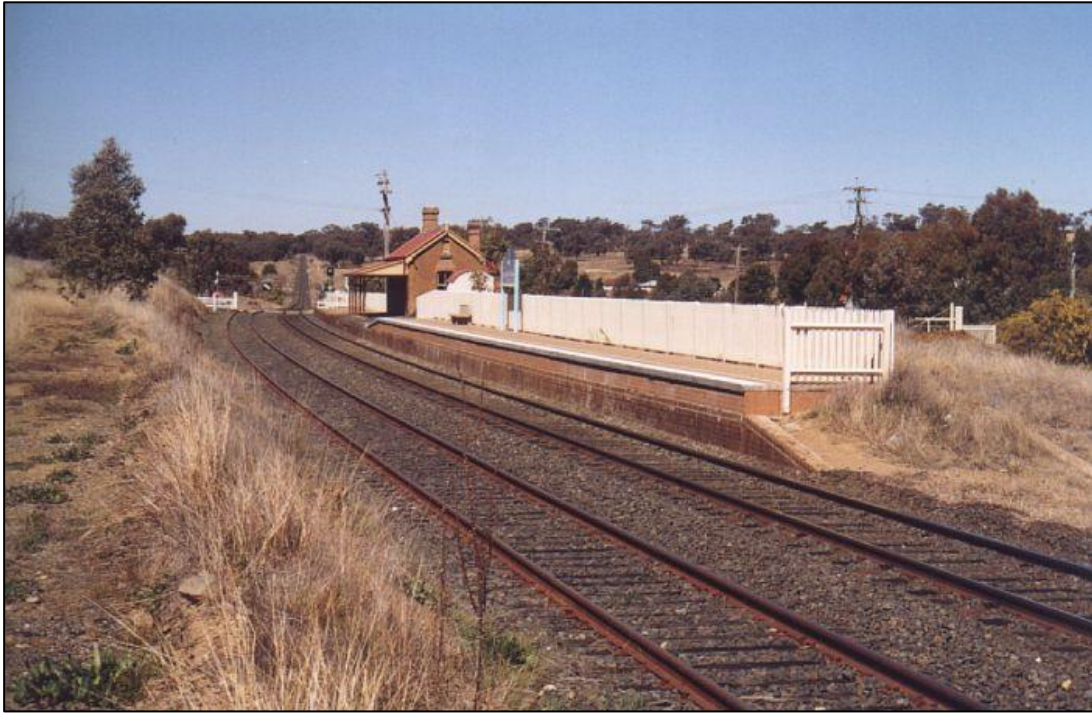
*Rolfe Bozier took this image on 30th August 2002. Countrylink raised part of the platform in 1999 by about 550mm (about 21 inches) or six courses of bricks. The two-tone blue Countrylink platform nameboard had been previously erected in 1992 and was refixed. It also built a second picket fence at the rear of the platform, thereby creating the present arrangement of twin picket fences on the platform west of the building. **SOURCE:** NSWrail.net*

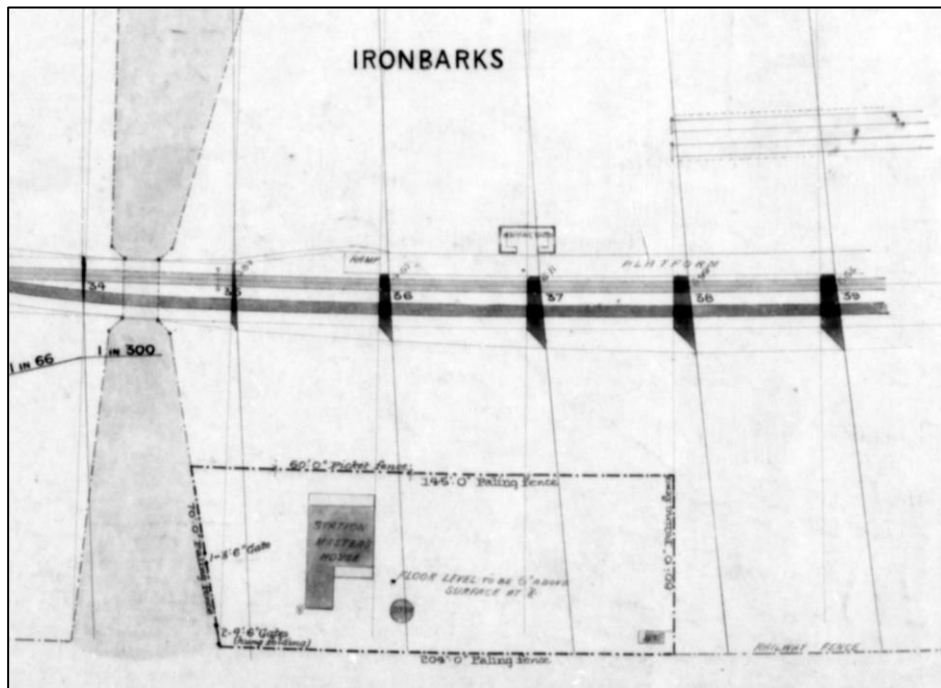
This plan, which was Initialled "JW" and dated 15th May 1880 shows all the proposed facilities with the residence in a topographically elevated position at the bottom, the passenger platform and waiting shed in the centre and the stubs of two sidings, which formed the goods yard. Out of view to the right is the remainder of the platform, the dock platform and the connections to the main line.

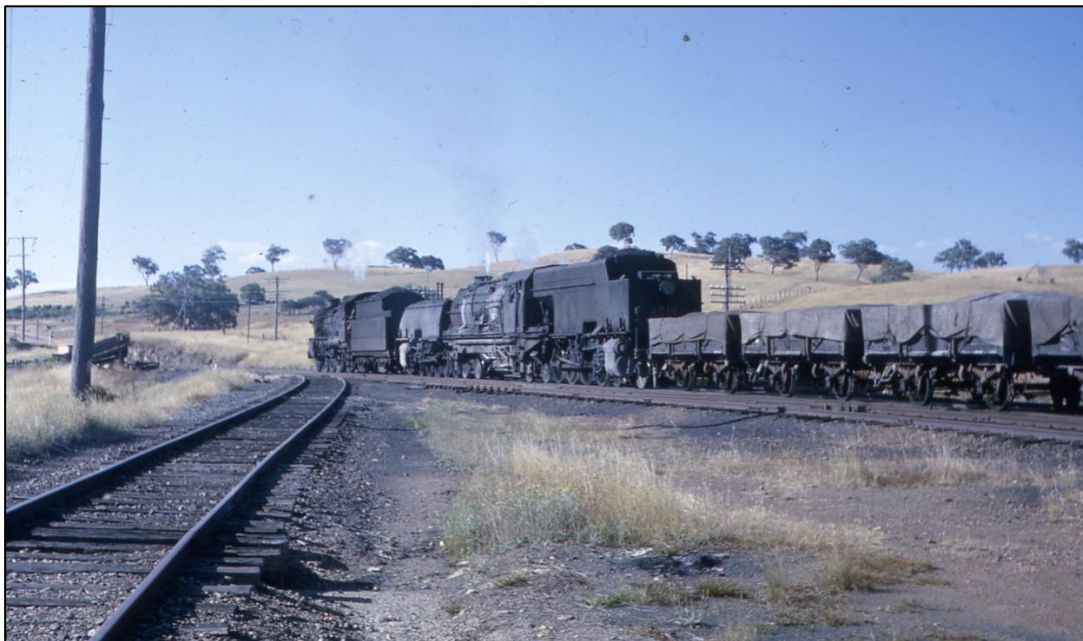
Locomotives 3638 and 6014 on No. 69 goods are moving at a fast pace past the station yard. On the left-hand side in the distance is the race for the stockyards. The railway line in the foreground on the left serves the goods shed while another line in front of the "S" trucks terminates in the dock platform. The date is 20th January 1967.

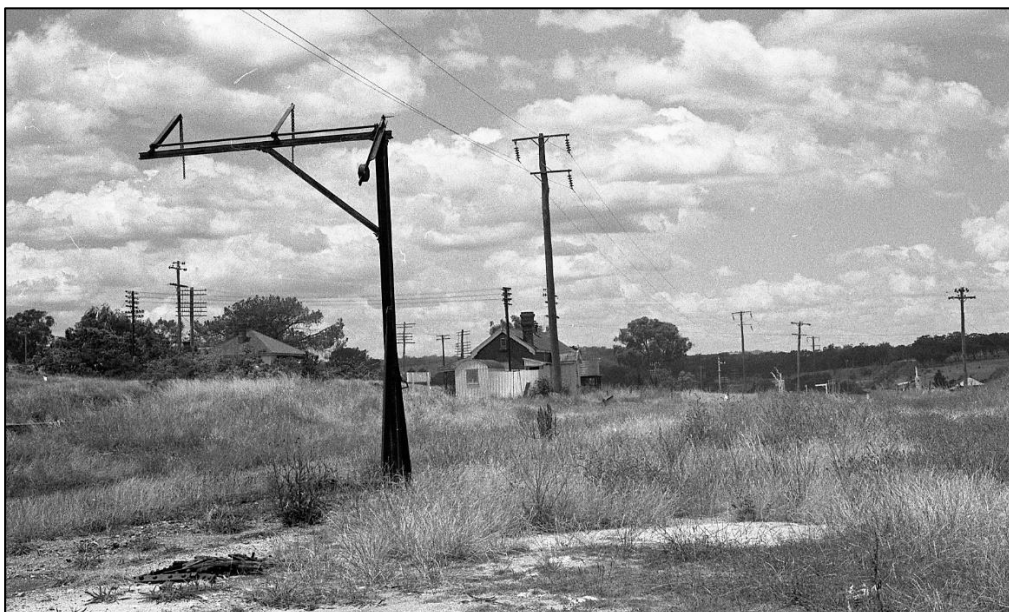
This photograph marks the location of the surviving goods siding after the removal of the second goods siding, which was closer to the passenger platform. This photograph provides considerable support to the argument put forward by Graham Harper that the post 1927 goods siding had not been relocated away from the main line but was, in fact, in the same position as it was initially in 1880. The structure towards the centre is the loading gauge which was used to check the height of wagons loaded with bags of grain or bales of wool. The photograph was taken on 24th January 1979.

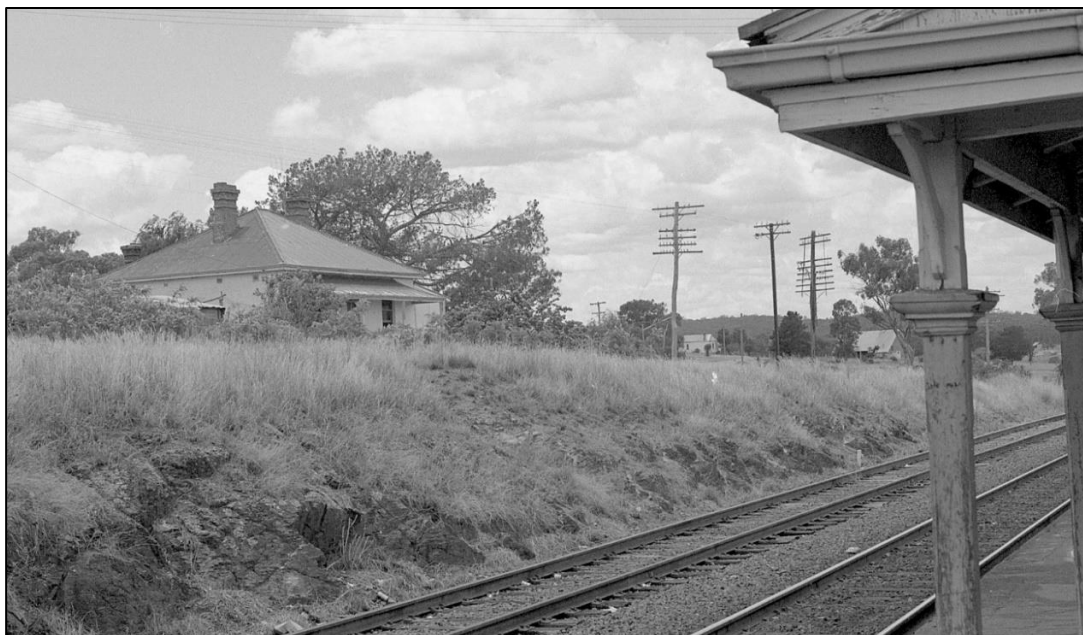
This photograph, taken on 24th January 1979, shows the geographic relationship between the platform and the residence. Often, John Whitton would approve an elevated posture for the Station Master's house, as at Stuart Town. The photograph shows the topographical limitation that prevented the goods yard being erected on the eastbound side of the passenger platform. Such a notion would not have entered Whitton's mind as he always endeavoured to place goods facilities on the same side as urban development in an effort to avoid slow-moving road vehicles crossing the railway tracks. The photograph also shows the simplicity of the timber posts supporting the platform awning and the absence of cast-iron awning brackets, which would have been provided had the building been directed by John Whitton.

When the station opened, the residence for the Station Master, located opposite the platform, the house was not built as its approval was given on 15th May 1880 just two weeks before the station opening. The architecture accorded with a standard design that John Whitton had introduced in 1876 for use on new lines throughout the railway system. Of the four initial examples erected in 1876, two survive on the Main West line – at Millthorpe and Spring Hill. Tenders closed on 6th April for the construction of residences for Station Masters at Mullion Creek, Warne and Stuart Town.⁵⁵ The three houses were of the same design featuring a full-width front veranda and symmetrically placed brick chimneys. James Douglas was the successful contractor, according to

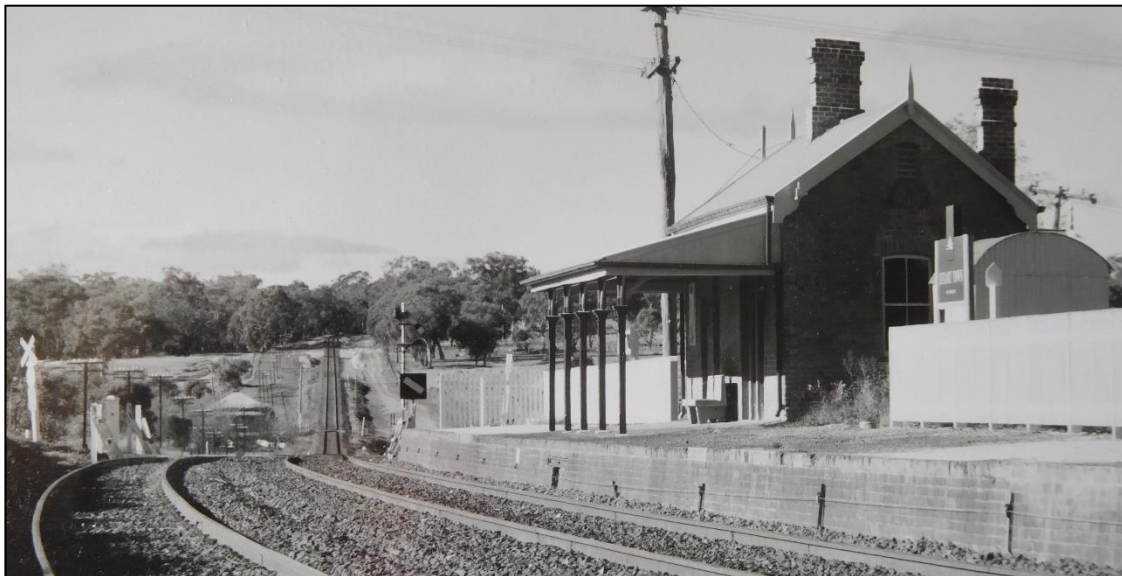
This 1992 image shows the relationship of the Alexander Street gatehouse to the platform. The gatehouse is just visible towards the centre of the picture where the main line dips between the hills.

Approval was also given in June 1880 for the construction of a Gatekeeper's house at the public level crossing on Alexander Street at the eastern end of the town approximately 2,000 feet on the eastern side of Stuart Town station. It was of brick construction being of a standard design of gatehouse with the chimney in the apex of the roof. It was built only 25 feet from the line. The gatehouse remains but is derelict.

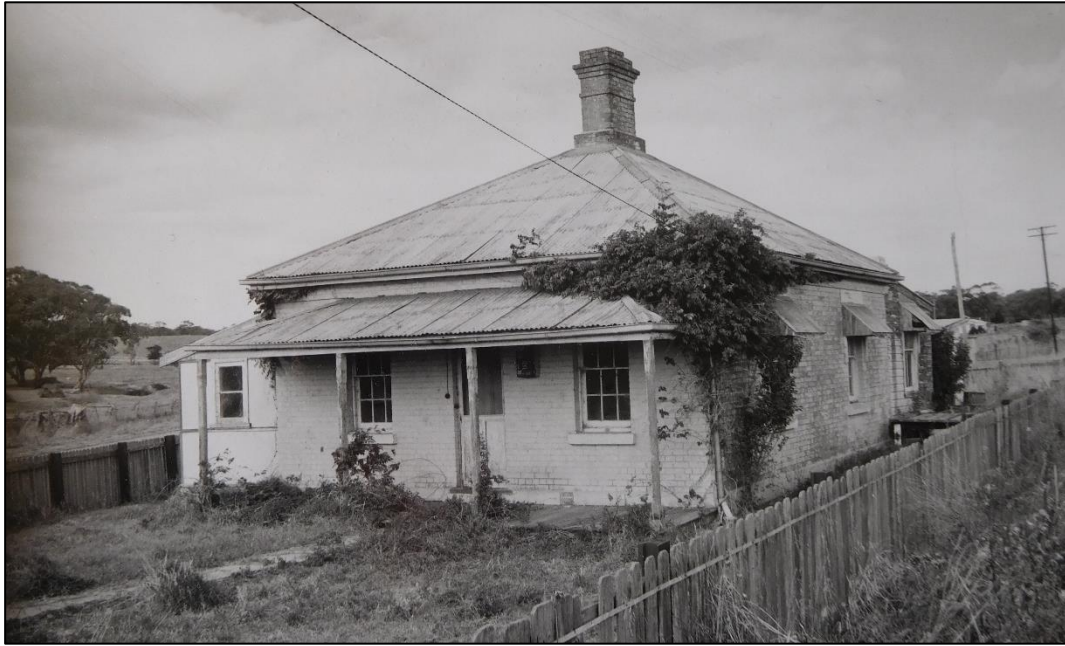
*This photograph is of the Alexander Street gatehouse, which addresses the adjacent road. The photographer, being a railway officer, was permitted to enter the rail corridor to capture the picture. **SOURCE:** Ian Percival.*

The Alexander Street house was small, measuring 26 feet by 26 feet, and contained four rooms and a kitchen at the rear measuring 12 feet by 9 feet. There was a full-width front veranda 5 feet wide but no rear veranda. The absence of an internal corridor was a feature of the design. Only two rooms had fireplaces.

The Gatekeeper, who resided in the Alexander gatehouse, opened and closed the gates across the thoroughfare for over 80 years between 1880 and 1962. The date the gates were removed, and the Gatekeeper was out of a job is unknown but probably was in 1962. Graham Harper searched exhaustively the various official railway documents and found an amending entry for the Department's *Working Timetable West* in 1963 in *Weekly Notice No. 41* of 1963 stating:

The State Rail Authority was adamant that the gatehouse could not be sold or leased to a non-railway employee or other tenant because of its proximity to the running line. Hence, the Authority was very keen to demolish the Alexander Street gatehouse but the protests from the local residents were such that the organisation decided in the 1996 to leave the structure as a monument.⁵⁸

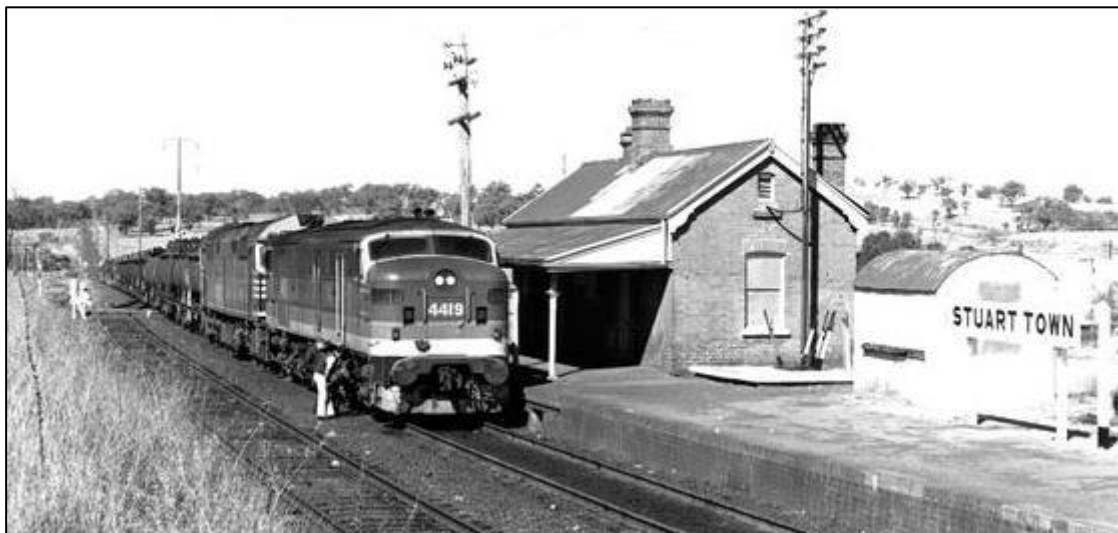
This undated photograph of the 1980s shows the Dubbo oil train. Something is wrong with the engine and the locomotive crew has stopped at the station opposite the building to use the telephone in the office. The roof of the station building needed repairs. The entire roof was replaced not by the State Rail Authority but as a donation by a local roofing contractor. The same person also repaired the vertical timber posts supporting the platform awning.
SOURCE: Transport for NSW

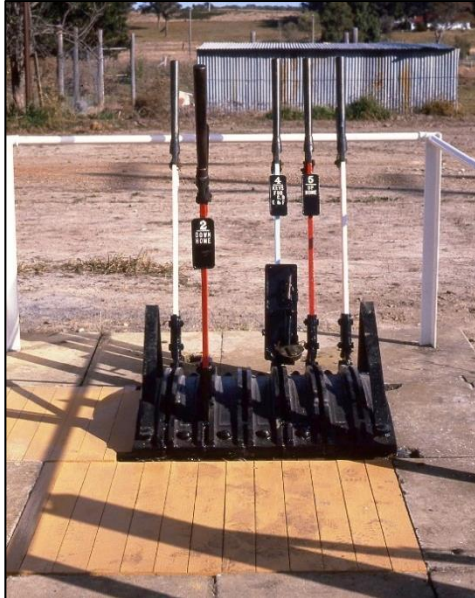
*This 1984 photograph shows a new timber apron in front of Frame "A" which replaced the original timber planks. Lever Nos. 1 and 8, which formerly connected to the Down and Up Distant signals, have been painted white following the replacement of those signals with fixed triangular shaped signs, which were officially known as landmarks. An improvement that had been made prior to 1973 was the provision of a stirrup adjacent to lever No. 1 to help staff activate the Down Distant signal. **SOURCE:** Lyn Harper.*

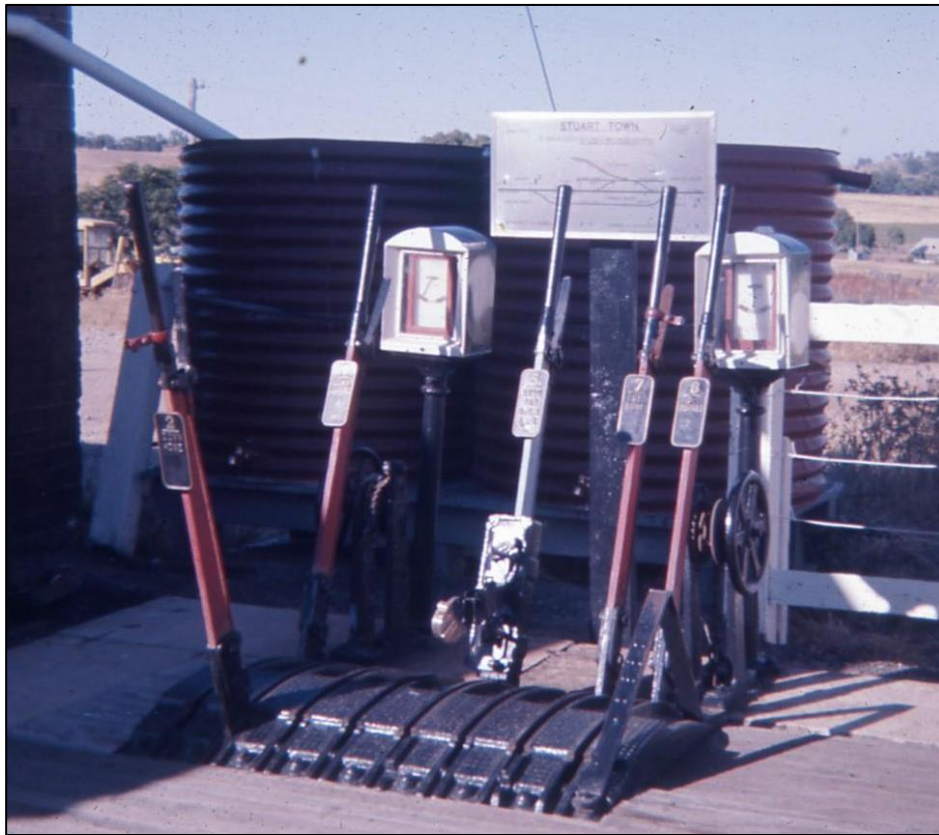
This 1967 photograph of the Stuart Town signal frame demonstrates several characteristics common to small key-locked crossing loops. The frame contains provision for eight levers. Such locations normally had provision for six or eight levers, occasionally twelve.

Behind each distant signal lever can be seen a GNR type signal adjuster. This made it possible for the signaller to tighten or loosen the wire on the distant signal by winding the wheel. The long runs of wire to the distant signals were subject to expansion and contraction according to the ambient temperature and the signal adjuster offered a simple way of tightening or loosening the wire, compensating for that. To loosen the wire, it was necessary to wind up a bit of tension and then flip the pawl, then while holding the wheel let the tension off a bit and put the pawl back.

A stirrup can be seen just after No.8 Up Distant lever. This was provided so that the signaller could brace his foot against it to give him better purchase when pulling over the lever. No.8 Up Distant was some 3400 feet (about 1.04 km) out from the levers and would probably be a hard pull on a frosty winter's morning. No stirrup appears to have been provided for No.1 Down Distant lever at the time of the photograph, but one is present in a 1984 photo. Such stirrups were common in conjunction with levers operating distant signals.

Levers 3, 4, and 6 are all missing, or in the signal terminology, spaces. The railway normally only provided levers for which a function was planned. As there were no plans for Stuart Town other than as a simple key locked crossing loop with a couple of sidings, no other levers were required.

Finally, the yard diagram can be seen behind the lever frame. This is not the original diagram, but a more recent replacement with aluminium replacing the original glass enclosed paper/card diagram surface. Such aluminium diagrams were more resilient to the rain, and the absence of any glass lessened the temptation for vandals.

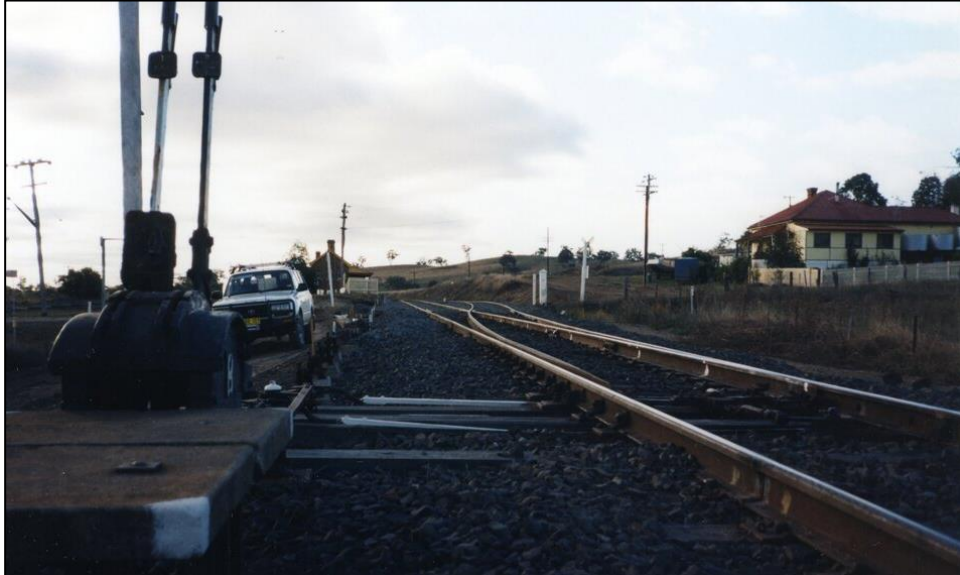
The section of line between Orange and Dubbo was the first occasion that Train Order Working had been introduced in New South Wales. That occurred in 1995. This mid-1990s photograph shows the black and white main line mainline point indicator associated with the train order system. In this picture, the point indicator faces Up trains and is located at the end of the eastern end of the platform. It displays to both Down and Up directions the photograph shows that the loop points are set and locked for the main line. If there were a problem with the points, the white rectangular element would be expressed in the horizontal plane. It is unknown whether there was any detection between the points and the signal; possibly the white on black board was left to warn a driver if the points were or were not correctly set.⁶¹

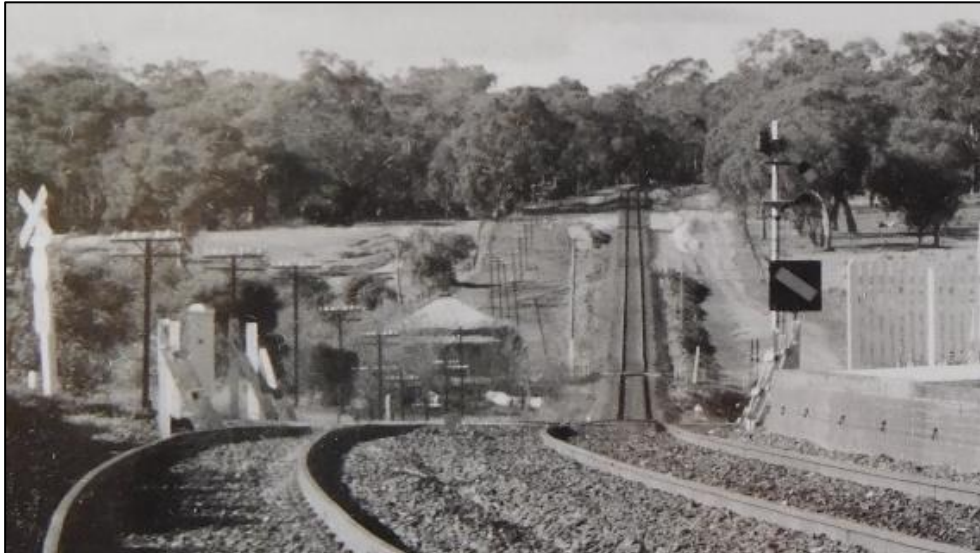
*This early 1990s image shows the black and white point indicator associated with the train order system. In this image the point indicator faces Up trains and is located at the end of the eastern end of the platform. It displays to both Down and Up directions that the loop points are set and locked for the main line. It is unknown whether there was any detection between the points and the signal; possibly the white on black board was left to warn a driver if the points were not correctly set.⁶² **SOURCE:** Ian Percival Collection.*
