STUART TOWN RAILWAY STATION

PERHAPS THE MOST PUZZLING SET OF STATION STRUCTURES ON THE NSW RAILWAY SYSTEM

THE SIGNIFICANCE OF STUART TOWN PLATFORM BUILDING

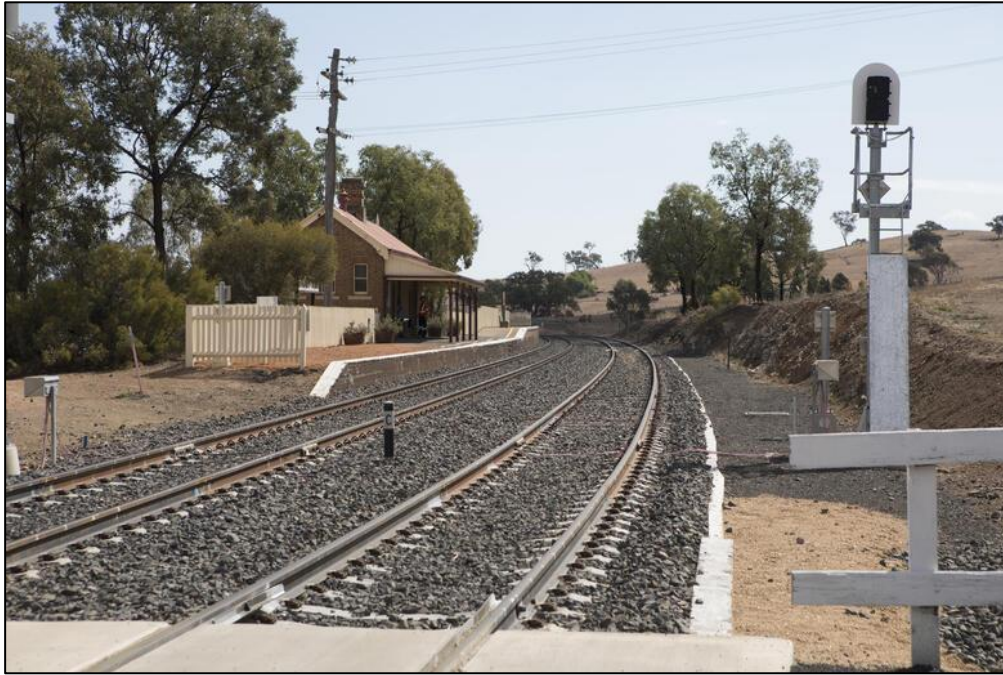
This image shows the Main Line Indicator facing Up trains using the loop. Upon the installation in 1998 of flashing lights on the road crossing, the lights and associated bell were automatically controlled by track circuit for Up and Down trains with the exception of the Up Central West XPT service, which requires the operation of a driver's pushbutton at the station to activate the lights and bell. Also, shunting at the eastern end of the Loop siding requires the operation of a shunter's pushbutton and duplex lock to operate the level crossing equipment. In conjunction with the provision of this equipment, a main-line indicator (MLI) has been provided in the Up direction on the Down side of the line at the clearance point with the Loop siding at the Sydney end. The MLI normally displays a pulsating white indication (to proceed) or a red indication (Stop). The MLI has been timed such that it will show a red indication during the period 15 minutes before due time and 60 minutes after due time of the Up Central West XPT. When the XPT is ready to depart, the driver must operate the driver's MLI pushbutton to activate the crossing equipment and cause the MLI to display a pulsating white light. SOURCE: <https://www.transport.nsw.gov.au/sydneytrains/culture-and-heritage/welcome-to-historic-stuart-town-railway-station/stuart-town-0>

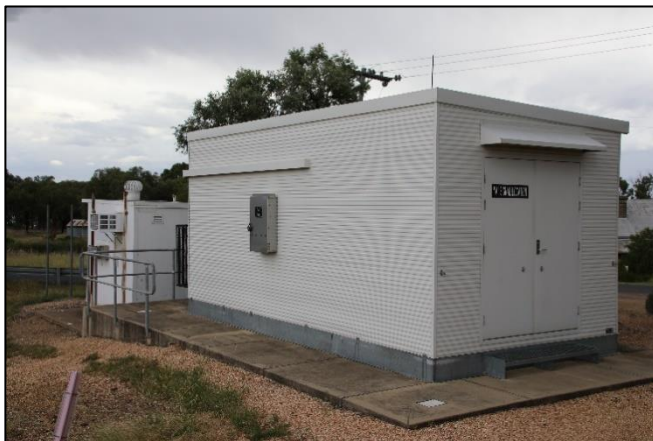
In areas where train order working operates, no signals are provided. The contractor who built the electrical structure behind the eastern end of the platform provided a sign on the door. The sign stated: " 'A' signal location". Someone forgot to tell the contractor there were no signals where train order working was in operation. Bill Laidlaw took this image on 23rd February 2024.

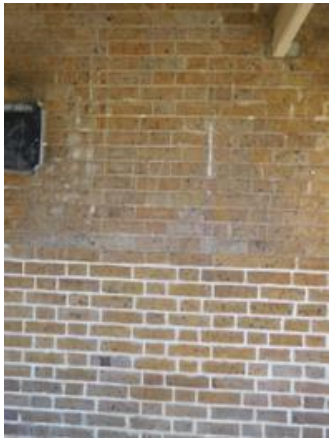
Consistent bond indicates simultaneous construction	While all the walls are built in Flemish bond, the platform wall and the walls of the dock are set in English bond, indicating different construction times. The chimneys are set in what appears to be stretcher bond and possibly suggest that at least the chimney at the western end replaced a stove flue.
Designation of the rooms	the number and order of the rooms identifies the design family and time of construction	The three-room building is consistent with practice, but the original two room configurations were unusual. A fourth room was added in 1970 by dividing the existing ladies' waiting room into two parts to accommodate a male toilet.

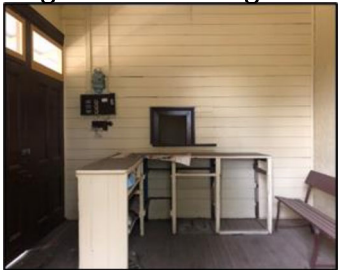
From 1877, the timber covers over some ticket windows moved horizontally rather than the traditional vertical movement.	The horizontal movement of the ticket window cover at Stuart Town indicates that the design was consistent with other experimental/irregular features of the building.
Window sills	The design and material reflect the time of construction. The extent of render on windowsills and	The absence of any render indicates that the building served a small centre. The horizontally

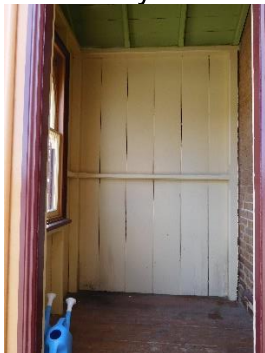
Porched entry

The provision of a porch to enter was used to signify a more important centre served by the station.

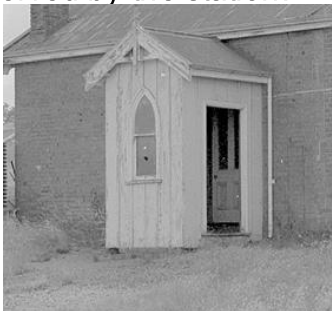
This hideous addition has all the hallmarks of a jerry-built, local project. The Gothic shaped window possibly takes its form from the church on the opposite side of the track to the platform located on the top of the nearest hill.
Use of vertical boarding – on rear porch and above set of three “doors”	Used by the New South Wales Railways for specific tasks in and after	Does not conform to traditional practice. Further confirmation of the

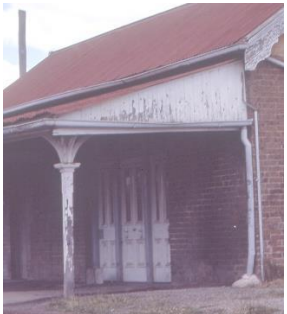
Located at the ends of the platform awning, these elements are usually an important decorative element of varying designs.	The absence of any decoration, including the bevelling of the ends of the vertical boards, reinforces the idea of local design input.
Above ground rainwater tanks

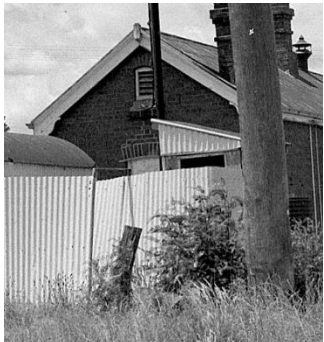
Location of male toilet

Indicates approving officer	The location of the toilet off the platform at the western end indicates that the station buildings were erected after the opening of the line with the work being carried out by the Existing Lines Branch.
Missing decorative elements	The extent of decoration and/or the overall attractiveness of a building mirror the status of the stopping place in the extent of money available	The platform building was purposefully designed in a restrained manner to show the relative low status of the town.
