SPRINGWOOD RAILWAY STATION

HISTORICAL NOTES

“THE ROMANTIC AND PICTURESQUE SPOT”¹

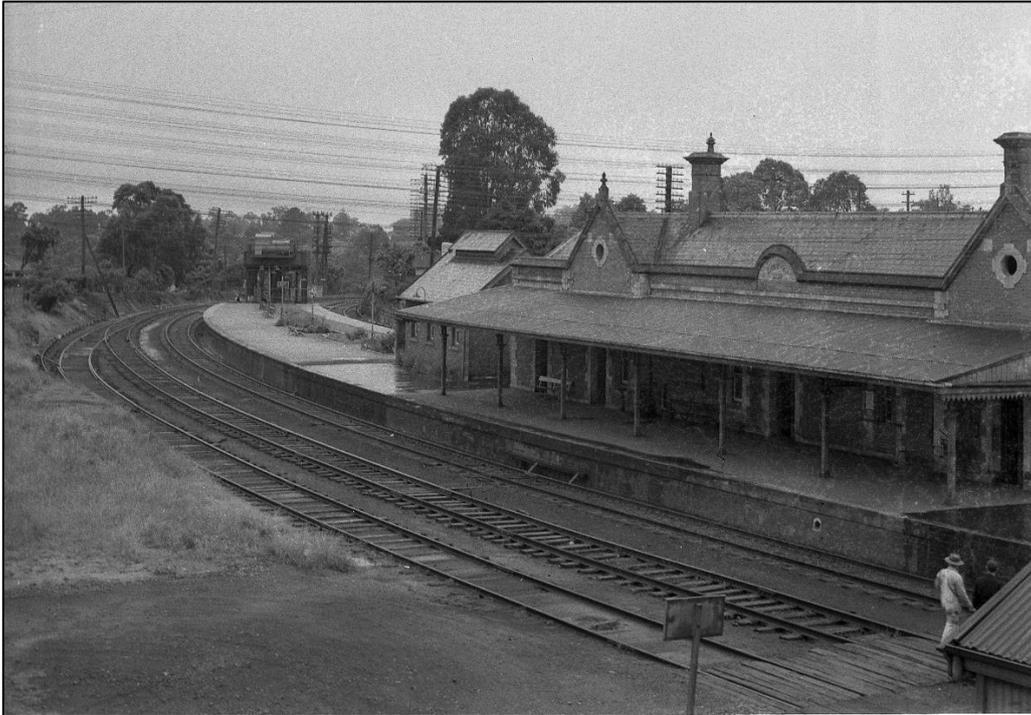
*The photographer is facing in the direction of eastbound trains in 1953 and he shows the platform building in its original, face brick presentation. Beyond the end of the platform is the elevated locomotive water tank and water column. Faintly visible on the platform wall about the centre of the building is an opening at track level from which rods and wires from the interlocking frame extended along the platform wall to the various signals and points. Prior to 1935, interlocking frame was located in front of the platform building but, in that year, was relocated into the main building. The timber walkway across the tracks is a feature of a railway system long gone. **SOURCE:** Photograph No. 214734, Singleton Collection, ARHS Railway Archives.*

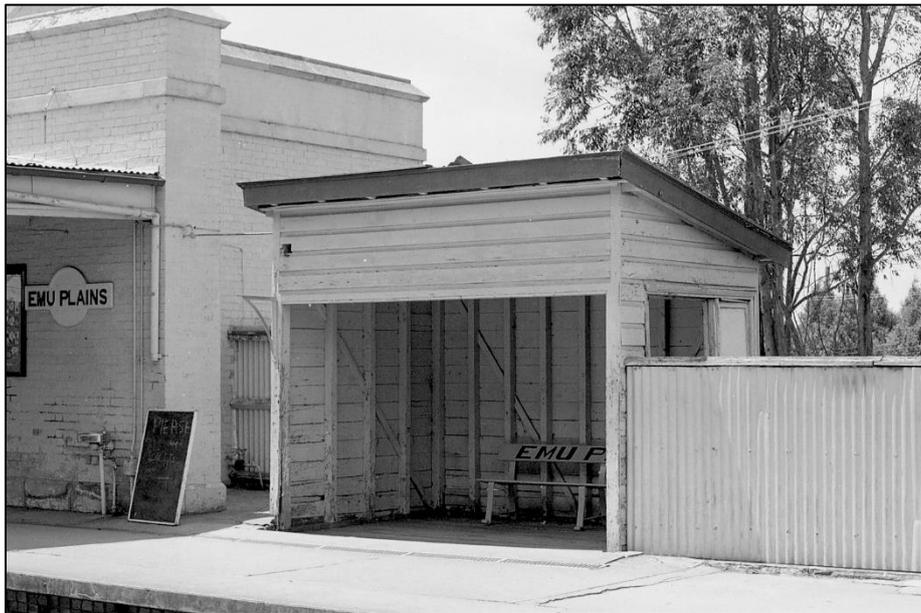
The above photograph shows the simple waiting shed at Emu Plains on 31st December 1977. It was the essence of economy with a single pitched roof, the omission of a platform awning and an absence of internal lining boards on the walls. The disgraceful neglect of building maintenance is obvious.

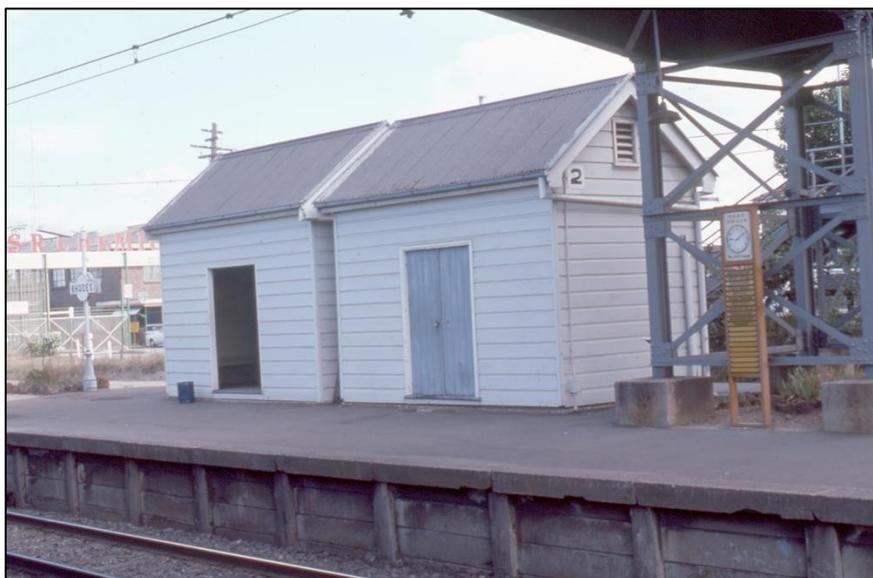
The foregoing photograph shows two forms of the second type of basic structure for small stations. The design was a bit more costly with a double pitched roof. The architecture came in two styles – one with an open front and, the other, fitted with a pair of doors. Again, there was no platform awning. Photograph was taken on 9th April 1977.

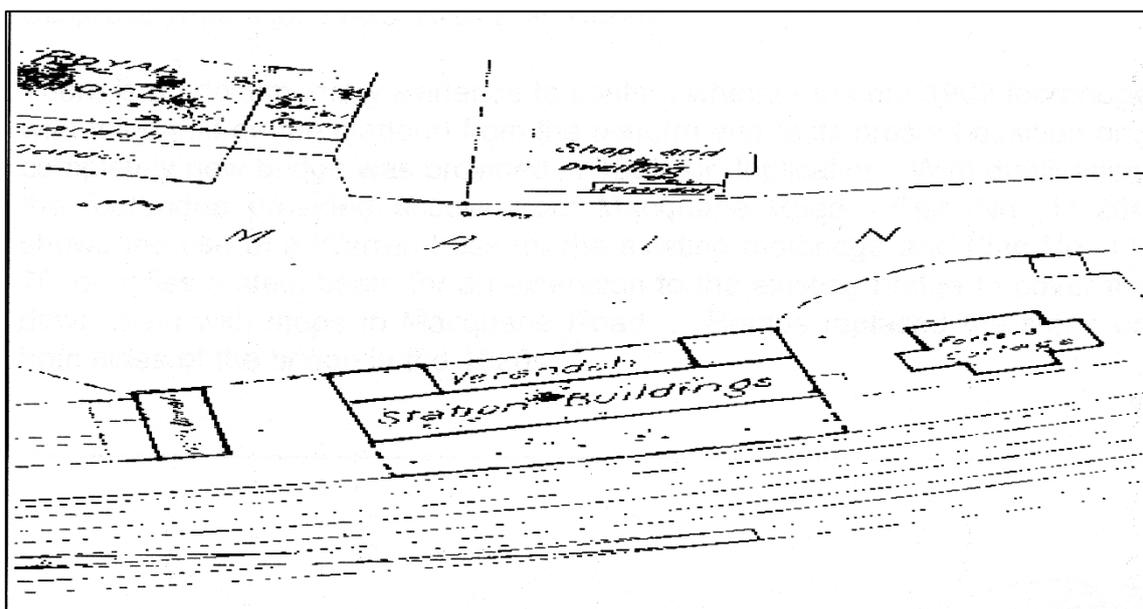
*The above plan shows the outline of the completed building in 1886. On the right is the official residence of the Porter-in-Charge, which was erected in 1878. The main platform is shown in the centre. Noteworthy are the adjacent projections of the structure towards the street at each end of the building. These were removed in 1902 to allow for track duplication. On the left-hand side is the detached male toilet with the heavily-inked outline of a new lamp room to be attached to the toilet block. On the top left is the Royal Hotel dating from 1881. **SOURCE:** Survey Plan No. 370 13/324, former State Rail Authority Plan Room.*

The floor plan was symmetrically based on the centre entry/exit/general waiting room which was 20 feet long by 14 feet wide (internal). On each side of the general waiting room were two rooms each approximately 14 feet square. On the western side of the general waiting room was a parcels office and a booking office and on the eastern side an office for the Station Master and the ladies' waiting room.

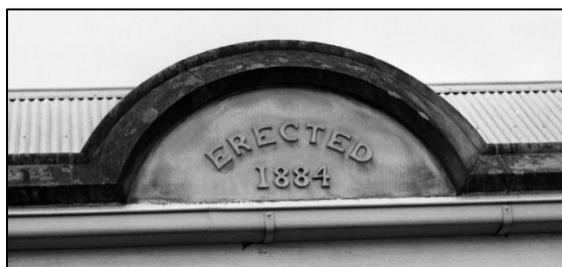
The photograph to the left shows one of the very unusual aspects of the Springwood building, namely a pediment with the date of construction. The photograph also shows the extensive dirt attracted to sandstone capping. The photograph dates from 31st December 1977.

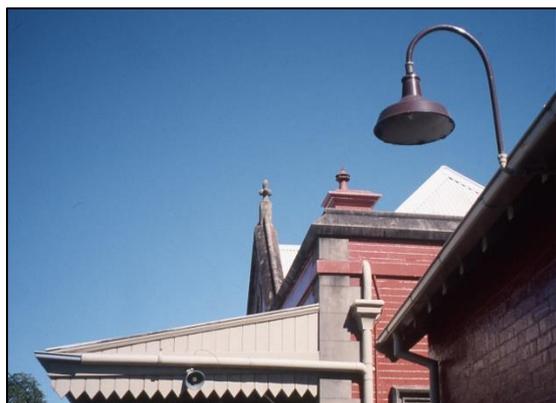
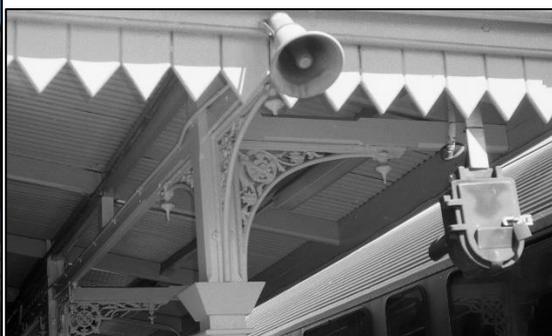
The above photographs show some of the architectural detail aspects of the Springwood station building. On the left is the spandrel (i.e., the vertical boarding terminating the platform awning) and the sandstone quoins at the building corner. The spandrel was very plain-looking and that feature marked the station in a small way as a Second Class building.⁴⁵ The gables have sandstone capping with sandstone finials. Originally, the gables extended towards the edge of the platform awning but were relocated backwards to the main building wall when track duplication forced the truncation of the gables. The building in the right foreground of the photograph on the left is the combined male toilet/lamp room. The picture on the right shows the ornate brackets supporting the awning on the eastbound track. Again, the omission of cast-iron vertical posts supporting the platform awning was another marker that denied the structure First Class status. The photographs were taken on 31st December 1977.

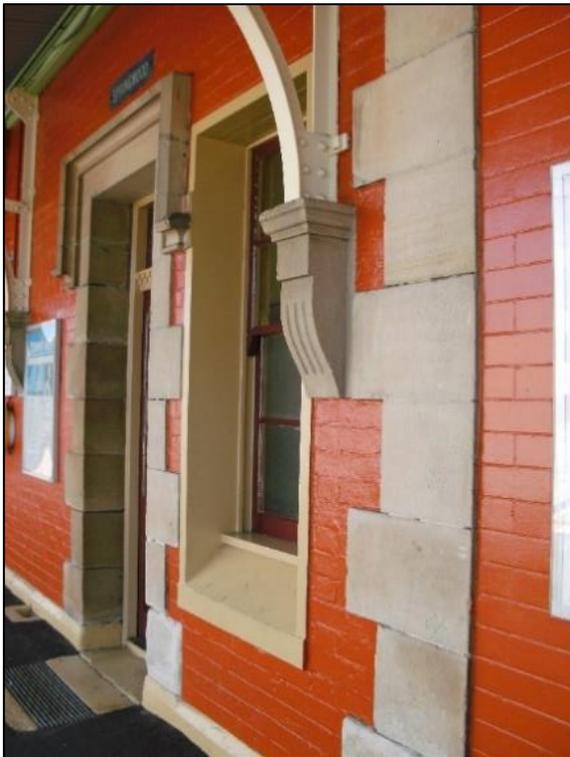
This image shows the westbound side of the platform building. The sandstone corbels, on which the awning brackets sit, are recessed into the double skin brick wall. On new buildings, corbels would sit on engaged piers but the absence of such piers clearly indicate that the corbels and brackets have been added to an existing building. Note that the external surface of the brickwork on the right of the image is not as rough textured as those elsewhere on the building. When the new general waiting room was added to the eastern end of the structure in 1944, machine made bricks were used. The bricks on the original building were hand made. Between the old and new brickwork is one of the quoins which formed the corner of the building prior to 1944. While the building was approved in 1882, Italianate architectural influences were employed on larger station buildings. That influence was not used on the Springwood structure, which featured ornamental stonework at the heads of windows and doors rather than the usual arched heads.

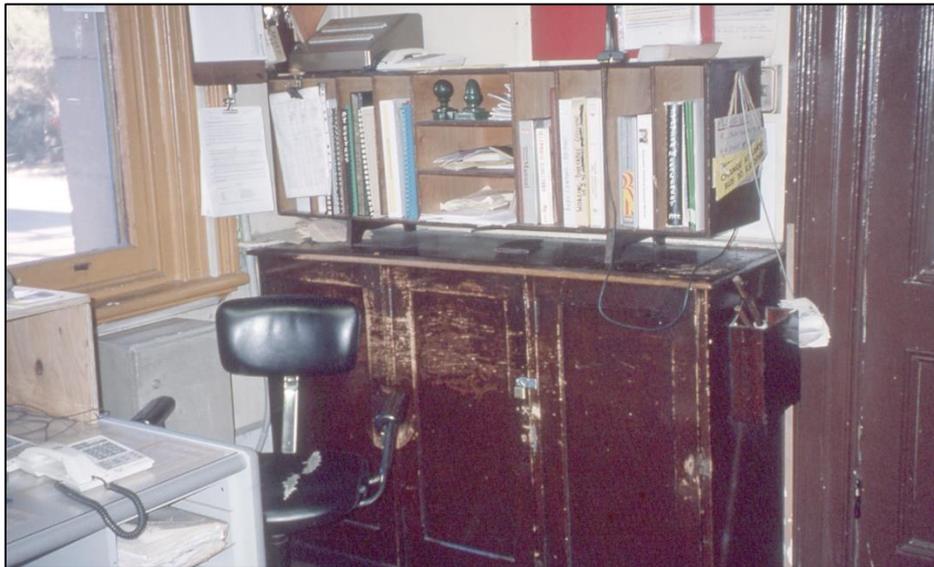
This photograph taken on 27th August 1997 shows the transition of office furniture from traditional times to the 1990s. It reflects the desire of CityRail to improve staff working conditions. On the left side is the newly installed desk for the Station Master while, behind his chair, is a timber cabinet having been made many decades ago in the Railways' own workshops. The constant ins and outs of the seat have removed some the paint from the cabinet. The window frame is painted in the traditional colour of light stone while the door on the right is painted in dark stone. There is a little box attached to the end of the cabinet which contains the green, red and white flags for dispatching trains.

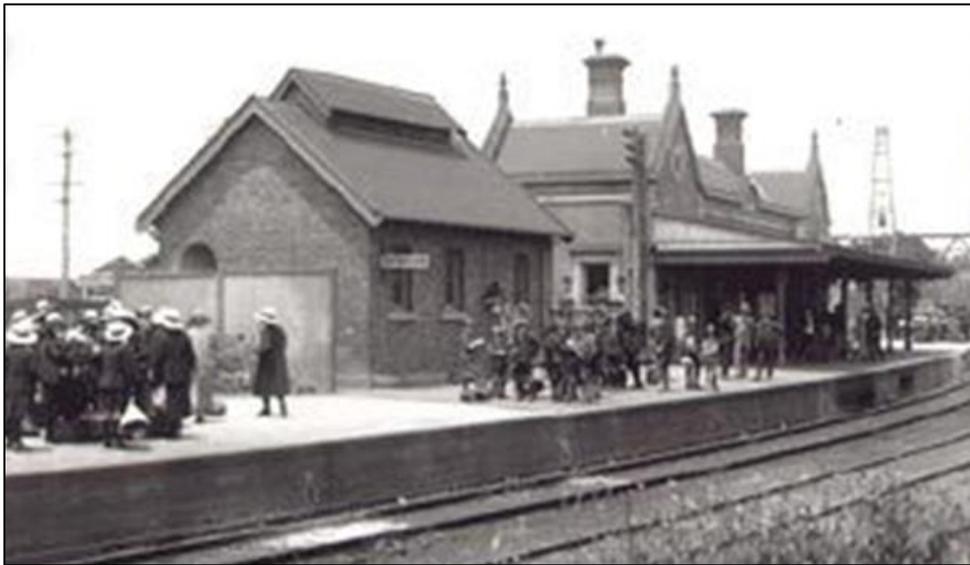
The above photograph shows the platform structures at Springwood in 1920 in original condition. Nearest the camera is the male toilet pavilion. The most unusual aspect of the pavilion is the position of the roof ridge, which is in line with the ridge of the main building. Normally, toilet pavilions in the 19th century would express the roof ridge transverse to that of the main building. Two other features of the toilet block reflected traditional New South Wales Railway practice. The first is the use of vertical timber boarding for the privacy screen in front of the entrance to the toilet, rather than brickwork. Why were privacy screens necessary? Male toilets were seldom fitted with entry/exit doors. Secondly, is the arched head of the entrance to the toilet. This stylistic feature was applied to male toilet structures even when all other doors had square heads. The face brickwork on the entire building was painted sometime between 1953 and 1965, probably in late 1953 or early 1954 for the visit by Queen Elizabeth II. Major buildings along the various routes on which the Royal train travelled were painted white. Towards the far right of the photograph can be seen a windmill which was used to pump water to the platform. A similar windmill was also in use at the same time at Emu Plains.

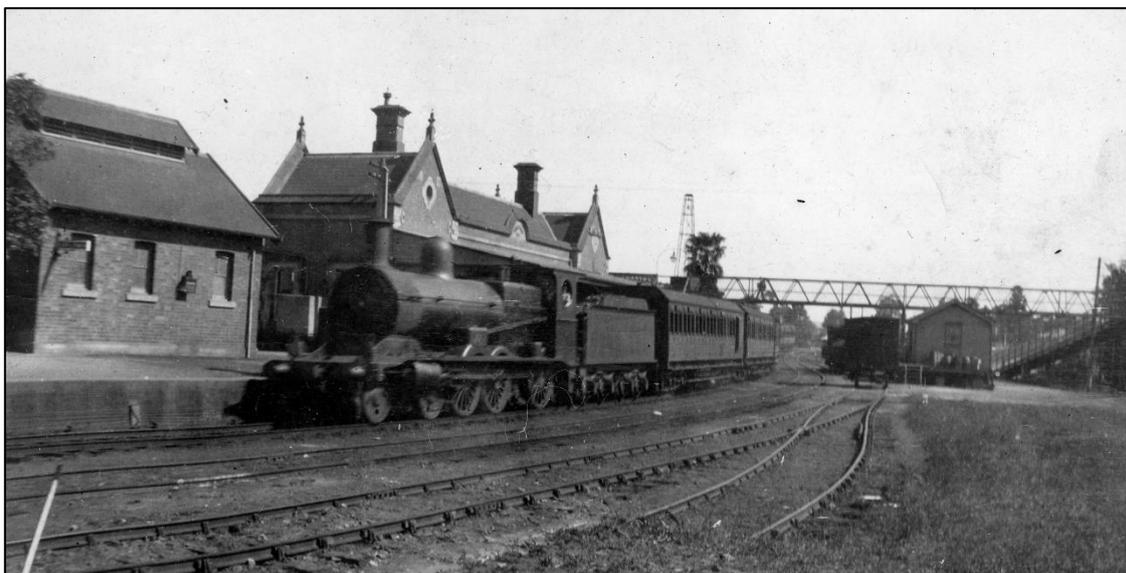
The photograph was taken in 1920 with the unknown photographer standing in the goods yard looking in a westerly direction. Note the lamp fixed to the wall of the male toilet block. The photograph shows the main building in its approved design before a new general waiting room was added to the eastern end in 1944. The initial general waiting room was gobbled in 1944 up in an expansion of the parcels office. Also visible is the unpainted, face brickwork of the

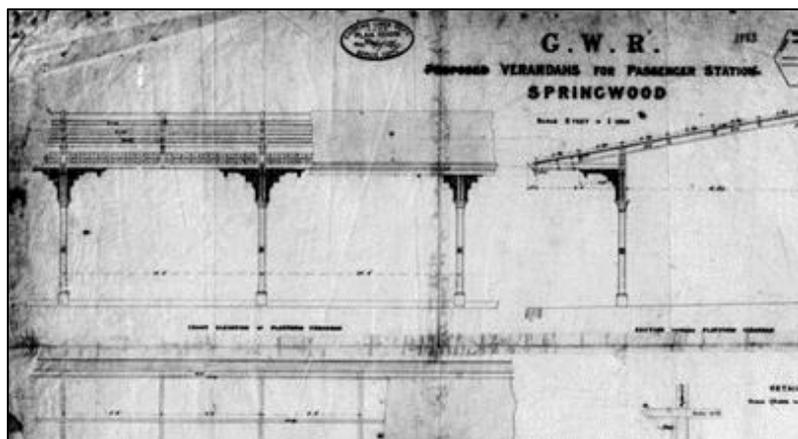
Unusually, one part of the proposed construction in 1883 that was not in the original plan was the provision of the awning on the road approach. Above is part of a plan dated 15th August 1883 for the in antis awning between the two end extended gables facing Macquarie Road. The awning was 12 feet 10 ½ inches wide from the building wall to the vertical timber posts,

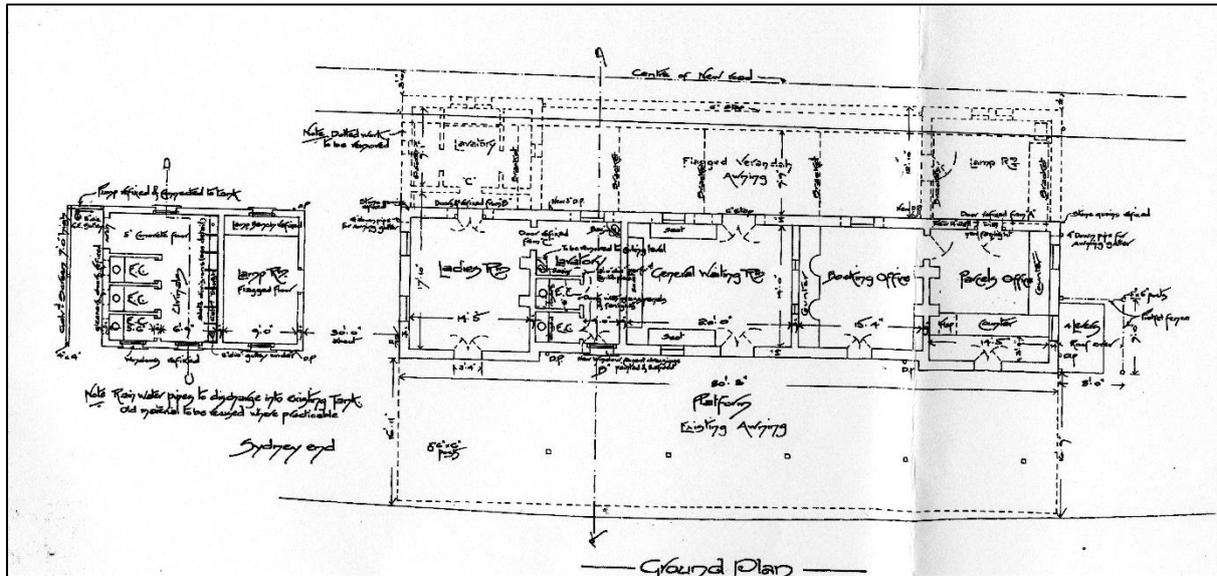
The above plan shows the additional width of the platform building at the ends – one contained female toilets and the other the lamp room. These extensions were removed to allow the new Down Main line to be built behind the structure. The in antis awning facing Macquarie Road was also demolished. A new lamp room was built behind the male toilet block on the left and the Station Master lost his office for the new female toilet.

Not every Blue Mountains station building was planned to be replaced in 1901 for the proposed track duplication. Springwood possessed an attractive building erected in 1884 of the neo-Gothic style. The general arrangement plan for the alterations is dated 18th December 1901. There, track duplication significantly affected the road approach side to the structure. The following changes were made to the structure:

- the platform was converted from side to island form
- the two projecting end gables (extending nine feet beyond the building alignment and 14 feet long) were removed with sympathetic repairs to match the existing work

- a new female toilet was inserted into the existing building envelope adjacent to the ladies’ waiting room to replace the former facility in the projecting gable at the eastern end of building

- a new 10 feet by 17 feet lamp room was added to the rear of the existing male toilet block to replace the former lamp room in the pavilion at the western end of the building, thus reducing the distance between the eastern end of the main building and the toilet/ lamp room

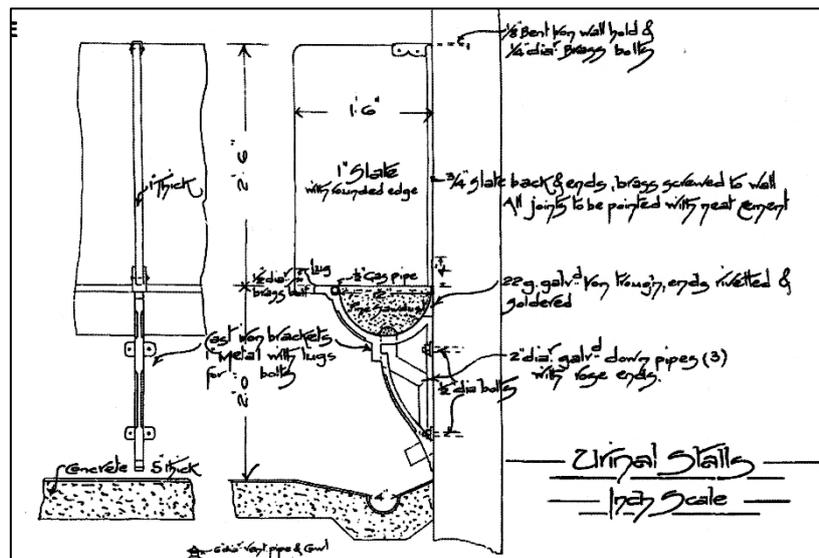
Above is an extract of the plan prepared in 1901 for the new urinal in the male toilet block. The former full height slate partitions were removed and much shorter partitions, using one inch thick slate, were erected. The new partitions commenced two feet above the floor level and extending upwards two feet six inches. The new urinal design was a feature of virtually every new toilet built between about 1895 and 1955. However, the back of the urinal was not similarly raised above the floor level, thereby allowing the urine to be discharged along an open drain within the toilet block and then disappearing under the platform surface.

- replacement of cesspits for the closets in both the existing male and new female toilet with earth closets
- Replacement of the existing urinal with full length stall dividers with half-height dividers

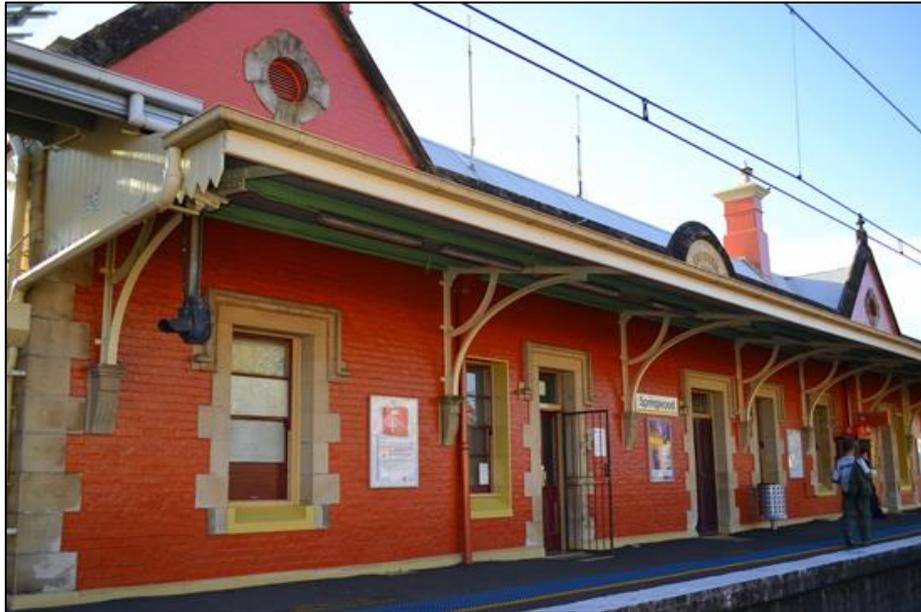
*This undated image shows the areas of the major impact of track duplication on the building on the westbound side. Both ends of the platform building were emphasised originally with gables crossing the roof line right angles. Their role was emphasised by circular sandstone vents facing Macquarie Road. The two gabled sections were extended approximately 12-15 feet towards the edge of the platform.⁶⁴ Between these extensions was an in antis awning supported by timber posts. Upon track duplication, both gables were truncated back to the alignment of the remainder of the building and the awning was demolished. A new awning was added to the full length of the building supported by cantilevered awning brackets standing on sandstone corbels. The photograph shows corbels set directly into the 18 inch thick brick walls. Such a presentation nearly always marked the provision of a cantilevered awning on an existing building. **SOURCE:** Google.*

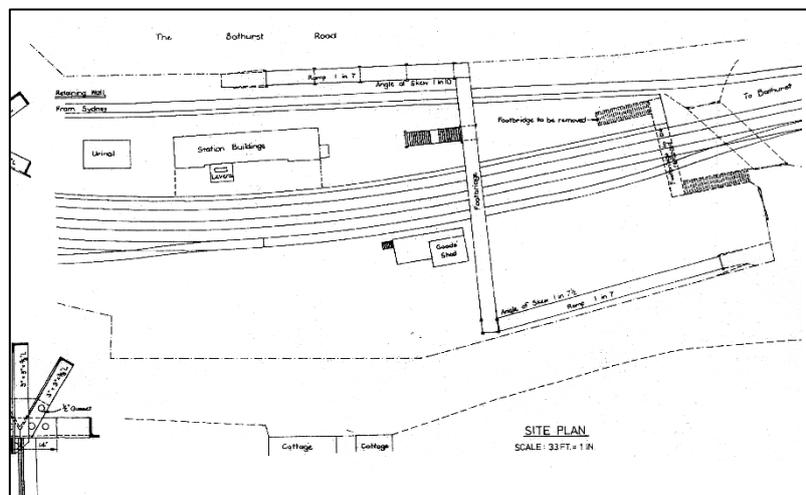
The above part of another 1901 plan shows the arrangement that was erected. The existing footbridge at the end of the platform and near the proposed subway was “removed to stock”, meaning that it was dismantled and stored at an unknown location. The footbridge was eventually re-erected at Flemington in 1905. The stepway on the existing footbridge was adapted to serve the new footbridge. The level crossing was closed and a subway for road vehicles carried traffic on what was called the Old Bathurst Road. As C.C. Singleton wrote in 1949, the subway, with its very sharp 90° turns at each end was the “bane of all present day motorists”.⁷⁰

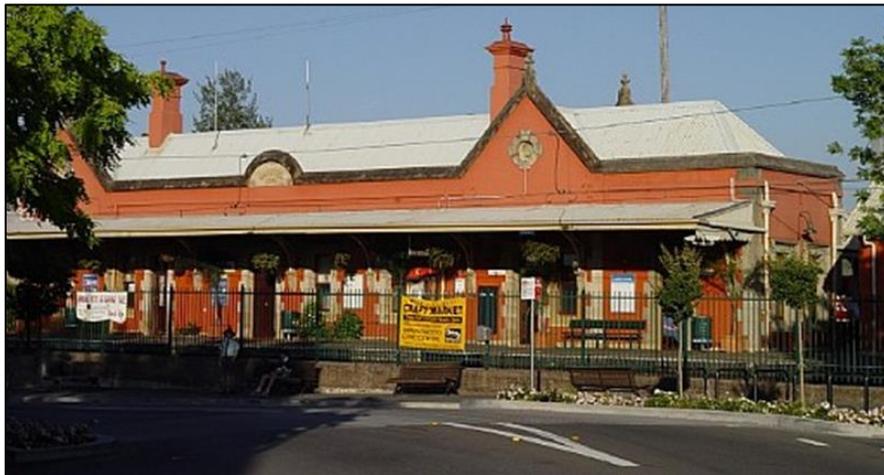
Apart from the alterations to the building to accommodate track duplication in 1902, there was only one major change to the platform building shown in the above photograph. A delegate for the Chief Civil Engineer, Albert Fewtrell, approved on 11th February 1944 the addition of a room to the eastern end of the building at Springwood for use as a new general waiting room. The work was necessary to allow the expansion of the parcels office into the area of the former general waiting room. The external walls were erected in face brickwork to match the existing building and the roof was covered with slates to match the existing material. There was one very amazing aspect of the approval for the new general waiting room. In similar cases in 1944 when the impact of World War Two increased parcels traffic virtually everywhere on the railway system, the existing general waiting rooms were generally eliminated for use as a parcels office and no alternative general waiting room accommodation was provided. Obviously, Springwood was a very important location where politically strong people lived.

As well as the new waiting room, replacement female toilets were also provided as well as the relocation of the single entry door to a store that was located in the western wall of the male toilet block. Formerly, the door faced the eastern end of the main structure but the door opening was relocated to the eastbound side wall.

When the station opened in 1884, the only inter-room access was between the ladies' waiting room and female toilet. At that time, there were two ticket windows facing into the original general waiting room. The opportunity was taken in 1944 to provide a door between the Station Master's office and the new parcels office. A direct consequence of that opening was the need to relocate one of the ticket windows. An existing door on the eastbound platform side of the structure was converted into a new ticket window.

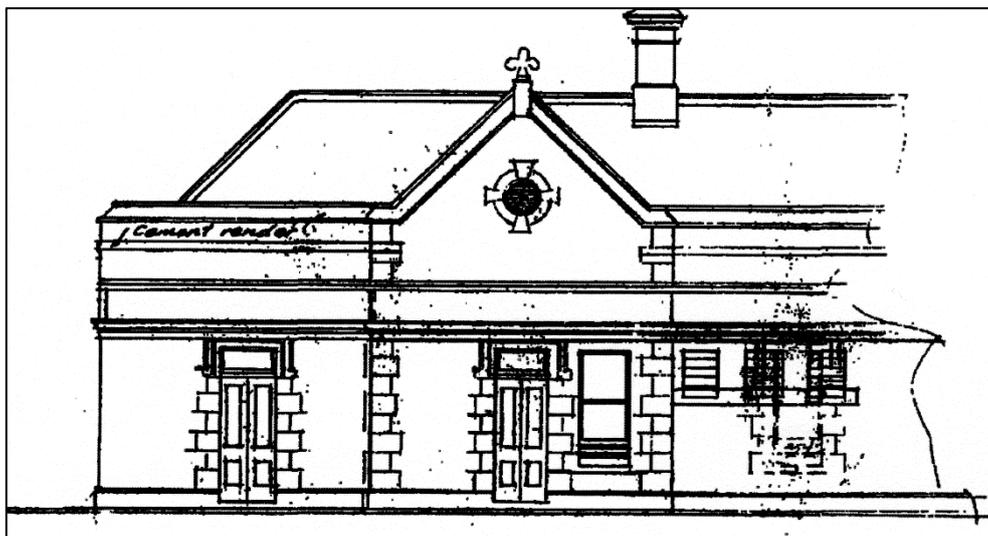
The above plan shows the 1944 new general waiting room added to the eastern end of the building. Originally, the end of the building was identified by the transverse gable with decorative circular vent and the sandstone quoins shown between the two doors. The plan is marked "cement rendered" for the decorative course above the platform awning. Probably, the decorations on each side of the new double door into the general waiting room were also cement rendered rather than sandstone.

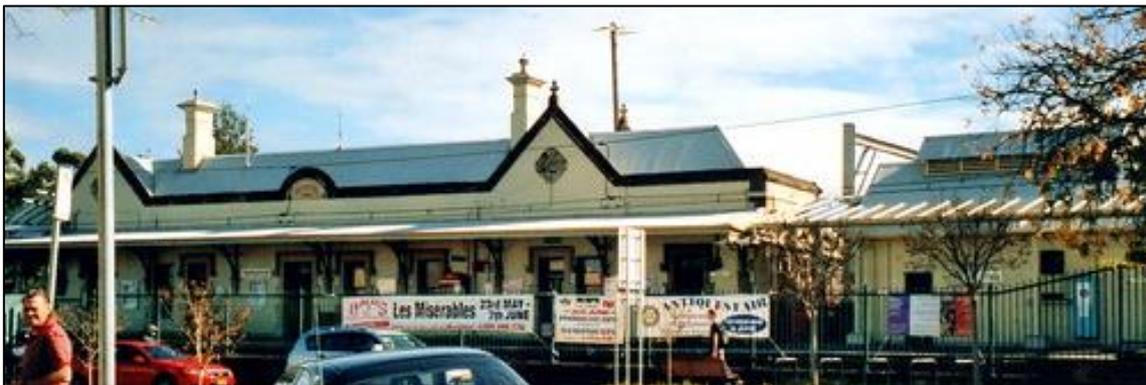
*Not only was the face brickwork painted a horrible yellow shade but the sacrilege extended to the painting of the sandstone decorative features. While the paint was removed from the decorative sandstone elements at platform level, the sandstone above the platform awnings were not similarly cleaned of paint and/or grime. No justice was done to the visible interpretation of the station by the placement of advertisements on the boundary fence. The photo was taken in the 1990s. **SOURCE:** Flickr*

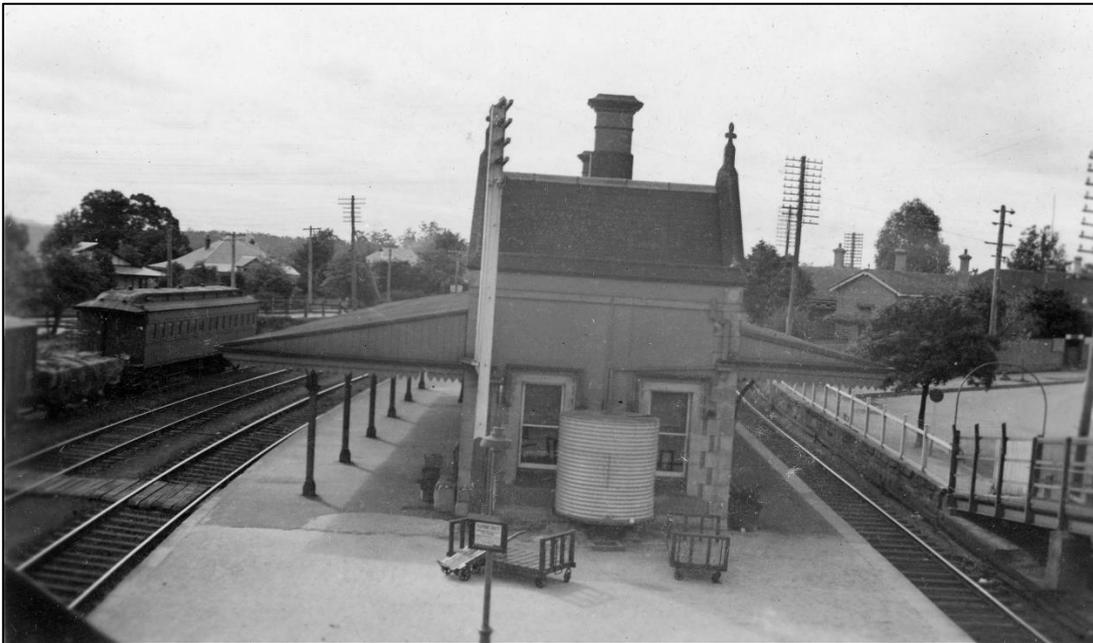
The photographer is standing on the deck of the footbridge looking towards Sydney in May 1938. The original posted awning serves the Up platform (on the left) contrasts with the considerable amount of work that has taken place serving the Down platform (on the right). Originally, the transverse gables at each end of the building facing the Macquarie Road approach extended to approximately the edge of the Down platform. These were demolished as were the verandah between the two transverse gables. For track duplication in 1902, a new platform awning was erected for the Down platform and, from that time, the structure reflected the transition in support systems for awnings with 19th century posts for the Up platform and 20th century cantilevered brackets for the Down platform. The aboveground rainwater tank situated between the two windows at the end of the building looks ungainly and was not part of the approved plan in 1883. An historian of rollingstock, Evan Rees, has provided the history of the carriage at the loading dock on the left. See Appendix 2 for Evan's history of the carriage in the good siding on the left of the photograph. SOURCE: ARHS Railway Archives.

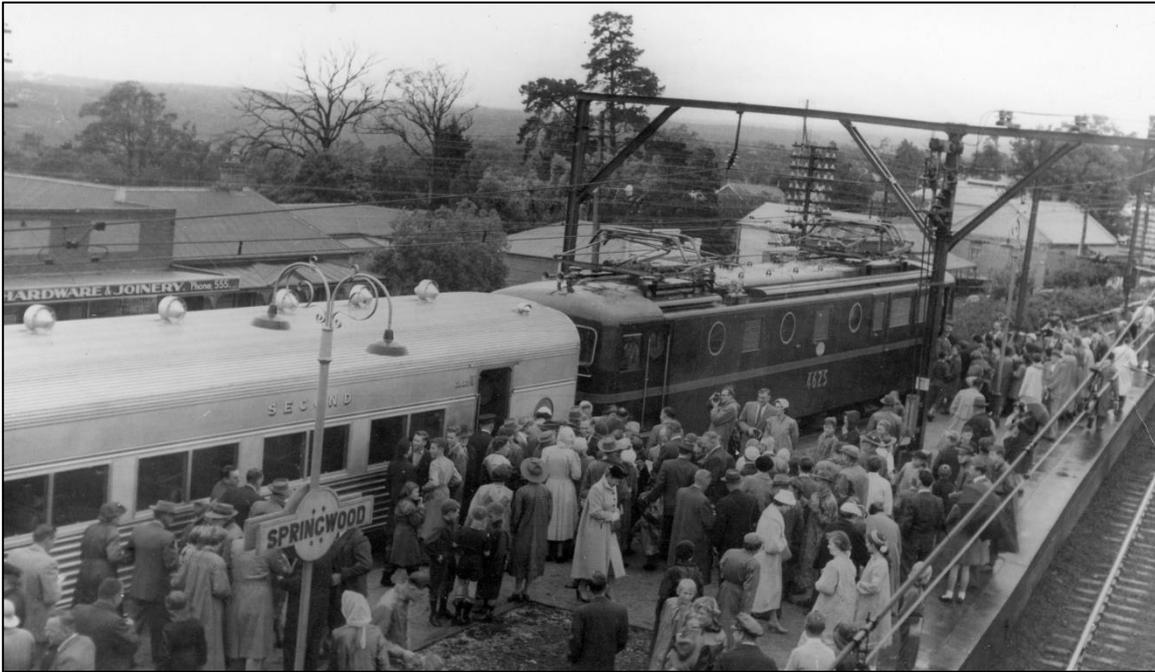
Free rides are being given to local residents on the day of the opening of electrification on 22nd June 1957. Locomotive 4625 is hauling a set of "U boat" carriages. The locomotive is at the western end of the platform. **SOURCE:** photograph No. 139713 ARHS Railway Archives.

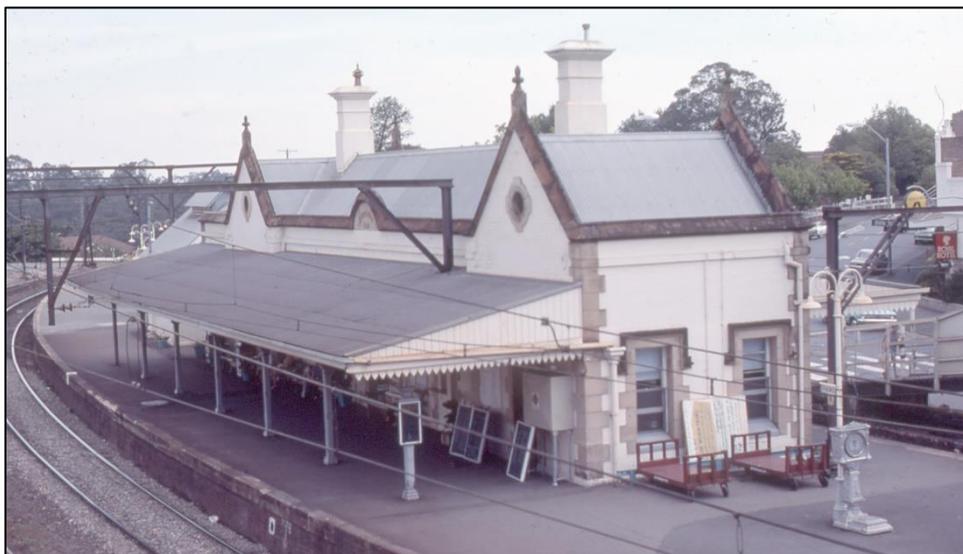
In the days before scrolling train indicator boards, communications to waiting passengers was undertaken using chalk on blackboards, some of which are seen in this photograph taken on 31st December 1977. The weighing scales were also a familiar item on New South Wales railway platforms. The two parcels trollies nearby have been recently repainted. The stonework above the platform awnings looks grubby and its condition is explained by the difficulty of accessing sandstone for cleaning purposes.

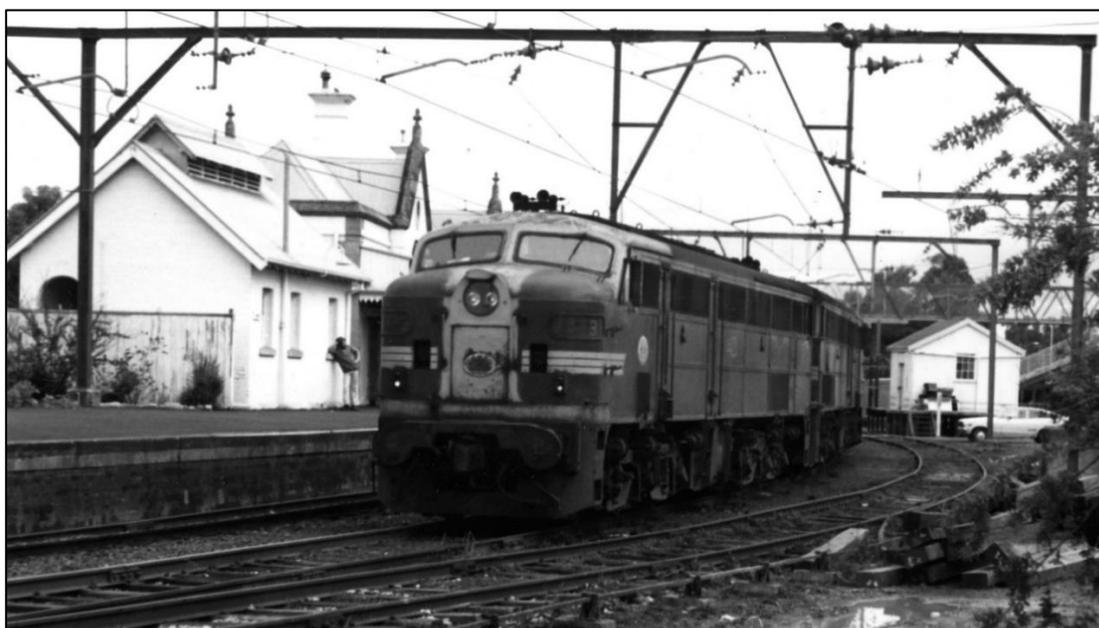
*Locomotives 4423 and 4444 stand in the Up Refuge Loop on 30th June 1978. On the left is the male toilet pavilion showing its roof ridge parallel with the ridge of the main platform building. In the 19th century, detached and semi-attached pavilions usually were expressed with the roof ridge at 90° to the ridge of the main building. Although the brickwork has been painted white, the painters have omitted the ventilator on the ridge of the male toilet pavilion. To the right is the good siding and goods shed. **SOURCE:** D. McKay, Photograph No. 000287 ARHS Railway Archives*

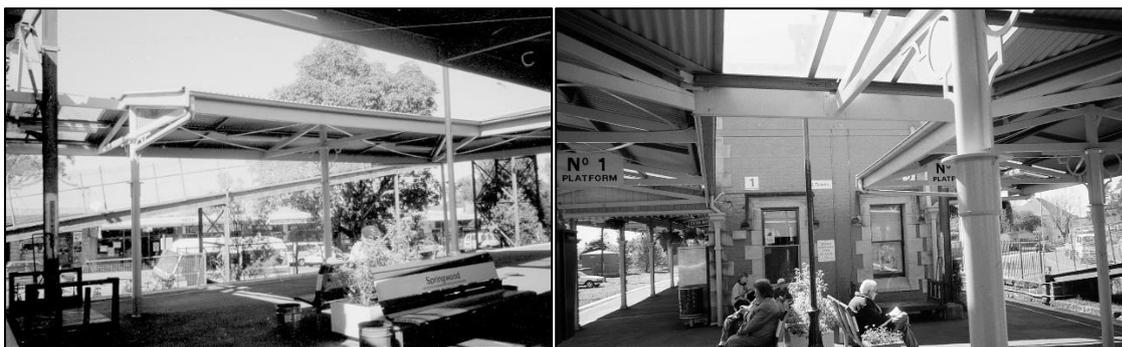
These two photographs show the arrangement of the platform awning between the bottom of the stepway and the building. On the left, there is no covering over the centre of the platform in 1989 but, when further works were carried out in 1998, the centre section of the roof was glazed. The two windows at the western end of the structure facing the former stepway were

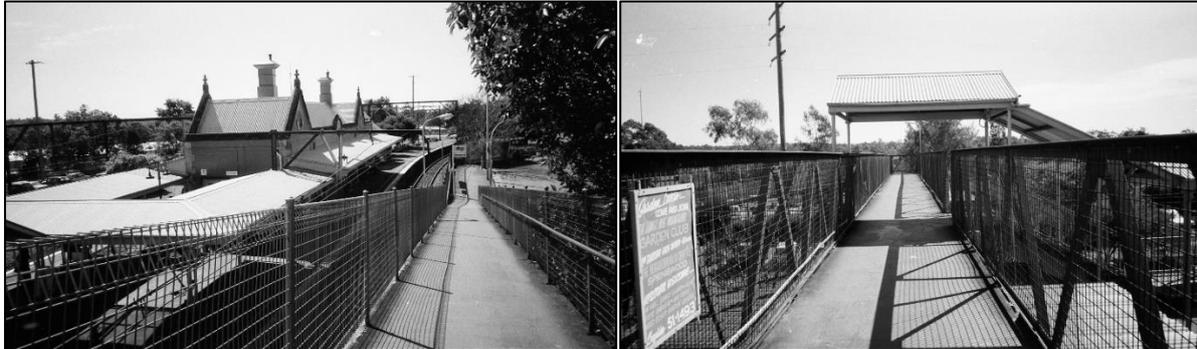
These two photographs show the extent of the 1989 shelters on the footbridge and ramps. On the left, no awning was erected over the ramps. On the right, a shelter was placed only across the footbridge in front of the stepway and down the steps. Photographs taken on 27th August 1998.

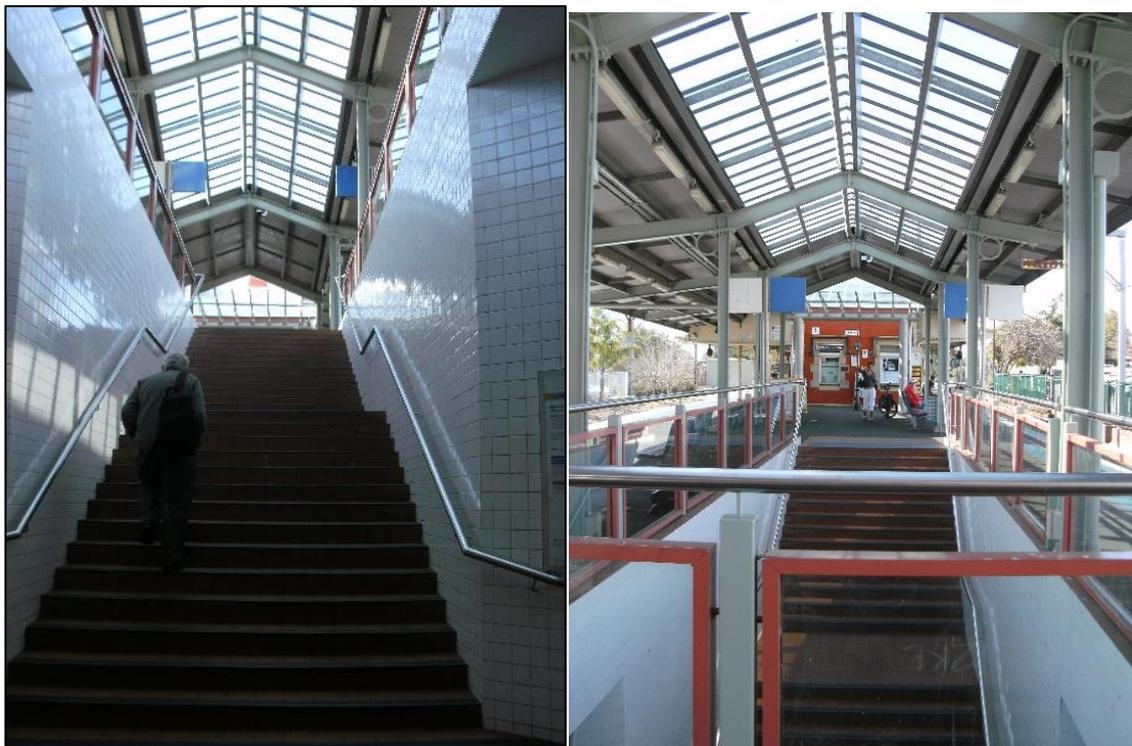
These two images taken on 10th September 2010 show the new stepway from the subway and the addition of transparent awning between the lift and the building.

Construction of the subway commenced in 1998 and on 12th August the ramps were opened on the Macquarie Road side of the corridor.⁸² The ceiling in the subway was 2.2 metres below the surface level. The ramp on the opposite side of the corridor was completed in October 1998. The official opening by Carl Scully, then Minister Scully, including a lift, occurred at the on 27th November 1998.⁸³ A plaque commemorating the event was affixed to the building wall.

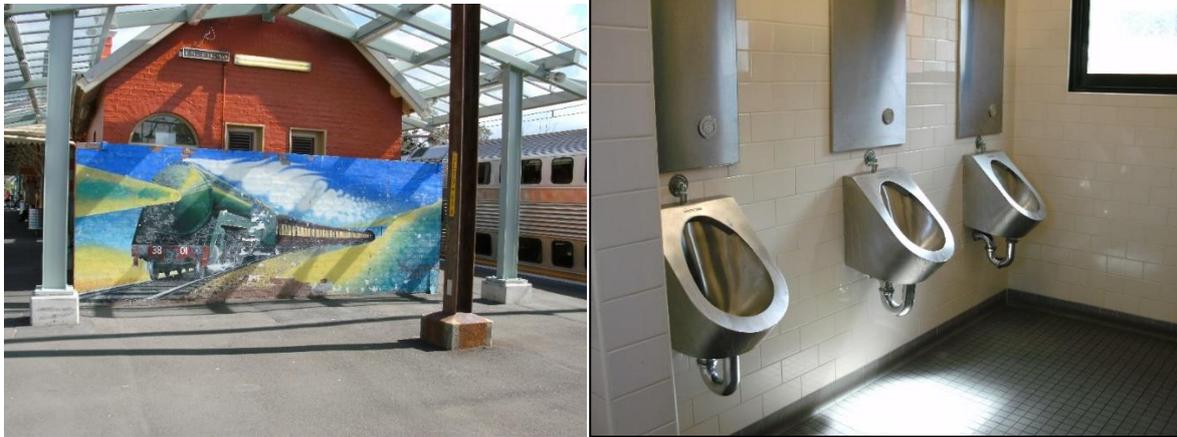
The above 2010 images show two aspects of the male toilet. On the left is the mural painted on the privacy wall covering the entrance. The deteriorating condition of the mural is evidence of the problem that arises when this type of artwork requires maintenance. CityRail was not in the business of art repairs and usually removed the murals, which was an expensive task, if the original painter/group who undertook the work did not wish to do the repairs. Just visible above the top of the wall is the arched head of the toilet entrance. This was the only opening at the station which did not feature a square head design. On the right are the new urinals which replaced the stalls erected in 1902.

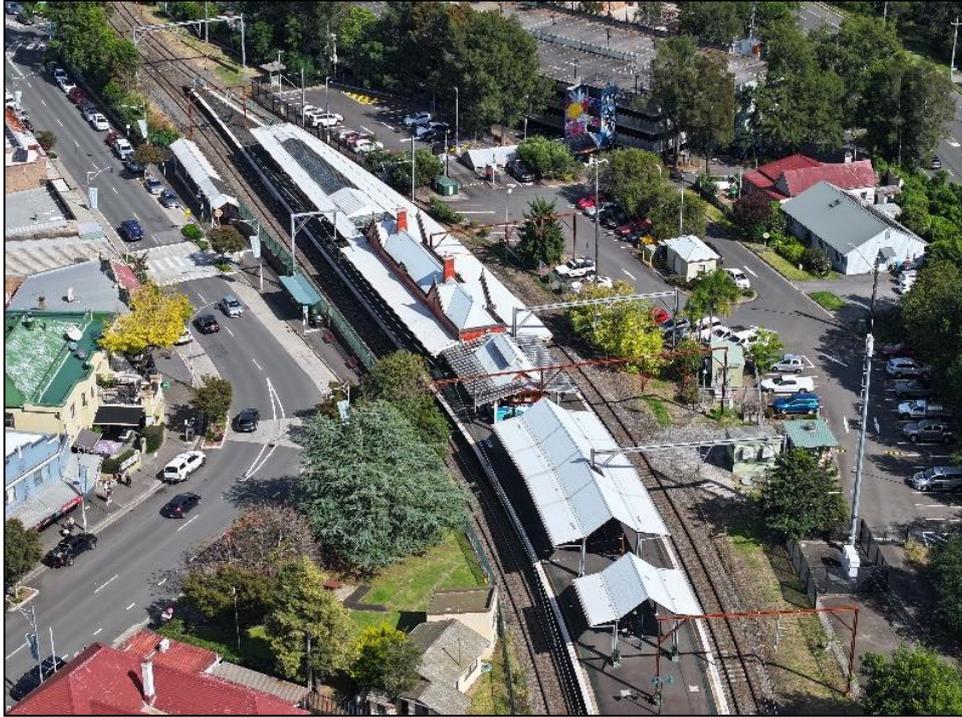
The above image by James Dalton on 19th April 2024 shows the eastern end of the platform in its current condition. The two stand-alone shelters towards the bottom of the image display the only major infrastructure change in the 21st century. CityRail says that the station “upgrade” was completed in 2007 and possibly the additional shelters date from that year. No doubt all the platform shelters were welcomed by commuters but, from a visual and conservation perspectives, they severely compromised the integrity and interpretation of the 1884 building.

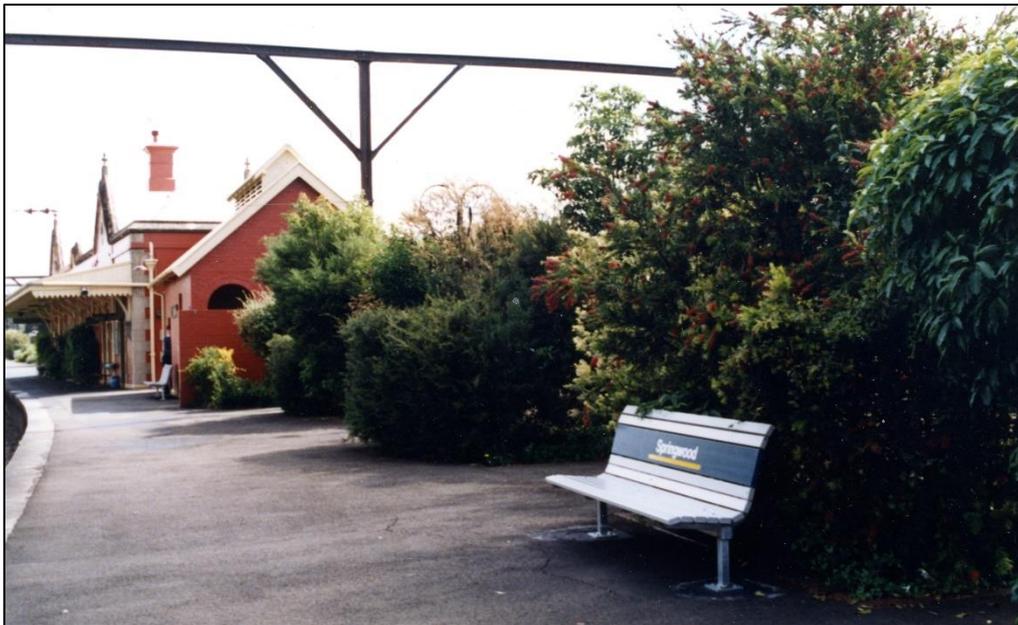
Perhaps if some commuters dismissed the impact of the of the degradation in the heritage values of the station after the construction of the two stand-alone platform shelters at the eastern end of the platform, they might have missed the pleasantness of the vegetation. These

shrubs had to be removed to provide room for the new shelters. The vegetation reflected the long tradition of station staff to provide and maintain platform gardens, shrubs and trees to enhance the station experience while waiting for trains. In the foreground, is a style of platform seat that was provided universally at almost all stations. Platform seats were painted red with white lettering from 1989 when Ross Sayers became the Chief Executive of the State Rail Authority. When he resigned in late 1992, the new Chief Executive decided to cease the application of red paint and replace it with the colour scheme shown above. However, not all of Springwood's traditional timber platform seats were replaced and some remained on the platform under the awnings of the building. The above photograph was taken in 1995.

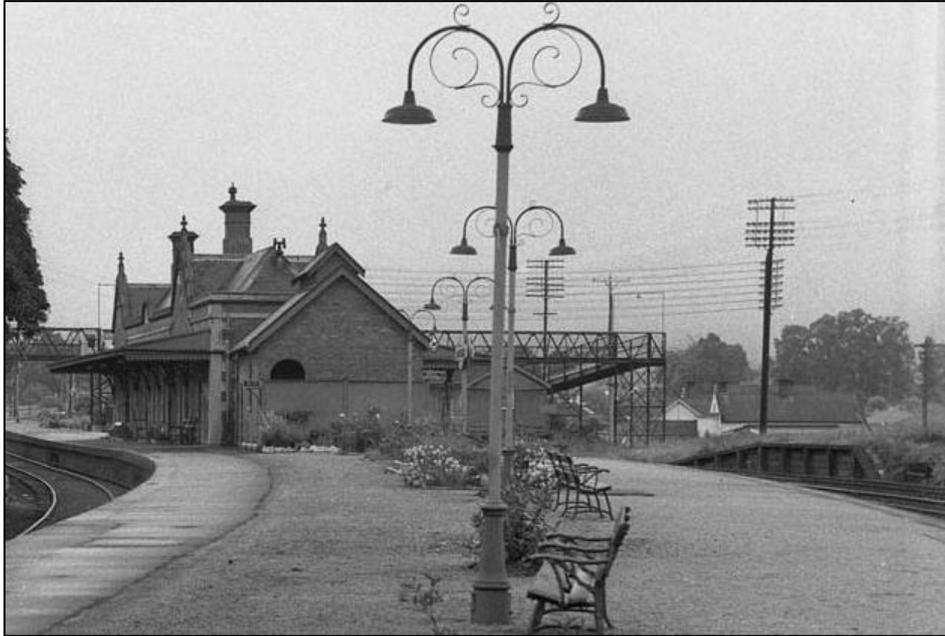
*The photographer is standing at the eastern end of the island platform in 1953 and has captured the location of the timber goods loading bank on the right, the goods shed opposite the platform building and the 1902 Warren truss footbridge. Also, the photographer included the elegance of the platform lighting standards, the ornate, cast-iron and timber platform seats and the platform gardens boarded with small stones painted white. **SOURCE:** Photograph No. 214735, ARHS Railway Archives*

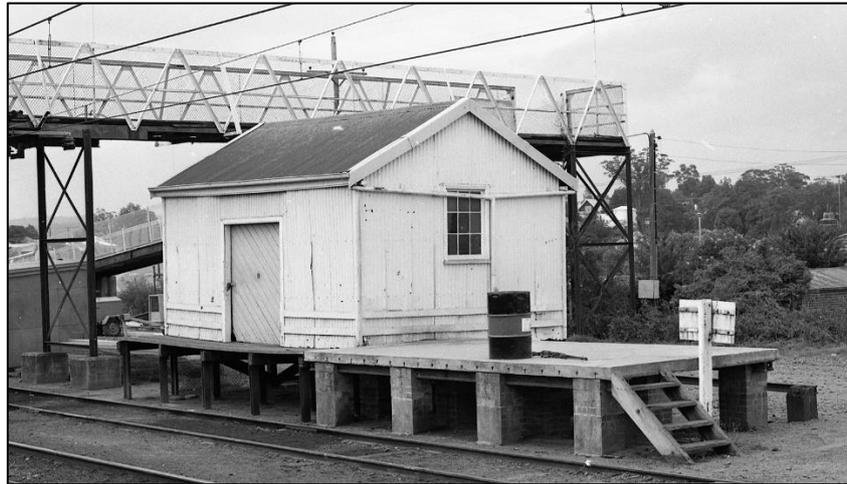
This photograph was taken on 31st December 1977 and shows that a replacement concrete loading stage had replaced the original timber substructure and deck at an unknown time in the second half of the 20th century. The design of the goods shed was typical of small, goods sheds on existing lines from the 1880s. It featured an absence of awnings on both the rail and road sides. Wide sliding doors of similar design were placed on both sides and the diagonal placement of the door timbers was typical New South Wales practice for goods sheds. The two bands of timber around the bottom of the shed provided protection from the enthusiasm of Junior Porters transferring and storing various shapes of freight items.
