SPRINGWOOD RAILWAY STATION

HISTORICAL NOTES

“THE ROMANTIC AND PICTURESQUE SPOT”¹

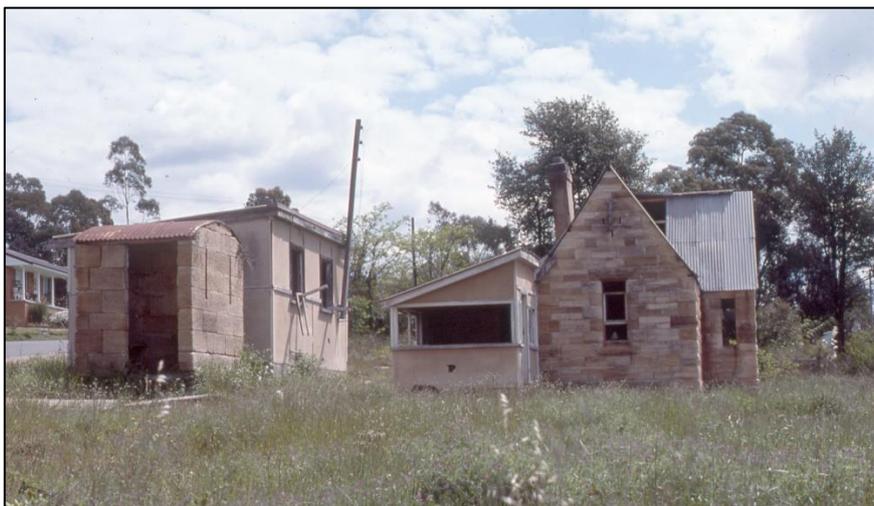
The gatehouse at level crossing No. 4 is shown above at 110 Green Parade, Valley Heights on 8th October 1978. While the cottage was not located at Springwood, the composition of

multiple structures emphasised the extremely small size of the sandstone dwellings with subsequent additions built at many locations. The design concept of the arched roof for the toilet was a standard feature in both the 19th and 20th centuries for toilets, both for residences and on platform buildings and was applied either to the roof of an entire structure or to just the entranceway to male toilets. Arch roofs were also used for other minor types of structures, such as lamp rooms.

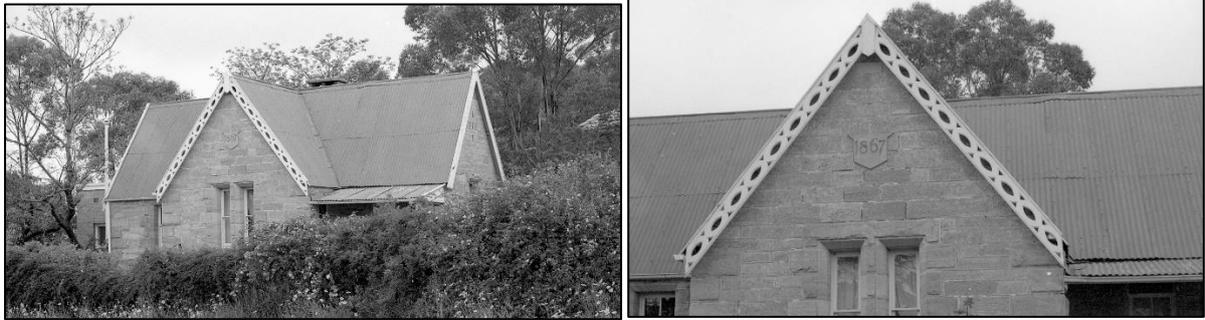
The above undated photographs show the gatehouse at the former No. 6 level crossing at 7 Macquarie Road, Springwood, which was about 500 metres from Springwood station. In total, twelve gatehouses were built over the Blue Mountain to the same overall pattern, though there were variations in size. John Whitton's design was taken straight out of a standard British architectural text and featured high-pitched roofs which were inspired by Gothic influences. SOURCE: Facebook.

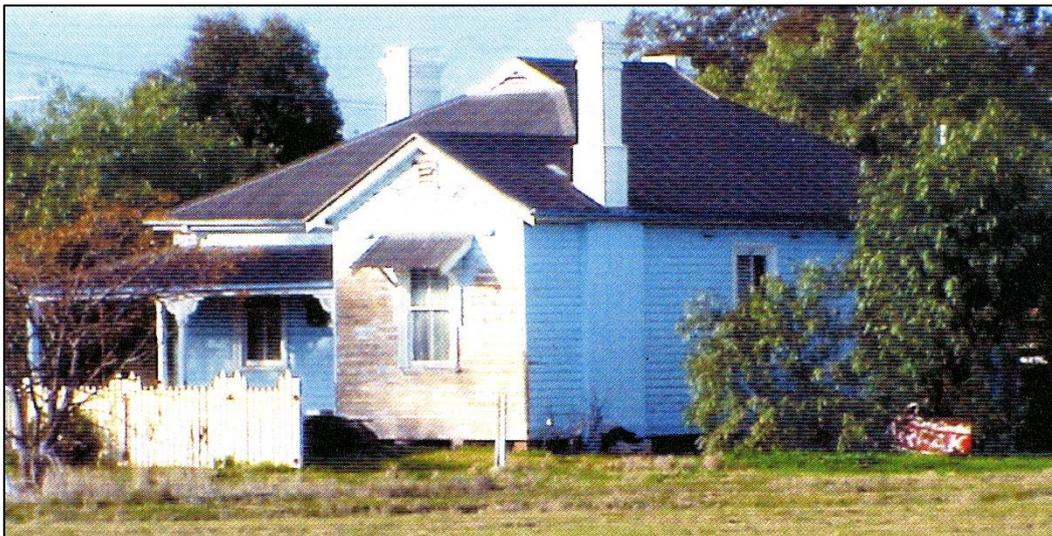
Standard plans were prepared in 1899 for the introduction of the "J" series of residences. In the absence of a plan and a decent photograph of the Station Master's house at Springwood, this image of a similarly designed J3 structure at Lockhart shows the defining features, i.e., projecting front bedroom, verandah across half of the front elevation with the verandah continuing along one side of the building and small ventilators on each end of the roof gable.

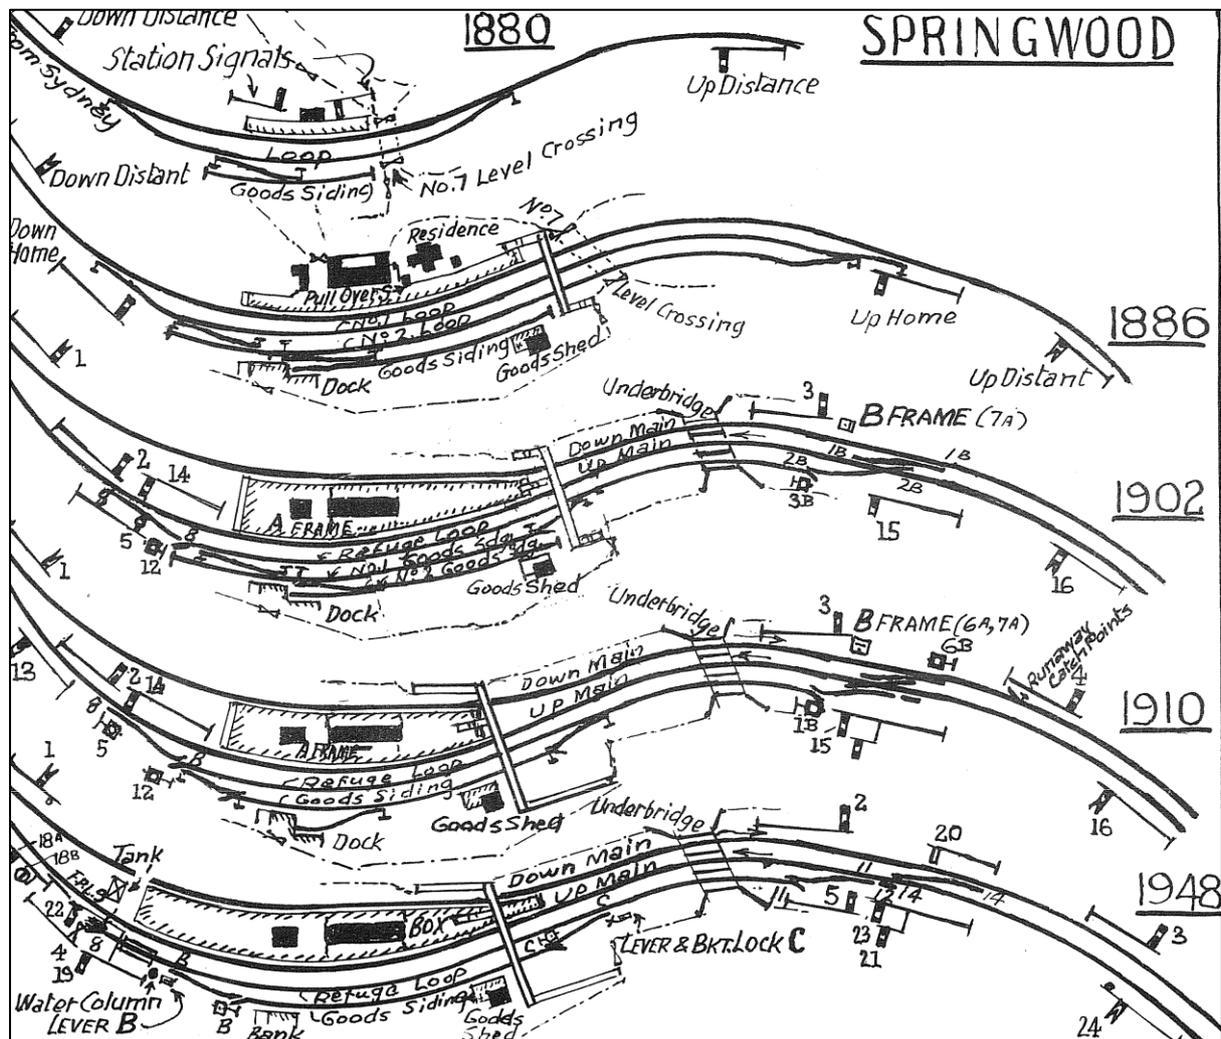
Above the five sketches by C.C. Singleton showing the developments of the track layout up to the early 1950s. In a 1950 article Singleton wrote: Frame "A" was located on the Up side of the station building and quite accessible to the public, who at the time seemed to be better brought up than at the present, as interference with the levers seemed quite unknown".⁹⁶ It will be noted that, on the sketch for 1886, Singleton has shown the 1878 residence for the Porter-in-Charge adjacent to the 1884 building. SOURCE: C.C. Singleton, "Station Arrangements on the Blue Mountains", *Bulletin*, June 1957, p. 90.

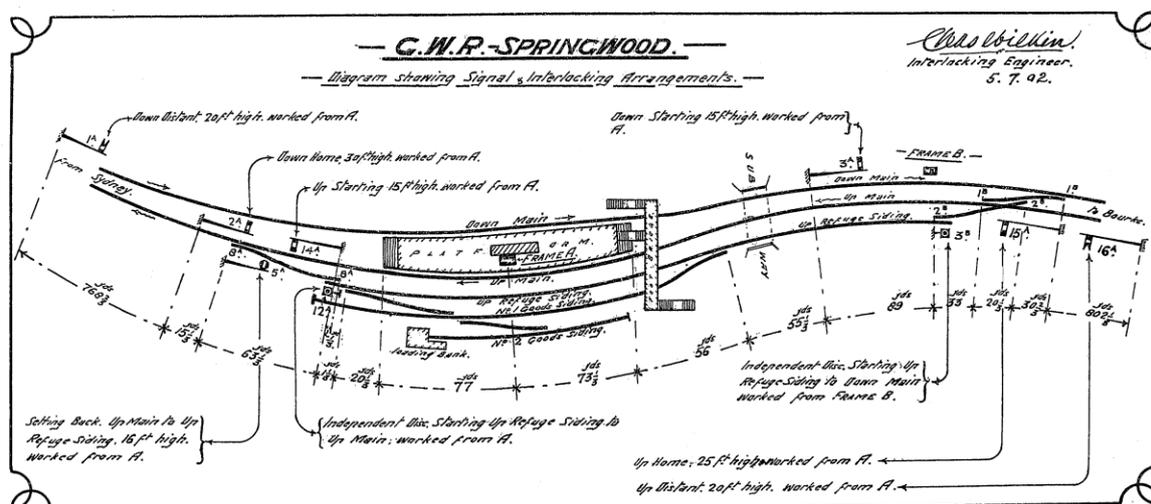
Above is the diagram attached to Circular No. A203 – 1902 Interlocking of Springwood. Note the two goods sidings shown in the diagram. Access to these sidings was not interlocked.

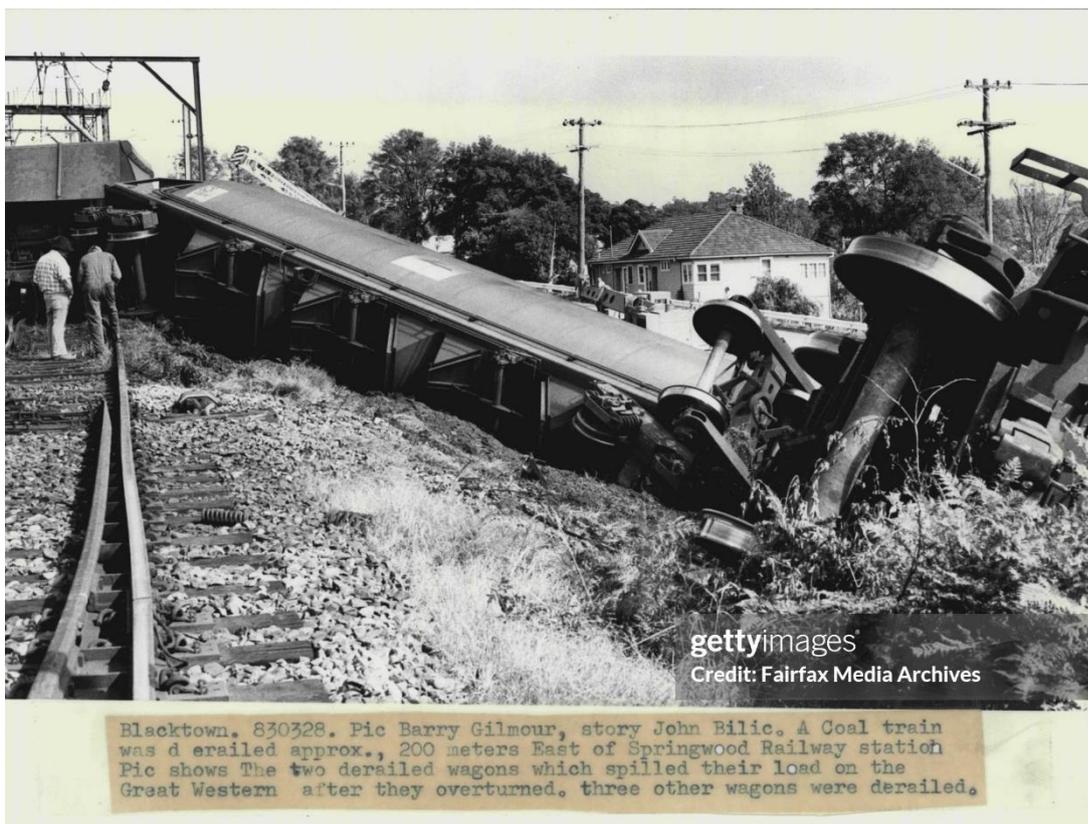
The 1983 coal train derailment

A serious freight train derailment occurred in March 1983 in which loaded coal waggons were derailed onto the Great Western Highway as a train was leaving the Up refuge. Ultimately, the accident led to doubts about the safety of the refuge. It was felt that the heavy trains braking as they rounded the curve past the station before stopping in the loop might tend to shift the track laterally and have an adverse effect on the exit points. Portion of the loop was retained to allow the goods siding to be shunted by Down trains, although it is believed that the eastern end exit points were removed at some stage.

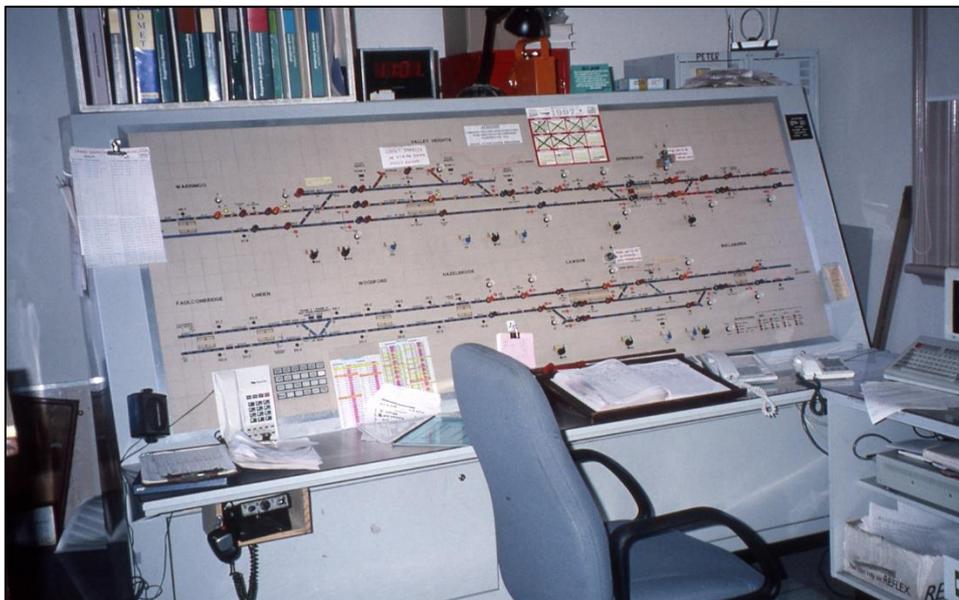
Above is a 1997 photograph of the 1995 route setting interlocking panel.
