DAPTO RAILWAY STATION

AN EARLY OMEN OF A FORTHCOMING COLONIAL FINANCIAL CRISIS

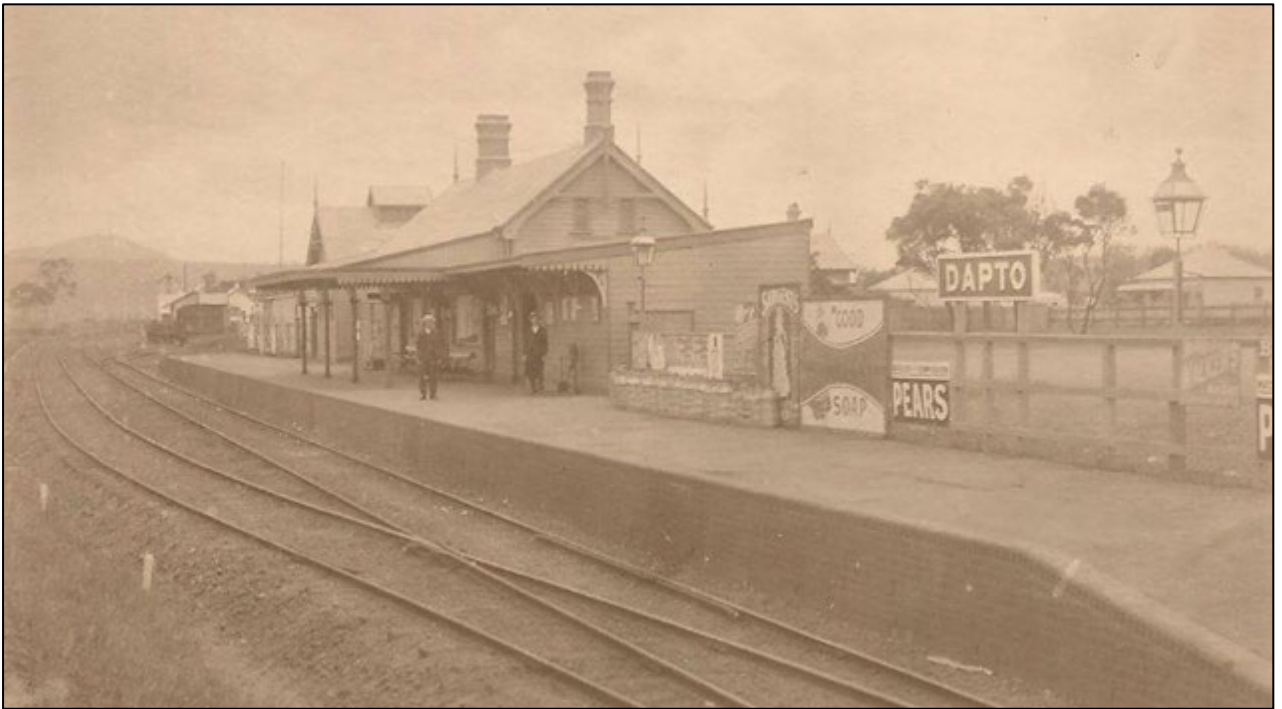
This photograph shows the platform building before any major alterations have been carried out. The singular feature of the structure from the platform side is the absence of symmetry. The use of one semi-attached pavilion at the northern end and the use of a single-pitched shed at the southern end looked ungainly and unattractive. However, Dapto was not a big urban area and John Whitton, the Engineer-in-Chief for Railway Construction, would have known that there was no need to provide a building with an elevated level of presentation in order to please local powerbrokers. How come? There were simply no big political players residing in the area at the time. By the look of the number of milk or cream cans on the platform, it would appear that the local milk depot had not been constructed at the time of the photograph. The historian of track layouts, signalling and safe working, Graham Harper, points out the poor location of the points that provide access to the Loop Line. He says that, because the points were located in front of the platform, a good chunk of platform access to a passenger train would have been unavailable if a goods train were entering or departing the Loop at the southern end.

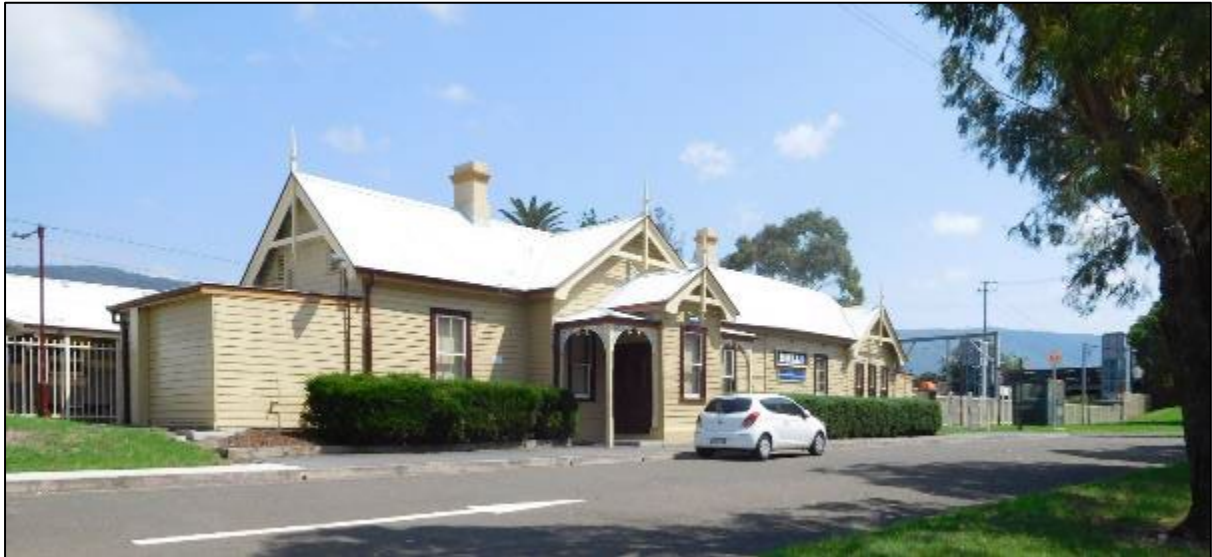
This photograph shows the rear of the building at Bulli on 29th January 2000.

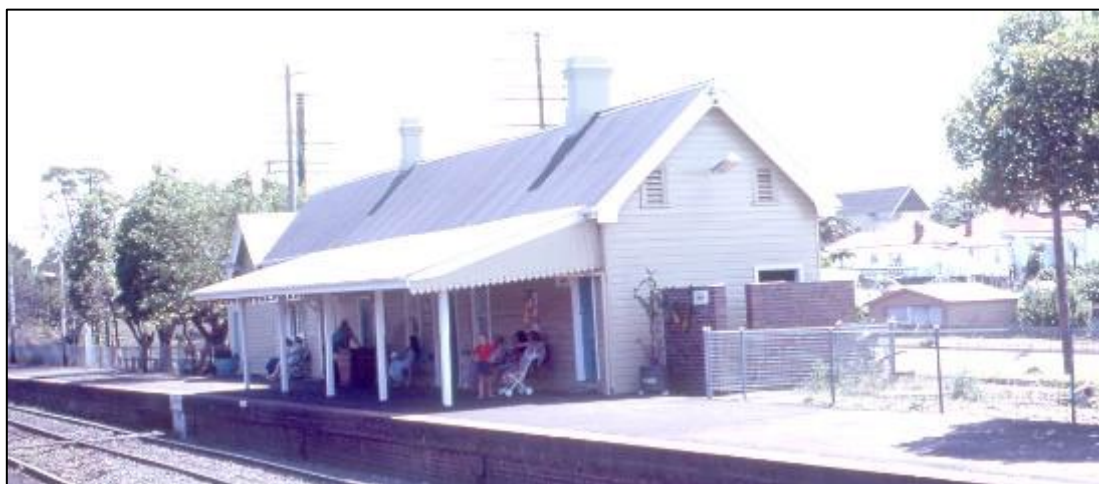
The timber building on the southbound platform at Bulli on 26th December 1977. The brick privacy screen protects the entry to the male toilet. Previously, toilets were located in a separate pavilion. The steel mesh fencing was typical of the 1960s and 1970s.

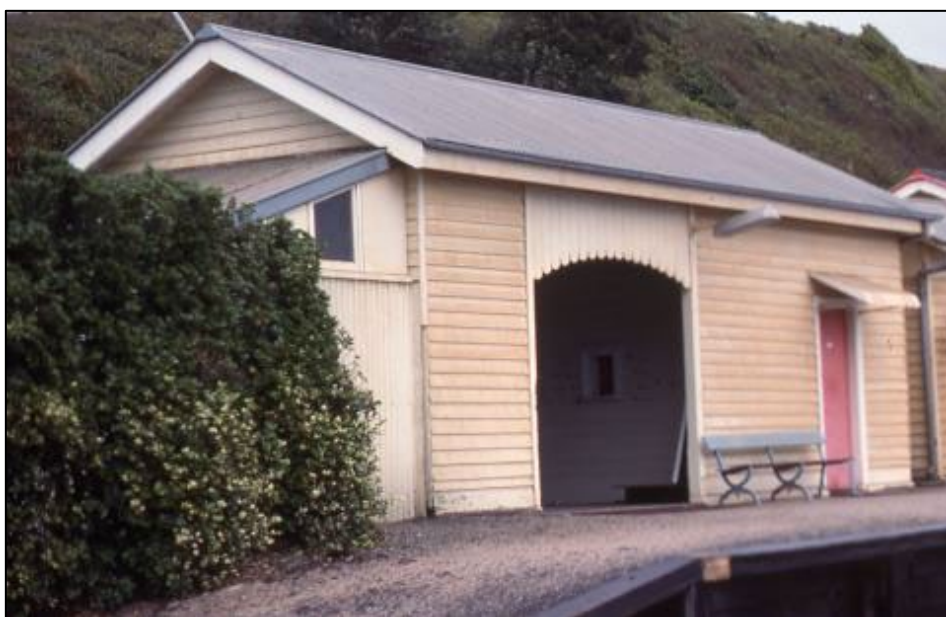
The above photograph of Bombo on 8th January 1978 shows the small version of building erected between Waterfall and Kiama but one of the very few examples with a female toilet. The most obvious aspect is the omission of a platform awning. Moreover, the construction of the female toilet with corrugated iron sheets for the wall reflected cost-cutting significantly, as was the omission of an anti-chamber in front of the ladies' toilet.

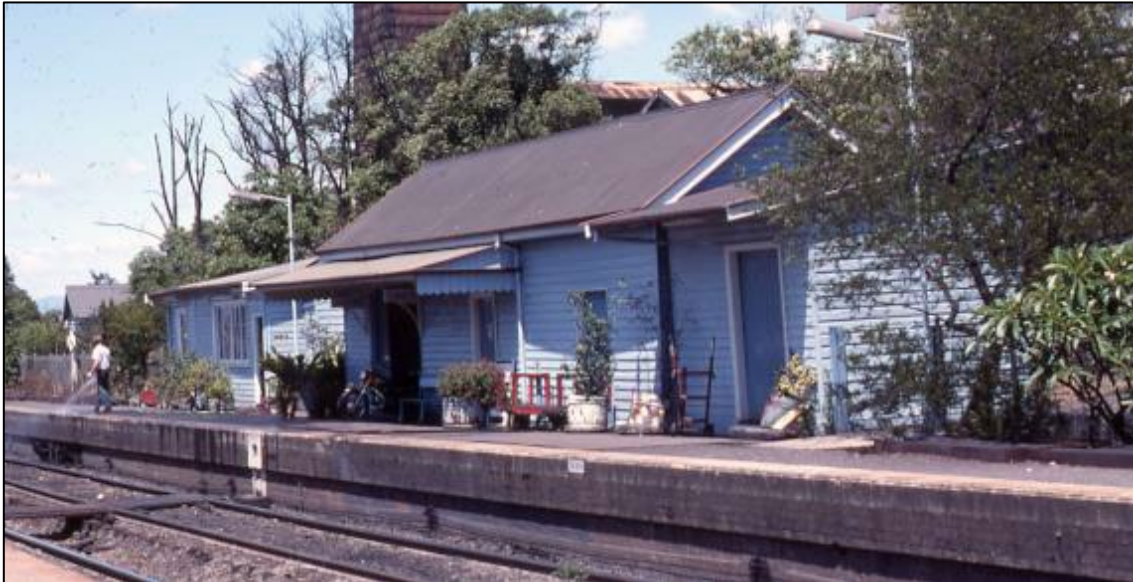
Another example of the small type of buildings erected between Waterfall and Bombo was located at Corrimal. The photograph above, taken on 26th December 1977, shows the original two room building, those rooms identified by the existence of a subsequent awning. A third room has been added to the northern end of the original structure. A detached out of shed also appears towards the right-hand side of the photograph.

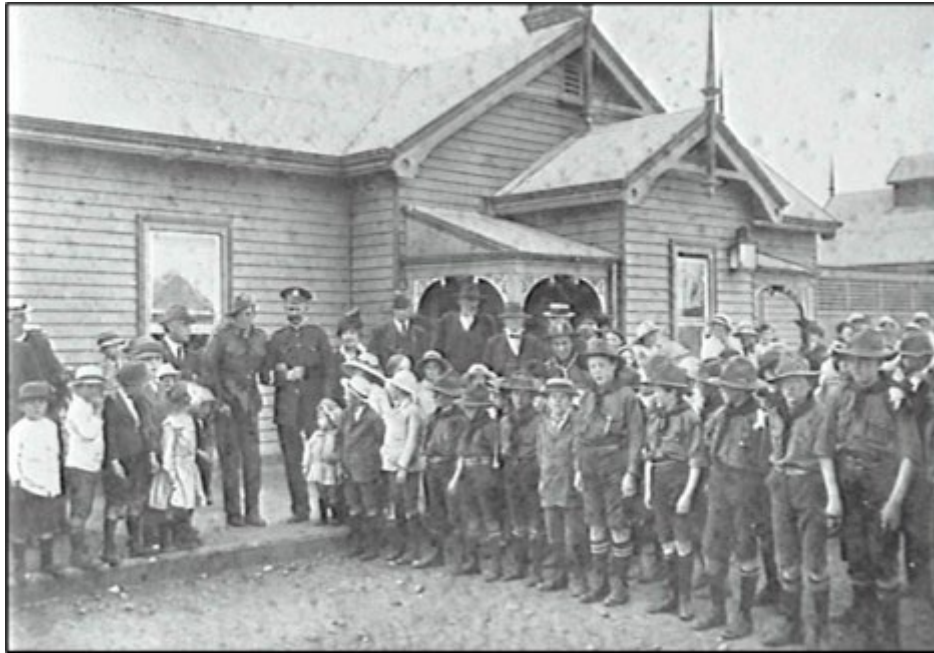
*All examples of John Whitton's standard three room roadside design utilised between Waterfall and Bombo featured porched entries. This photograph, taken on the return of a soldier in 1919 from World War One, shows the extent of decorations on the forecourt approach. Fretted barge boards, finials with drops on gables and cast ironwork form the decorations. Also visible on the right-hand side are the louvres on the 25 foot long passageway that connected the ladies' waiting room with their toilet, which is just visible on the right side of the photograph. **SOURCE:** Google*

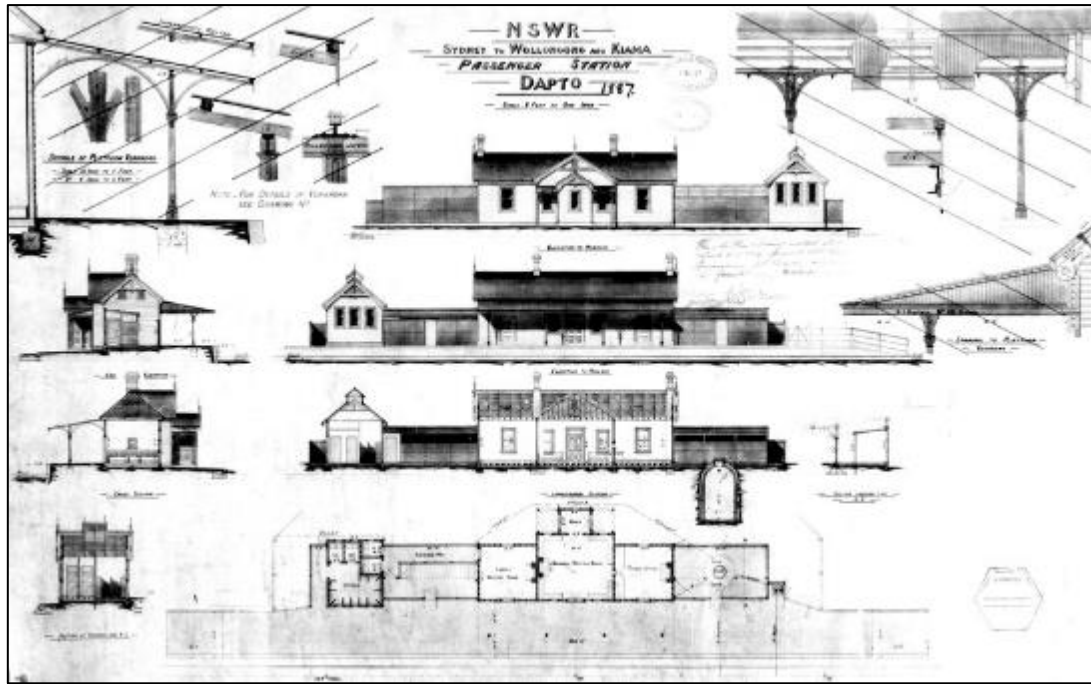
The above plan tells us that it was initially proposed to use of cast iron for the awning posts and brackets but that part of the plan was abandoned and timber posts were utilised to support the platform awning. The timber posts supporting the platform awning possessed limited decorations and the spandrels at the ends of the platform awning had mild decorative vertical boarding.¹¹ Sometime between 1970 and 1972 the decorative vertical boarding in the spandrels was replaced with plain boards.¹²

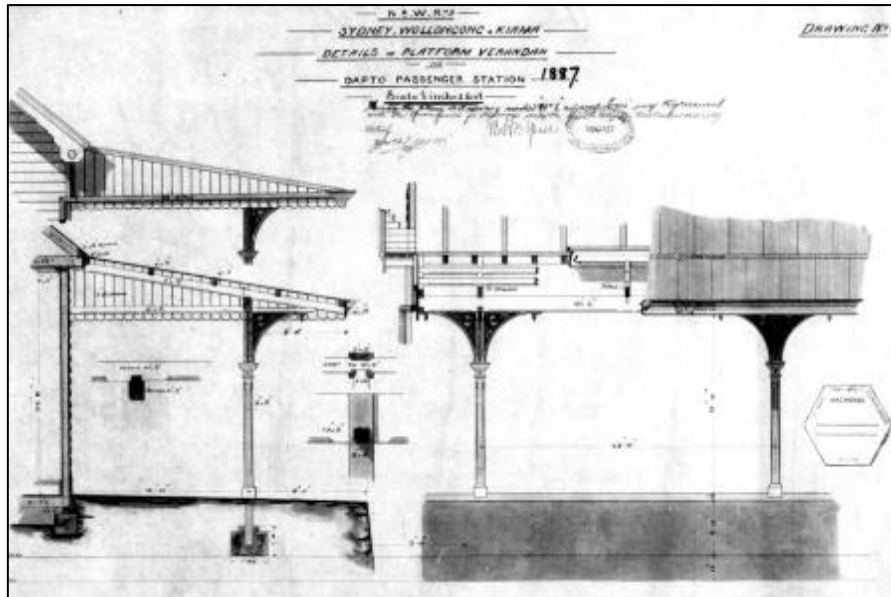
Whereas the previous plan shows the year 1886, the above plan has a stamp of the Public Works Department dated 13th May 1887. Robert Spiers, the successful contractor, signed the above plan on the same date as the previous plan, i.e., 4th November 1887. The revised plan shows a much for restrained method of supporting the platform awning. Although timber was used for the vertical posts, they were exquisitely designed.

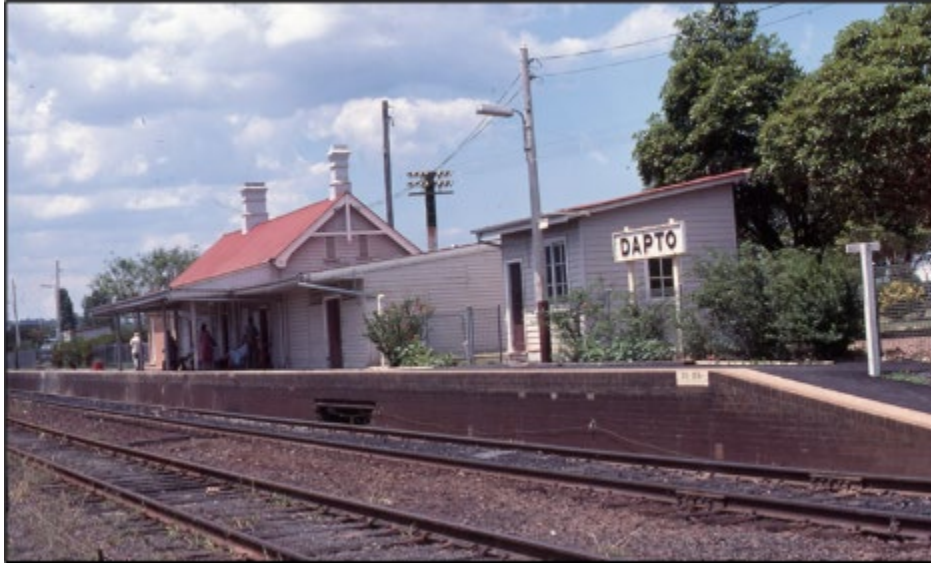
On 26th December 1977, the station looked spick-and-span. The 25 foot long shed at the southern end of the main building acted as the parcels office. On the left is the 1918 opened signal box.

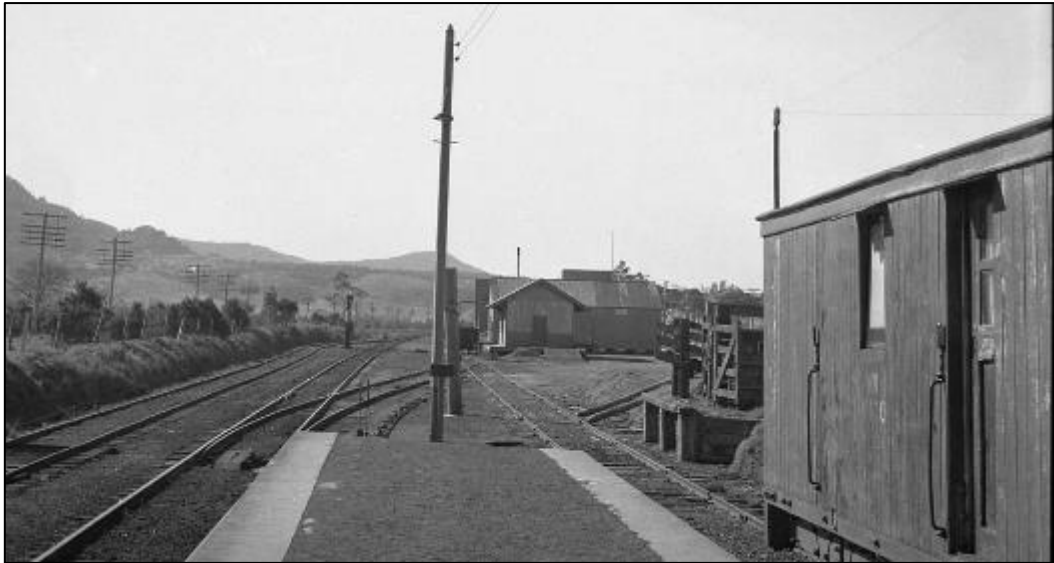
The above photograph taken on 26 July 1951 of the northern end of the platform shows the post-opening dock siding, the small stockyard and, in the middle distance, the goods shed. Beyond the goods shed were the butter factory/dairy cooperative and also a produce store. Between the Main Line and the Loop Line was a water column to which water flowed from a 20,000 elevated tank outside the picture on the left. The tank was demolished in May 1969. The stockyards were demolished in 1961. Photograph No. 215139, ARHS Railway Archives.

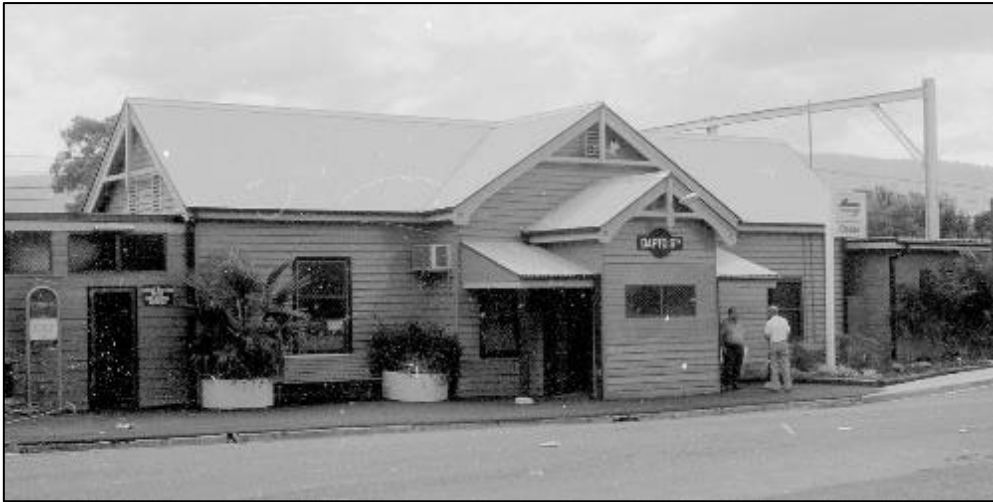
On the left-hand side adjacent to the door is a sign that reads: "Station Master's office and General Enquiries". When originally constructed, there was no dedicated space for the Station Master and he worked out of the ticket office. After the cessation of parcels traffic in 1987, the 25 foot long shed at the southern end of the main building was utilised as a staff amenities area which included a staff toilet and kitchen. This photograph shows that the building has been stripped of virtually all the ornamental cast ironwork associated with the porch and unsympathetic changes have been made to the pedestrian entry/exit.

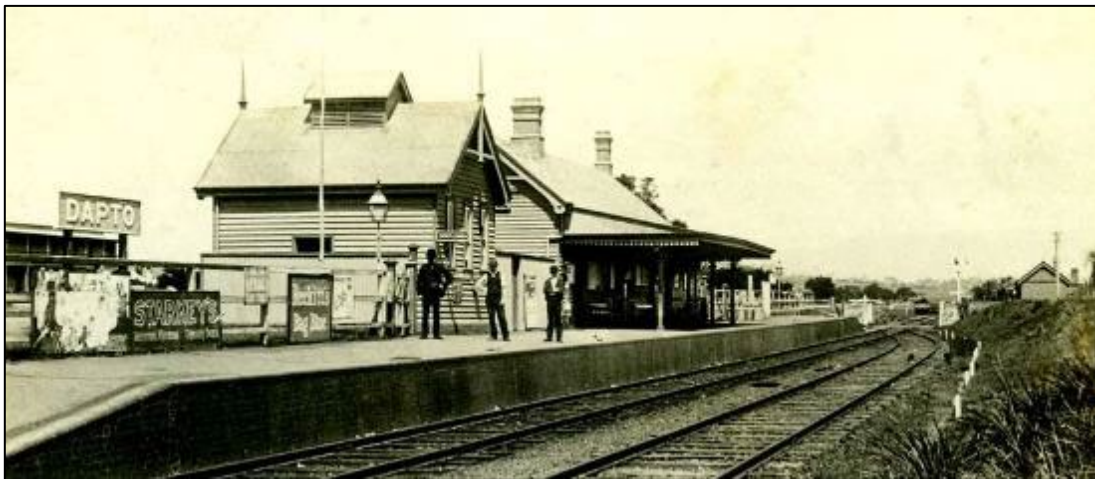
This photograph is looking towards the south and shows the 1887 toilet pavilion in the foreground. As was usual New South Wales practice, the ridge of the roof of detached and semi-detached pavilions were rotated 90° to the ridge of the main building. The Dapto building accorded to that practice. Ventilation of male toilets in the 1880s took

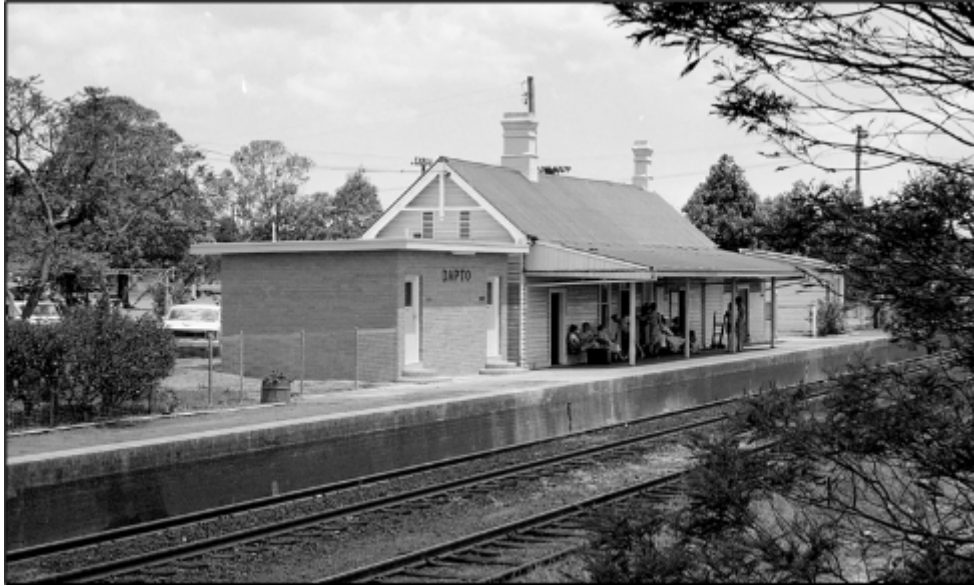
The above photograph dates from 26th December 1977 and shows the new, Commonwealth funded toilet block at the northern end of the station. This design was used at approximately 20-30 other locations.

In each half there were two water closets with the cubicles measuring 1500mm by 900mm. For men, there was also a 1200mm long stainless steel urinal which could theoretically accommodate three users. In the female section, there was a hand wash basin and mirror – neither of these facilities being available for men. Some toilet blocks contained a wet store in the middle of the structure for mops and brooms and cleaning aids but there was no such store room in the new brick toilet block at Dapto.

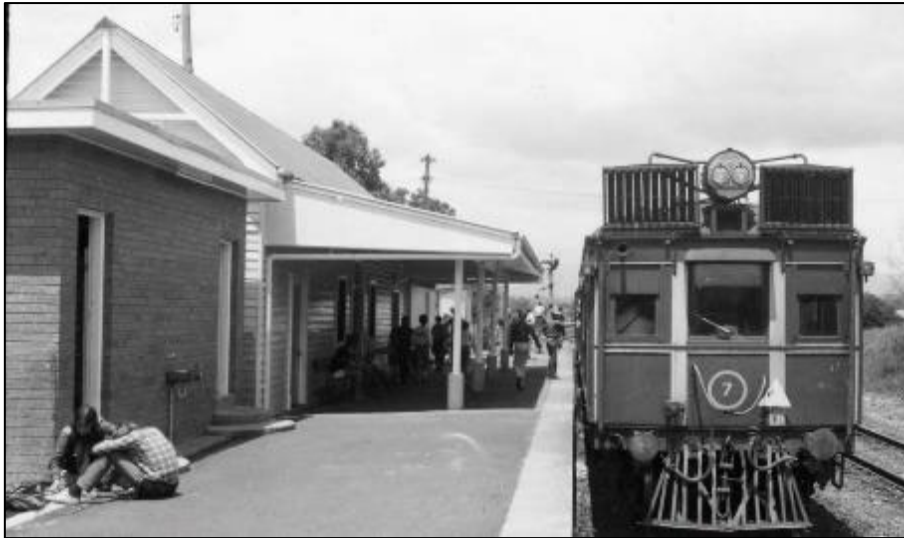
Well-known railway historian and photographer, Ken Winney, took this photograph in November 1883. It shows the 1887 building retaining its three room composition despite the removal of the two chimneys. Concrete has been poured around the bases of the awning posts to keep them in vertical alignment. Photograph No. 113192, ARHS Railway Archives.

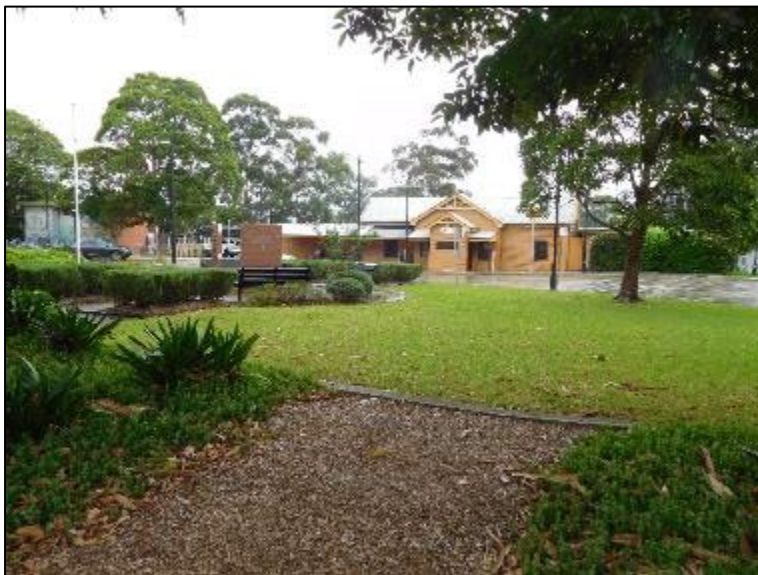
This image shows the circular approach to the station with a war memorial in the garden area.

Further plans to beautify the station forecourt, which was known as Hartigan Park, were prepared in November 1987 and provided for a 16 feet wide semi-circular approach to the station entrance. One month later, a revised scheme was prepared using a complete circular approach. It was that scheme which was adopted. The local war memorial is now located in the station forecourt.

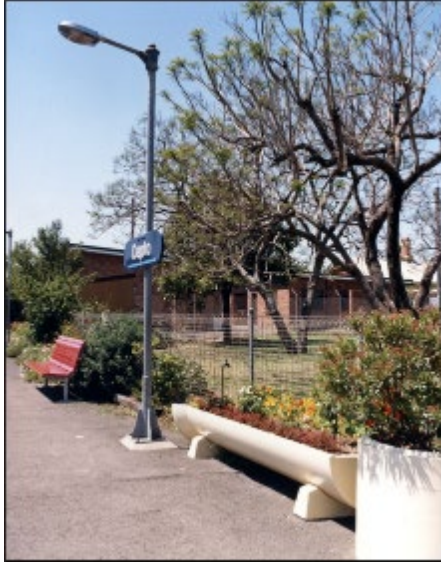
The establishment of CityRail 1989 has seen the only systemwide rejuvenation of every station in the State railway network. Red platform seats, bins and lamp posts were obvious features. However, CityRail worked hard in the first five years to provide a pleasant environment for waiting customers. At Dapto, pleasant planter boxes and shrubs were provided. In this image, pre-CityRail signage has not been replaced. CityRail was so pleased with the attractiveness of the work that it inserted a photograph in the State Rail Authority, Annual Report to 30th June 1991. Page 24 has photo showing the “greening” of the platform.

In 1991, CityRail applied the usual red platform seats and red bins and three level station nameboards featuring blue letters on a white background. The work was completed by July 1992.²³

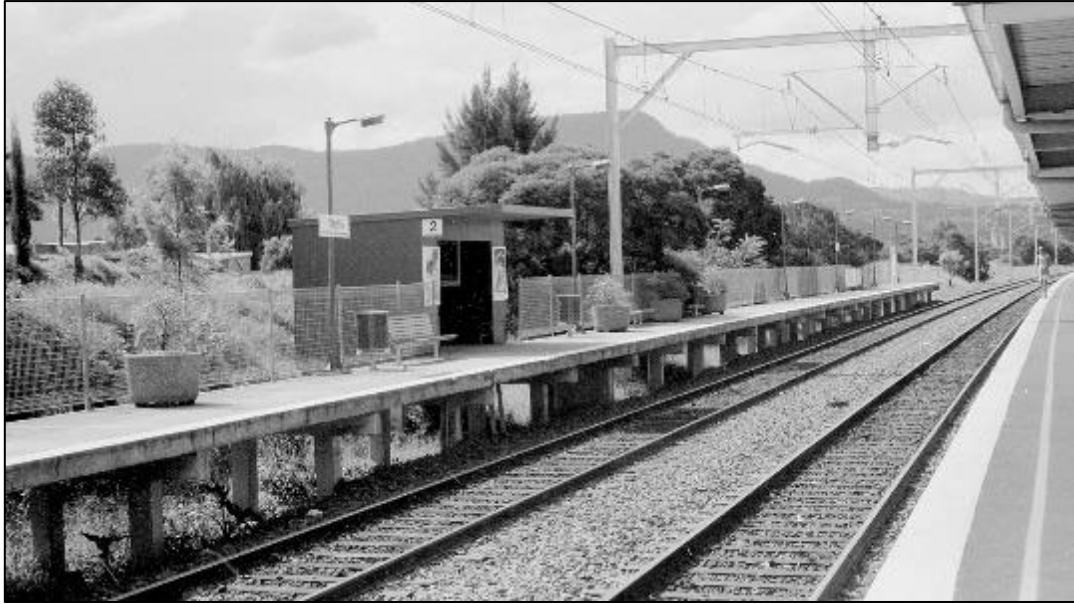
This photograph above is of a very simple, steel-framed and steel clad waiting shed but its construction in 1988 was representative of the policy of the State Rail Authority (SRA) in regard to the type of accommodation suitable as a waiting room. The structure was built to withstand incessant attacks by vandals – a problem that had existed for the previous 30 years throughout the railway system. The 1988 waiting shed was one of the last SRA waiting sheds to be built before the emergence of the enlightenment of CityRail, created in 1989, which fundamentally reversed the design philosophy and, in place of vandal resistant steelwork, preferred transparent accommodation through which station staff could keep an eye on waiting passengers.

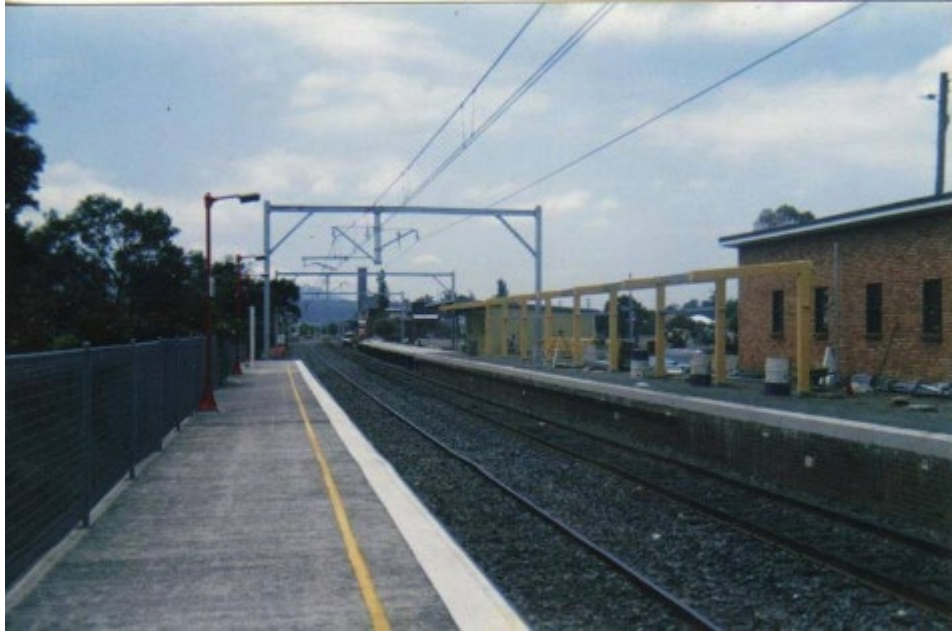
The above photograph shows the extension of platform No. 2 and the erection of a new awning at the northern end of the platform. It would be a further decade before an awning was erected over platform No. 1 on the left. SOURCE: Facebook

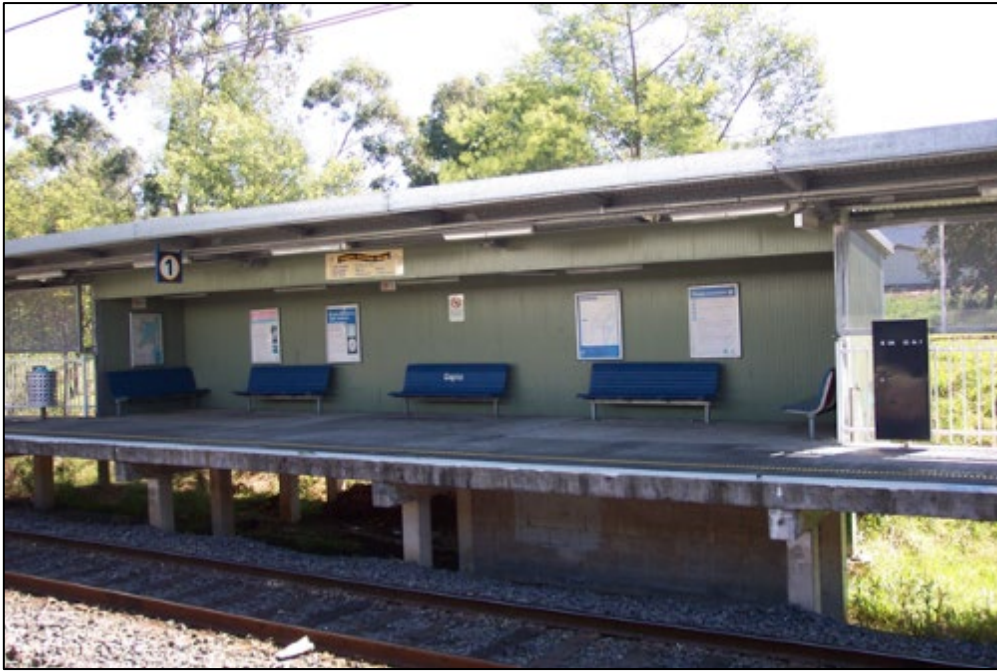
The architecture of CityRail is divided into two periods split about 1998. The early period was identified with bright colours and transparent structures. The change came about with the departure of one Chief Executive and the arrival of a new boss. The enlarged waiting area on platform No. 1 dates from the later CityRail period, as evidenced by the absence of a transparent rear wall. The above photograph dates from 2007.

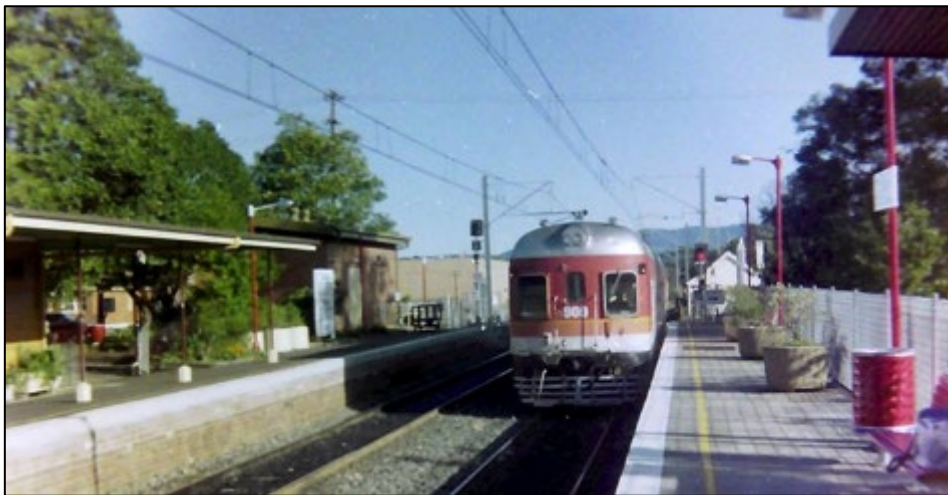
*This photograph shows the 1988 platform on the Loop Line, which was known as platform No. 1. The photograph was taken in the early 1990s and shows the galvanised mesh fencing and the red and white seats, bins and lamp posts. **SOURCE:** Google.*

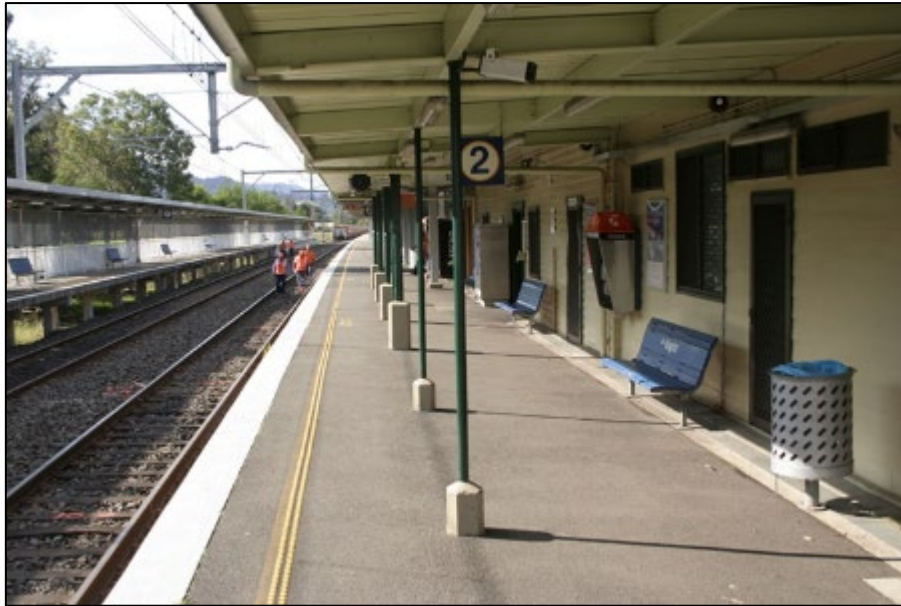
The above photograph was taken after the erection of the full-length awning over platform No. 1 in 2004. SOURCE: Google

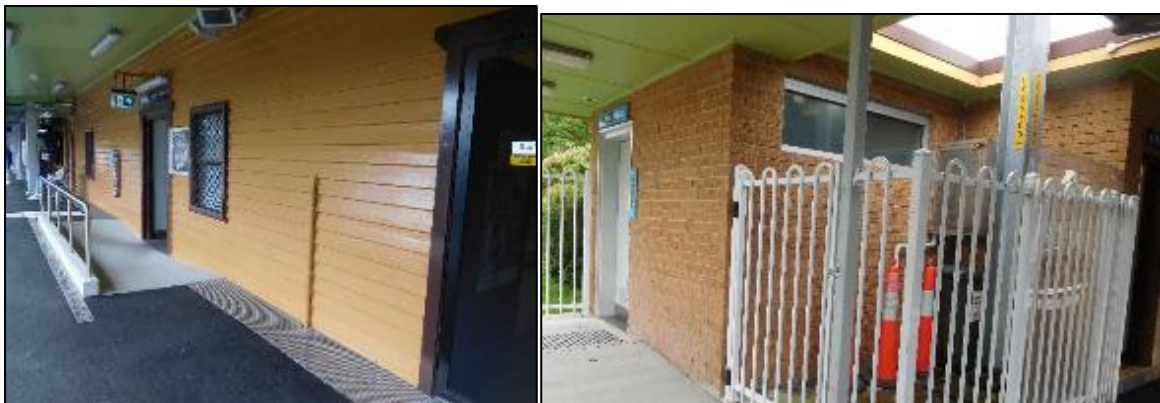
These two images show aspects of the improved access to the station carried out in 2023. On the left is the new ramped access from the former general waiting room onto the platform. On the right is the construction of the toilet for disabled people, which has been built at the rear of the 1977 toilet block.

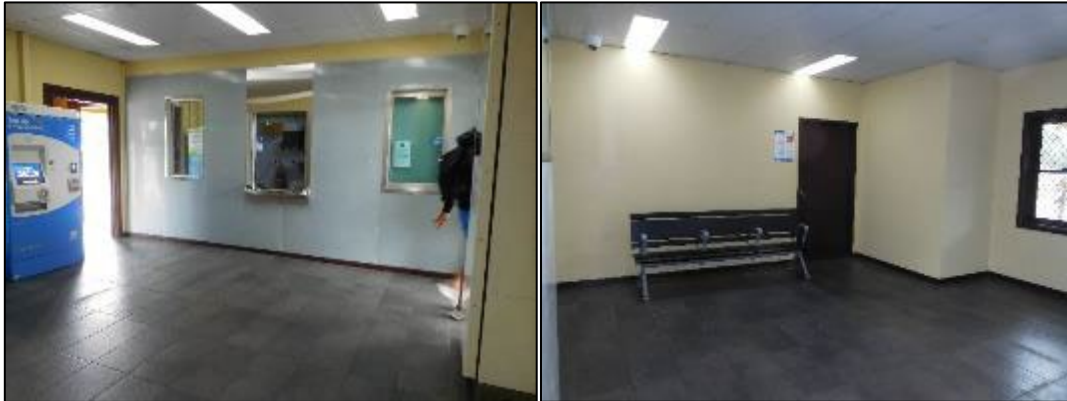
These two images show the way the former internal spaces that were once the general waiting room and the ladies' waiting room have been transformed into an unrecognisable single entity. Chopping up the internal spaces started with the resumption of a space of the ladies' waiting room in 1902 for an office for the Station Master. It would seem that either CityRail or Sydney Trains or both have continued the enthusiasm for purging the delineations of the former rooms. In 2024, the structure lacks entirely any interpretation of the original footprint of the 1887 building.

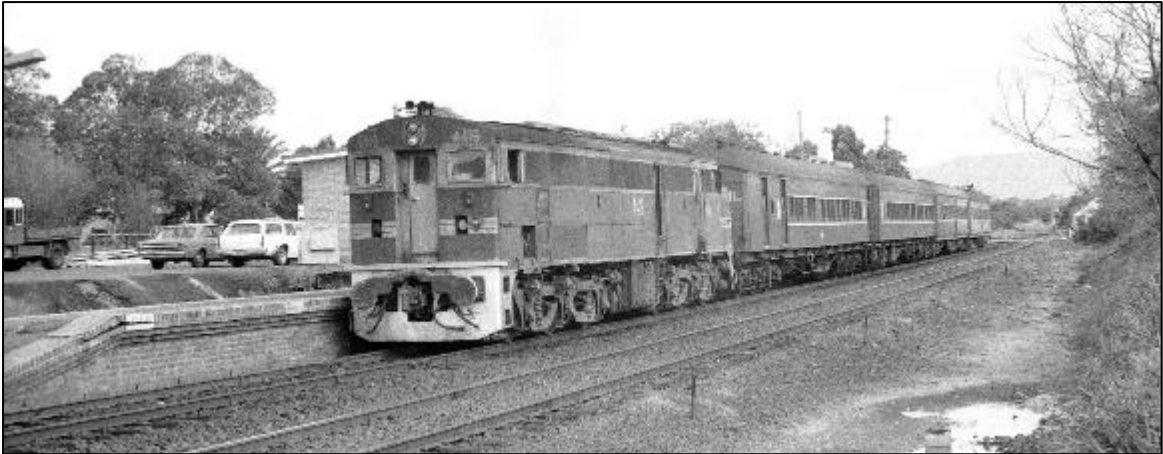
*Neil Munro writes: 4419 is arriving at Dapto with a service to Sydney on 17th April 1983 with two supplementary interurban carriages in the lead (conversions from surplus wooden-bodied corridor cars) and two FS steel side-corridor cars bringing up the rear. 4419 was one of the first 20 Alco locos ordered by the NSWGR from Sydney manufacturer A. E. Goodwin in the 1950s. Their success resulted in another 80 similar locos being ordered in several subsequent batches from the same company. I recall in later years a respected driver saying that despite all the growing creature comforts provided in later and more modern locos he would rather a Mark 1 44-class with streamlined end leading any day. In 1983 Dapto only had a platform on the main line while the passing loop was devoid of any passenger facility. With State Rail focused on electrification between Wyong and Newcastle in 1983, the 'Cinderella' South Coast line would have to cope with diesel rail cars, diesel loco-hauled trains, manual semaphore signals and electric staff instruments for many more months.²⁷ **SOURCE:** Neil Munro.*

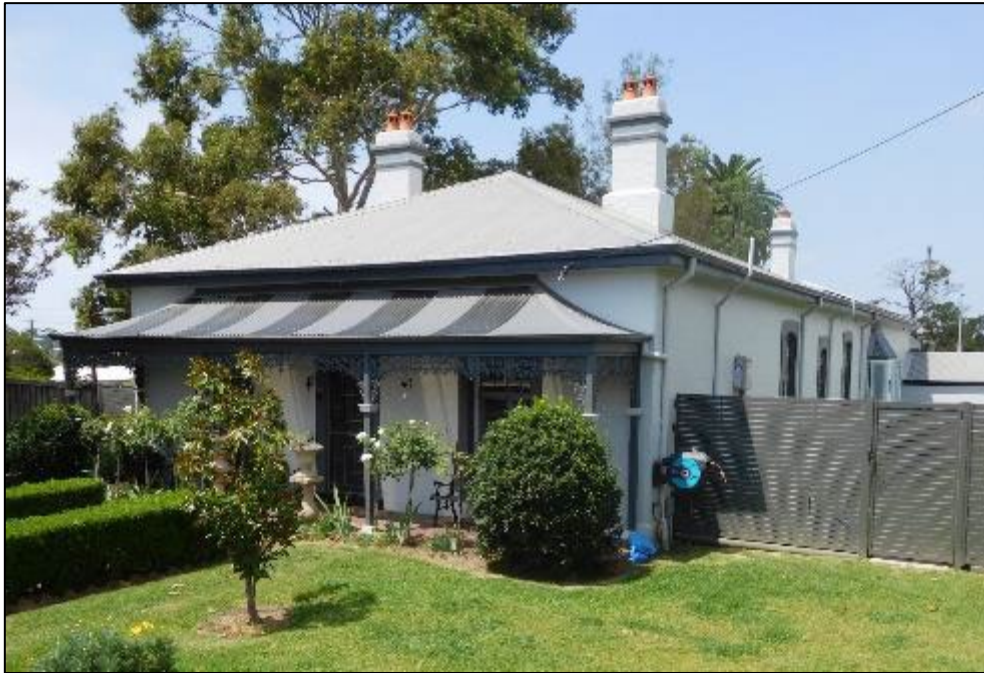
John Whitton had introduced a new, standard design for residences for Station Master's in 1876. He approved four examples of his standard design south of Waterfall. They were located at Stanwell Park, Clifton, Bulli and Wollongong. The image above shows the 1876 standard design at Bulli. Strangely, Whitton decided against using this standard design south of Wollongong, including Dapto and, instead, selected a smaller structure designed for occupation for officers below the rank of Station Master.

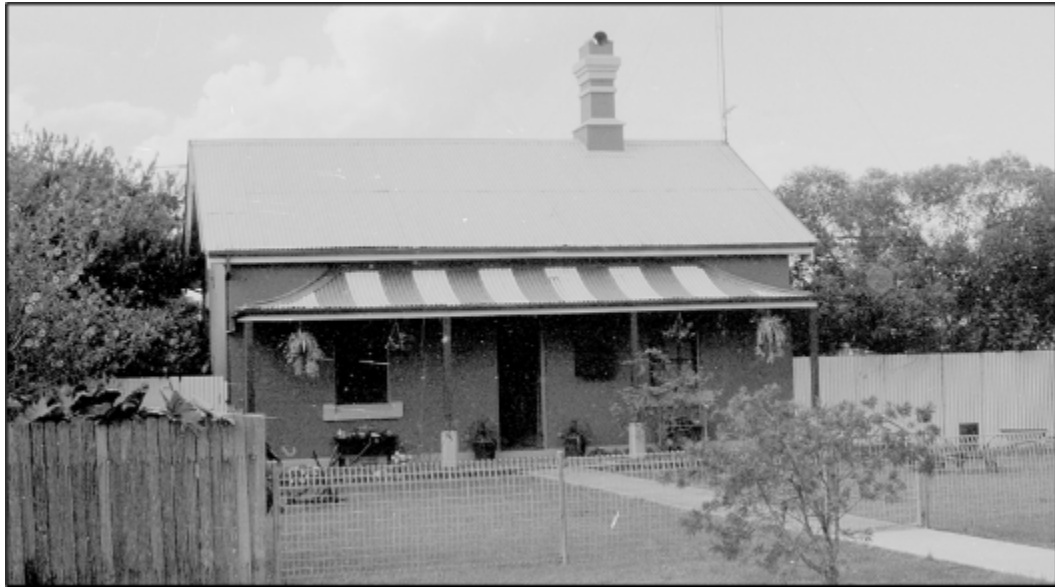
This 1992 image identifies the transverse gabled roof as the dominant architectural feature with the full width, concave shaped awning over the front elevation. The use of less costly official houses south of Wollongong was another indication that money was in short supply.

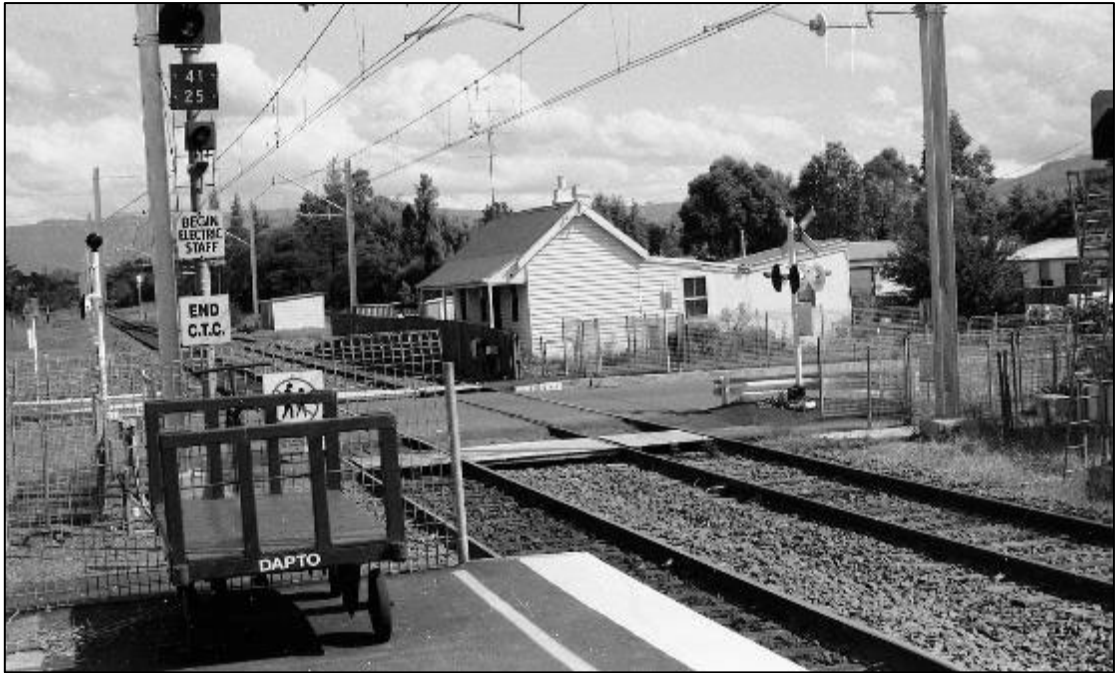
The above photograph, taken on 26th December 1977, shows the timber gatehouse at the southern end of the platform

The small size and primitive design were typical of gatehouses built south of Wollongong. The timber gatehouse was destroyed by fire in the 1990s.²⁸

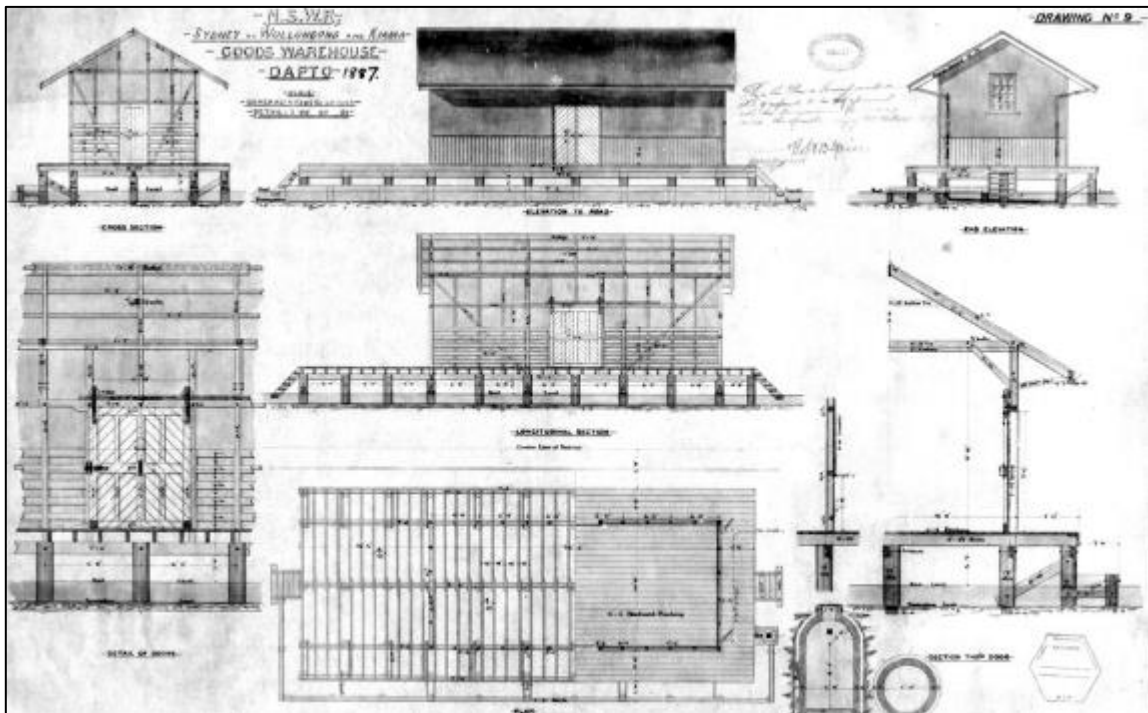
The above plan shows the small goods shed of traditional New South Wales design. The building measured 36 feet by 18 feet with a 4 feet wide platform on each side of the structure. At one end was a timber platform 16 feet long.

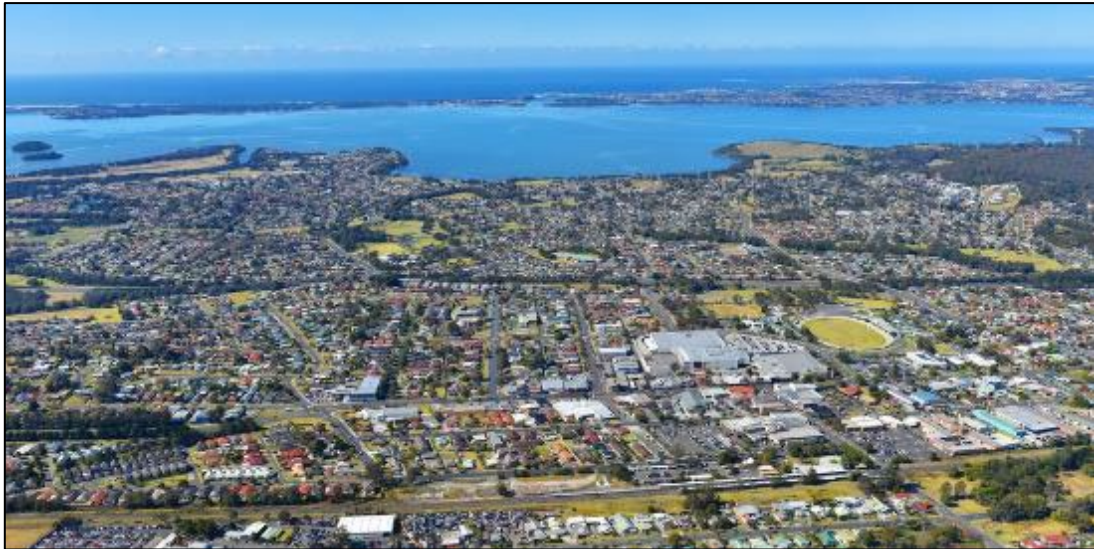
The above picture shows the relationship between Dapto station, which is visible in a line across the bottom of the image, and Lake Illawarra. **SOURCE:** Chilby Photography, Dapto History Photos.

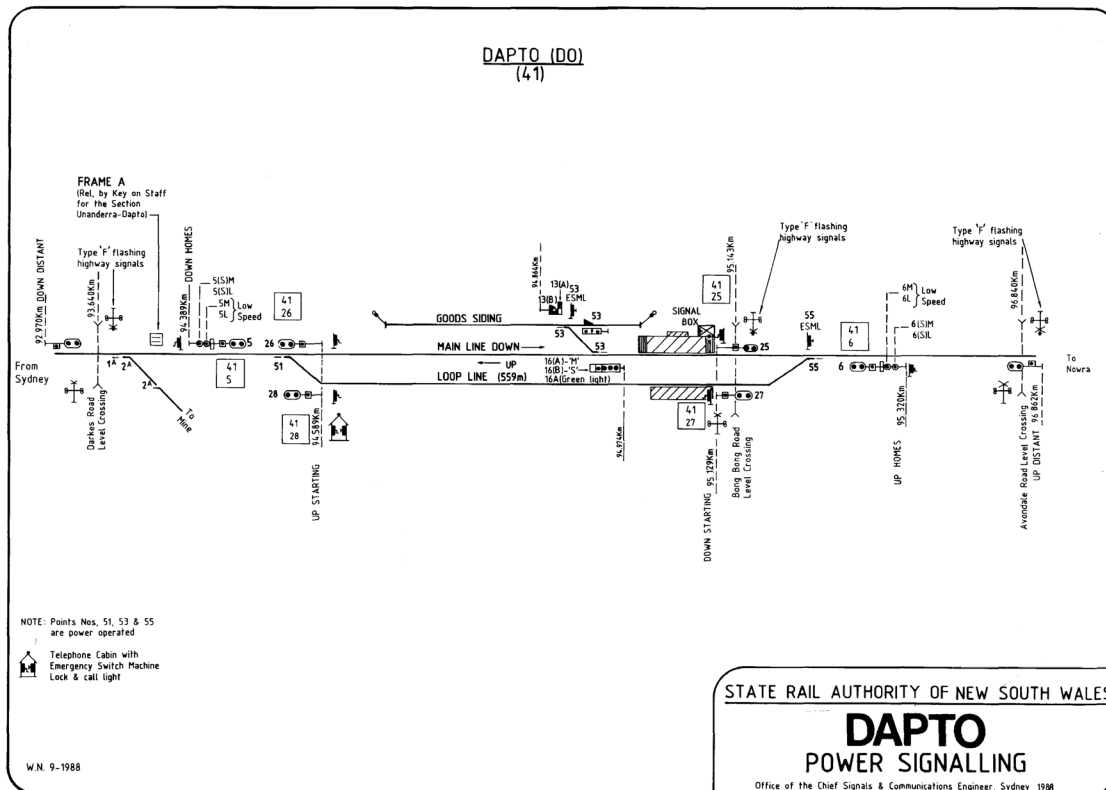
SOURCE: ARHS Track and Signalling DVD

- Replacement of the mechanical home and distant signals with single light colour light signals
- New starting signals for the main and the loop in each direction
- Power operation of the loop points at each end and of the single remaining goods siding connection
- Low speed signals to enter the loop at each end
- Shunt signals to and from the goods siding.
- Formal abolition and removal of Clarke's Timber Siding
- Control of points and signals by a new control panel in the SM's Office.
- Provision of an additional platform opposite the existing one, serving the loop

Electric staff working continued at this stage. The new arrangements are shown in the next page,

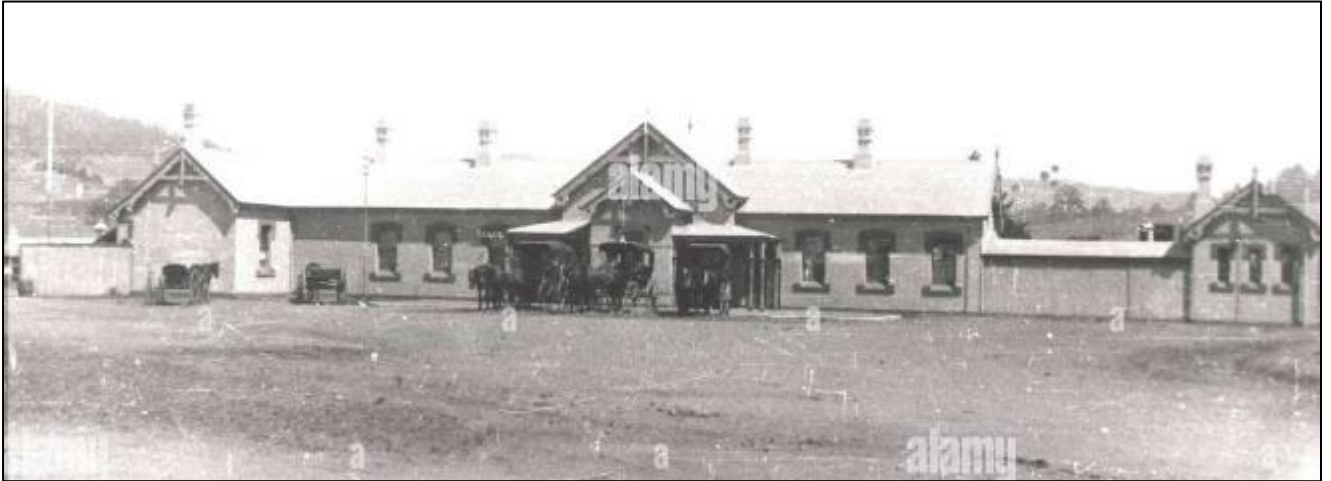
Photograph is taken after 1890 when an infill development has joined the pavilion on the left side with her main, five room structure. **SOURCE:** Alamy
