# A RAILWAY STATION IN A HERITAGE-MINDED AREA – GORDON

STUART SHARP

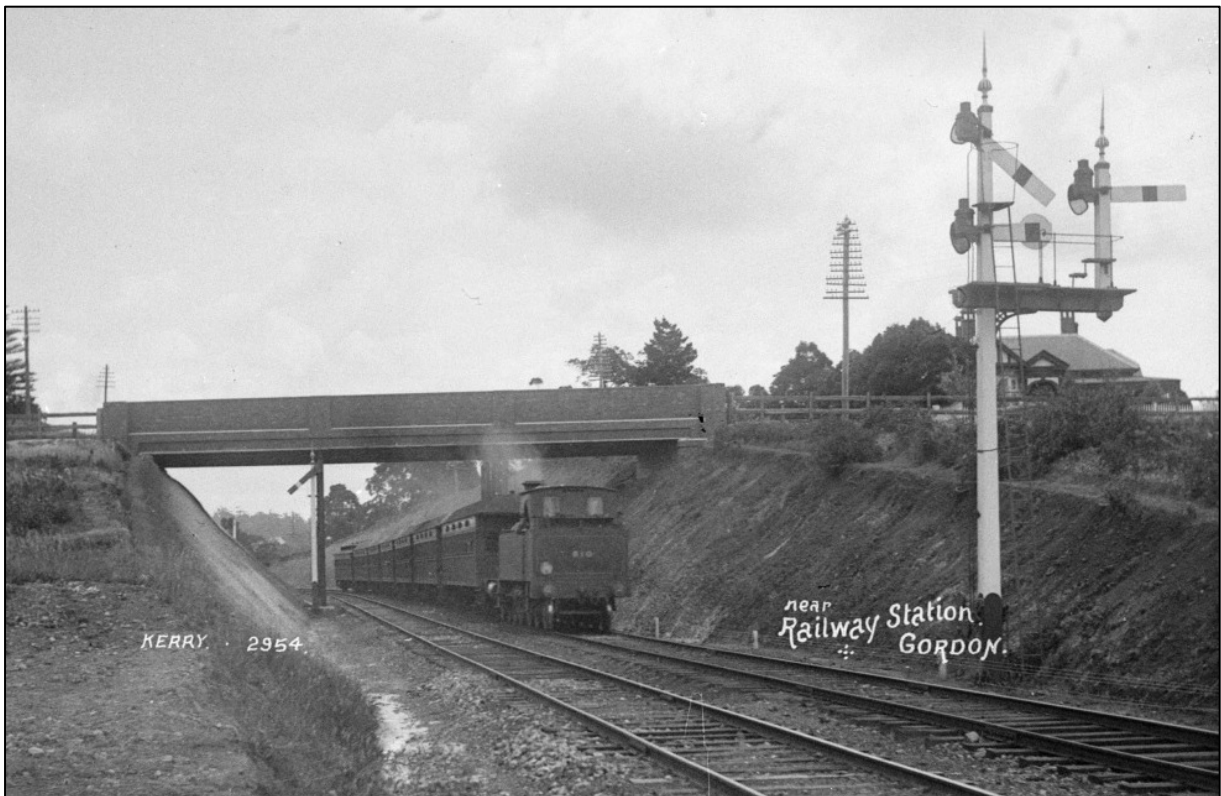
*The photograph shows the Park Road brick overbridge which is a little to the north of the station.<sup>1</sup> Evan Rees, rollingstock historian writes: “The train is proceeding from Hornsby to Milsons Point. There is not much remarkable about the carriages in this photograph. A 30 class tank locomotive is hauling a fairly typical consist of a six-car set of American suburban cars with an earlier clerestory-roof suburban car at the rear building up the set to meet demand. At the time of this shot, the cars are all still gas lit evidenced by the Anderson ventilators along the letterboard sides of each car”.<sup>2</sup>*

*The overbridge was completed in 1909 in conjunction with the track duplication. It replaced a timber bridge which had been built at the opening of the line in 1890. The plan was prepared*

by one the Railway Draftsmen, T. E. Moorhouse, on 10th July 1909. It was 74 feet long and 30 feet 6 inches wide, including a six feet wide footpath. Bullnosed bricks were featured on the top of the brick balustrades. The deck of the bridge was supported by eight longitudinal metal arches known as jack arches in conjunction with the brick abutments and two steel trestles – a technique that was often used in the 1920s. Since construction, the centre sections of both balustrades have been raised tastefully a further five courses, possibly in an attempt to mitigate the local ruffians throwing items onto the tracks.

Safeworking historian, Graham Harper, adds the following details expressed in the photograph: “The photograph shows an up passenger service approaching the Gordon Up Home signal. The road is set for the Up platform road (i.e., island platform No. 2). The arm on the other side of the bracket is for moves into Terminal Road. This latter move would have been a rare one, as Up trains rarely terminated at Gordon.

The shunt signal arm beneath the home signal is not a kind of call-on for entry to the Terminal Road but, when cleared, it allows the engine off a terminator from Milsons Point, having cut off from its train and shunted out into the Pymble block section, to pass the home signal and run through the station and set back onto its train. The arrangement was cumbersome, but it survived until the introduction of automatic signalling in 1928. The exchange of block bell signals to do this movement would be interesting to hear. Gordon must have been a busy place at times – the Down starter has been cleared as well for the passage of a train to Hornsby.<sup>3</sup> **SOURCE OF PHOTOGRAPH:** Google.

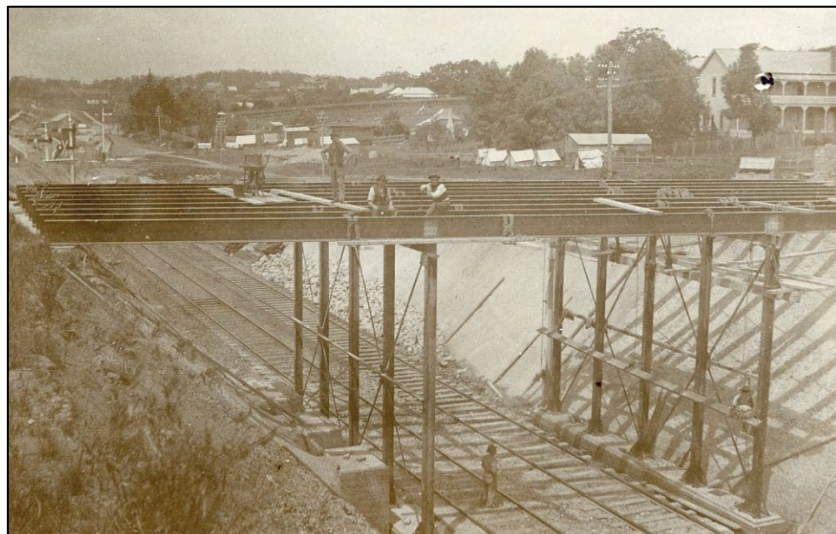
This 1909 photograph shows construction of the Park Road overbridge. The photographer is looking south towards the station. The replacement of the 1888 platform building is yet to take place. The jack arches will be inserted between the longitudinal steam beams. **SOURCE:** Ku-ring-gai Council Library. <https://www.krg.nsw.gov.au/Community/Ku-ring-gai-Library/Local-History/Local-History-photo-galleries/Scenes-from-Gordon-and-Killara>.

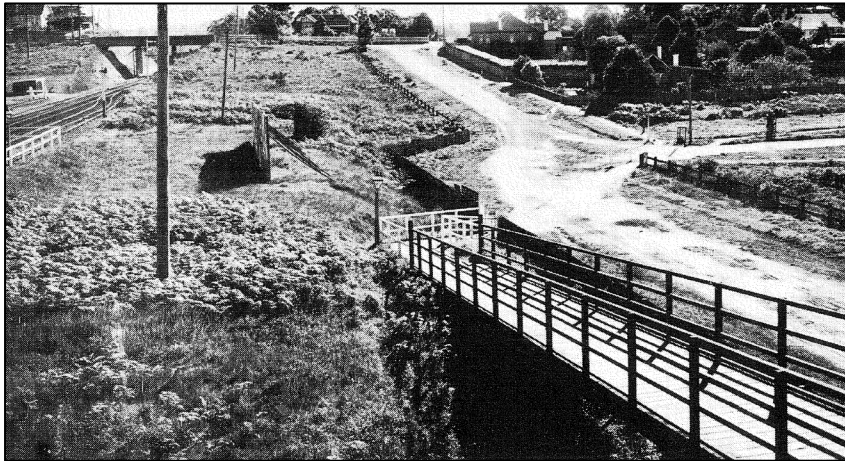
*This photograph looks north to the Park Street overbridge from Gordon station. The two rail timber fence at the rear of platform No. 1 is visible on the left side.*  
**SOURCE:** C.C. Singleton, "The North Shore Line", ARHS Bulletin, July 1959, p. 105.

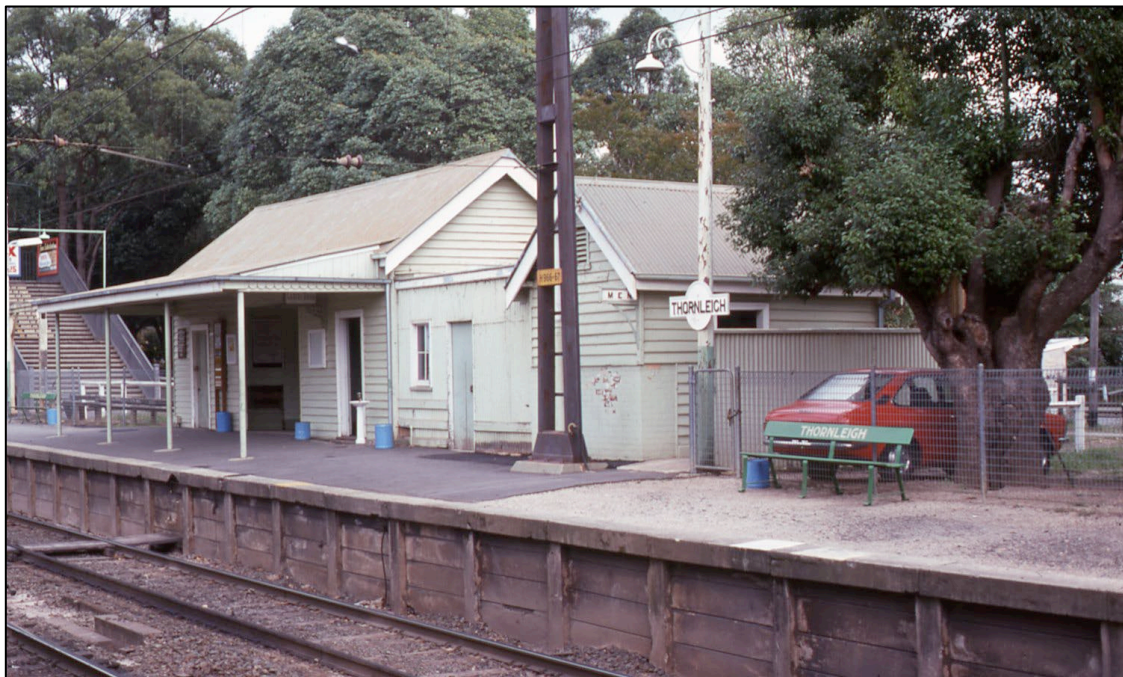
*The first platform building at Gordon contained three rooms plus toilets. It accorded with a standard design introduced in 1880 by John Whitton, the Engineer-in-Chief for Railway Construction. It was a compressed version of his three room model. The above picture shows another example of the same mini three room design - at Thornleigh, which was approved for construction in 1886. All but three examples of this compressed type were erected in rural regions. Only those at Thornleigh, Gordon and Chatswood were constructed within the present boundaries of the Sydney metropolitan areas and, at the time they were built, those parts of Sydney were similarly very much rural. The 1977 picture of Thornleigh shows the same layout of spaces as at Gordon with the open-fronted waiting room in the centre, which was flanked on the farther side by the ticket office and, on the side closer to the camera, by the ladies' waiting room. Women proceeded through a secret passage, concealed by the shed in the picture, to the rear of the toilet pavilion. Male toilet facilities were contained in the front half of the pavilion and their space is identified by the green-painted, dwarf brick wall facing the platform, which formed the rear wall of the urinal.*

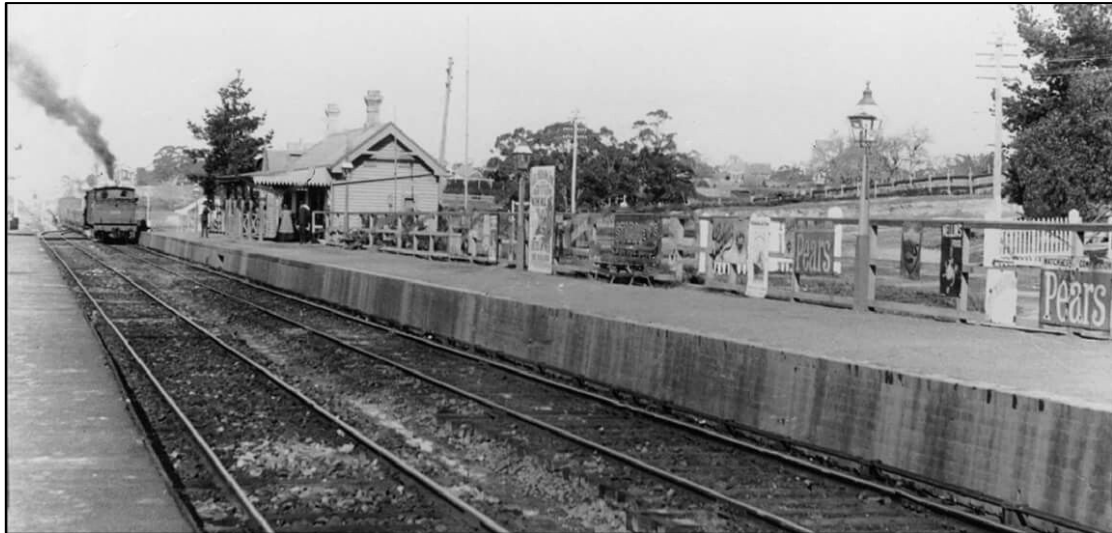
*This photograph was taken between 1900 and 1909 and shows the 1888-approved building. The platform wall shows one of the classic hallmarks of John Whitton's design policy. The wall slopes gently but consistently towards the toe unlike platforms erected after 1890 where the coping is square to the vertical wall, rather than sloping. On the extreme righthand side can be seen the white-painted posts and gate for entry to the goods yard. **SOURCE:** Google.*

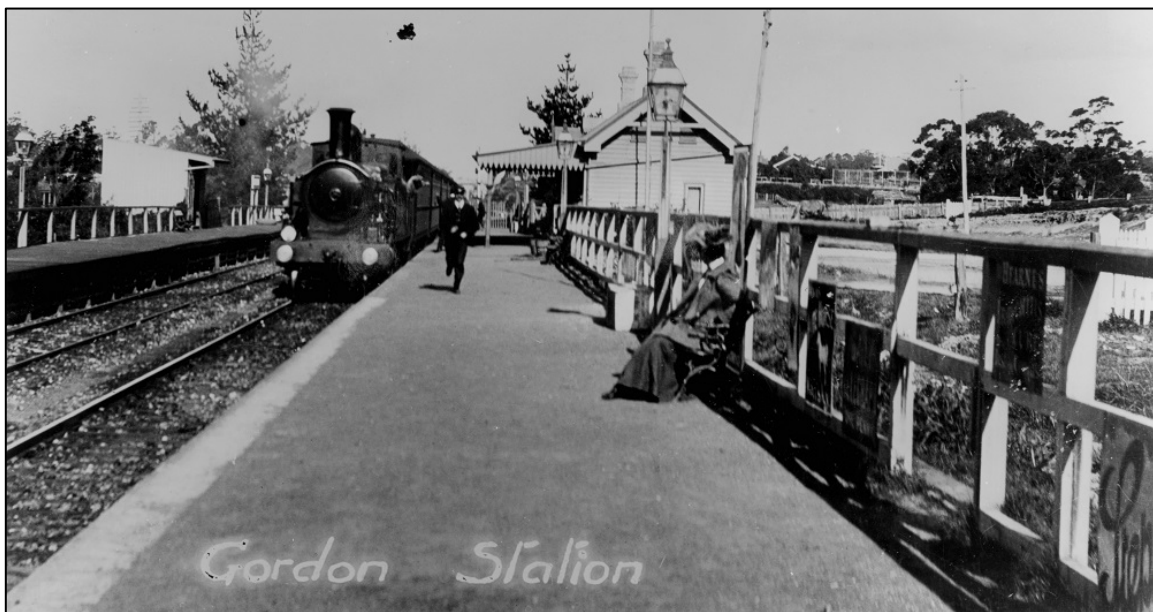
*In this photograph, the station officer is running along the platform to hand the staff to the locomotive driver. The three-rail fencing at the rear of the platform was representative of most stations on new lines in the 1880s and largely replaced the use of pickets because of the lower initial cost. In the 19<sup>th</sup> century, the Railways minimised the number of platform seats. In this photograph, there are only two seats. There was one seat under the platform awning but no seats south of the building. Usually, platforms were widened from 12 to 15 feet in front of the buildings but this was not done at Gordon. That omission was consistent with other stations having mini three room buildings and no doubt related to the need to minimise expenditure.*

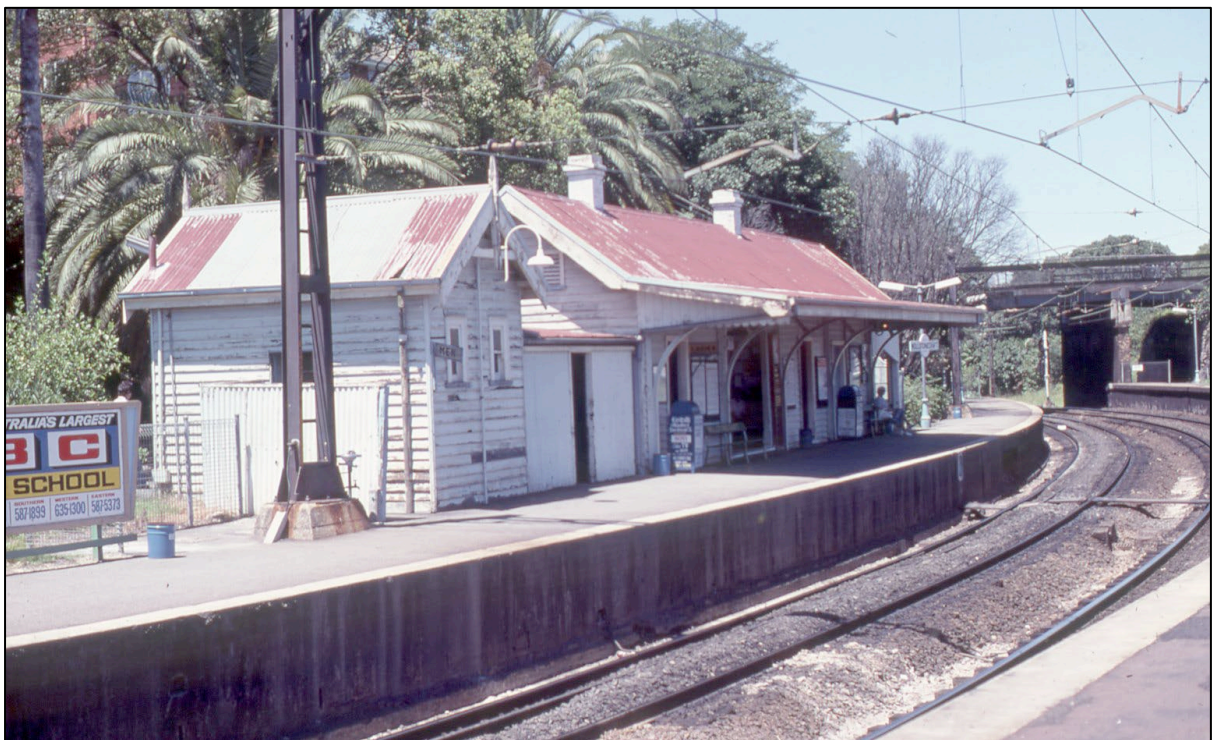
*The above photograph taken on 8<sup>th</sup> February 1978 shows the building at Wollstonecraft after it had been relocated from Gordon in 1909. An additional room has been added to the far end to provide a parcels office. The roof was extended also at the southern end to protect an interlocking frame when it was installed in 1911. The roof extension was subsequently*

enclosed.<sup>16</sup> *The timber posts supporting the platform awning have been replaced by non-standard brackets cantilevered off timber posts affixed to the building wall.*

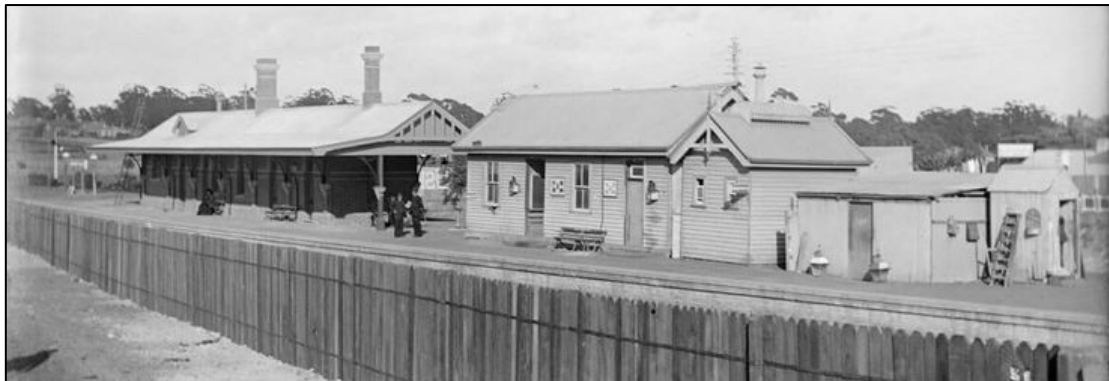
*The above photograph of Chatswood was taken in 1901 when the 1888 approved timber building, which was the same design as at Gordon, was about to be demolished. The replacement building on the left is nearing completion. It was slightly more ornate than the building at Gordon in 1909 as evident by the location of gablet ventilators on each side of the roof. The awning of the 1888 structure has been removed to allow trains to proceed around the platform, which had been converted from side to island configuration. **SOURCE:** Pinterest.*

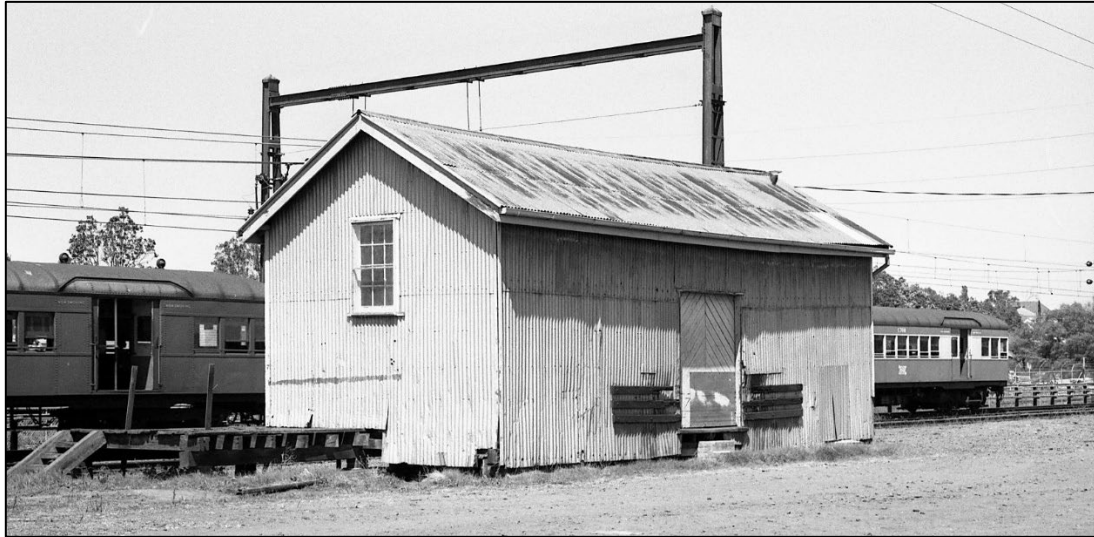
*The goods shed at Gordon was of the same dimensions and materials as the one shown here at Belmore in 1978. In the above photograph, the deck has been removed from the road elevation. There was one other addition since it opened in 1895. Horizontally set boards have been placed on the external walls each side of the six feet six inch wide pair of sliding doors. The boards were intended to minimise the damage by unthinking staff to the corrugated iron walls. Otherwise, the structure in 1978 retained its 1895 appearance.*

A goods siding and goods shed, measuring 36 feet by 16 feet were provided on the western side of the line. The plan was stamped 30<sup>th</sup> August 1885. The structure was founded on 12 inch diameter timber piles. The eaves of the roof extended over the decks on both sides to facilitate the rail/road transfer of goods. The decks were three feet four inches above the head of the rails. Alex Scouller signed the plan as the contractor on 7<sup>th</sup> December 1888, which was over three months after he signed the platform building plan. The siding at Gordon held 15 four-wheeled vehicles but the number of vehicles was later reduced to 12.

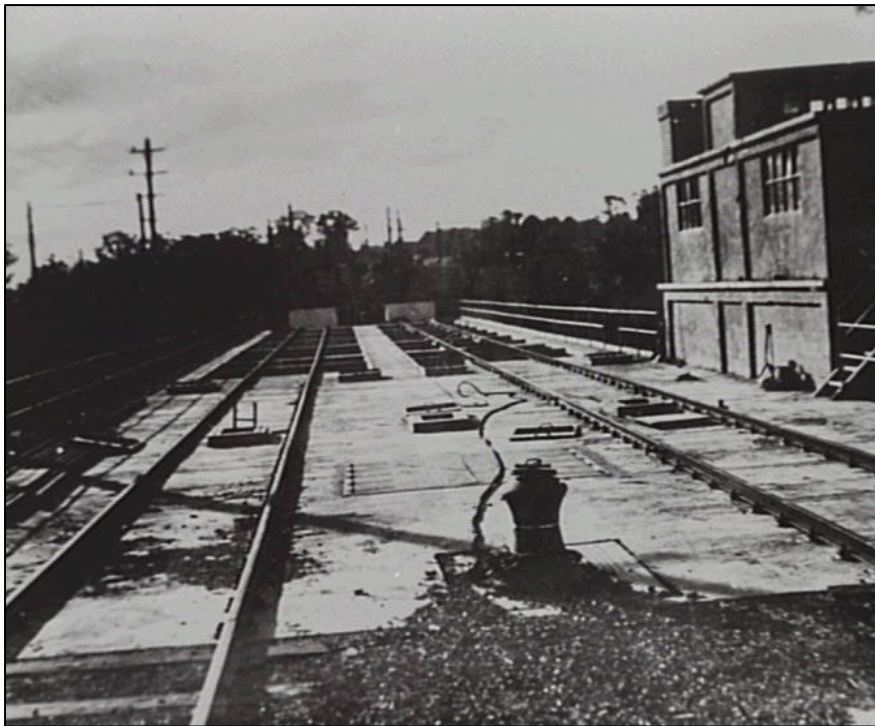
*The photograph on the left, taken about 1928, shows the two sidings with the bins at the far ends of the tracks. The capstan to move the rollingstock is in the foreground. **SOURCE:** Photograph No. 1995 Ku-ring-gai Library Local History Collection.*

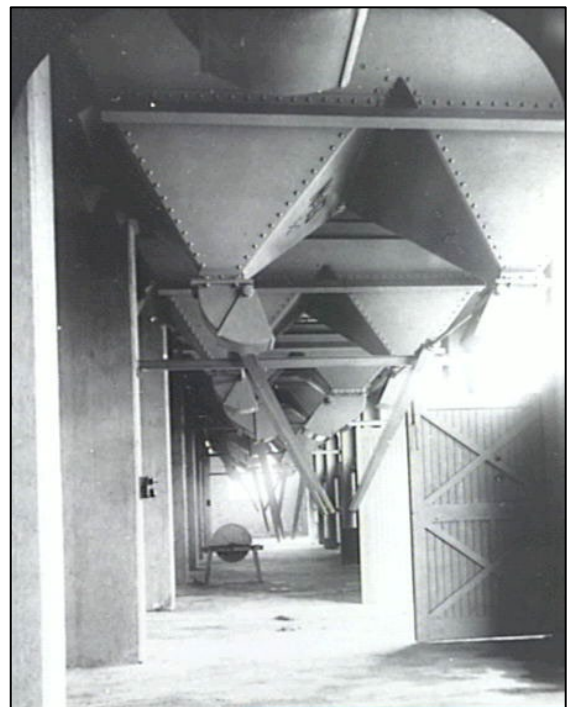
*This photograph shows the bins underneath the two tracks. The long handles open and close the outlets. The gravel discharged into road vehicles beneath the bins. **SOURCE:** Photograph No. 1810 Ku-ring-gai Library Local History Collection.*

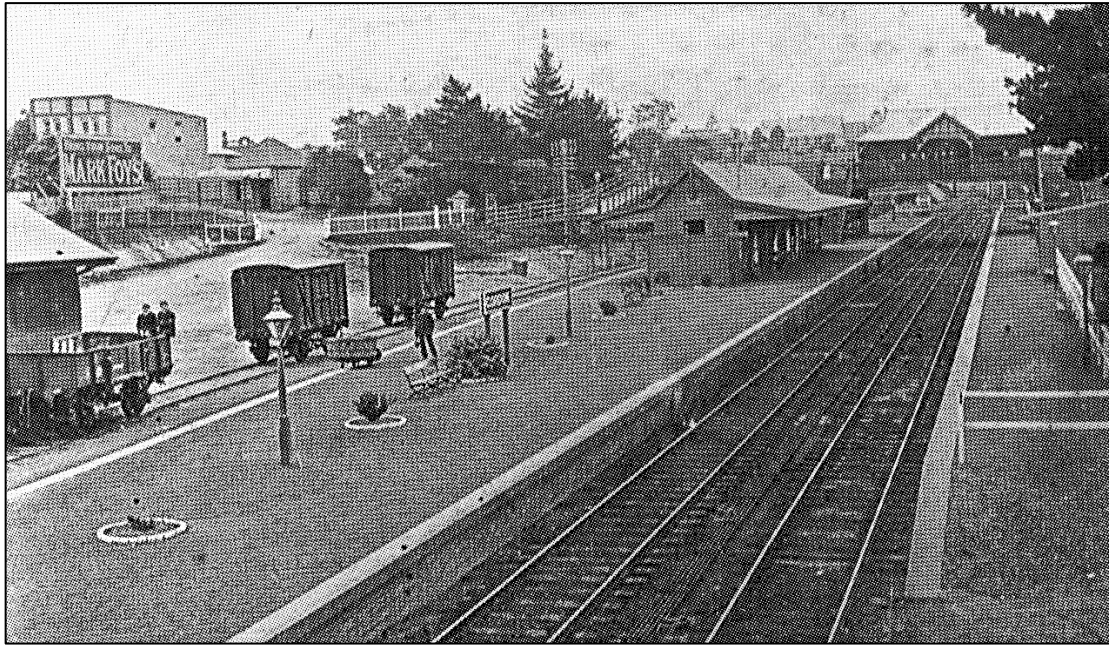
*This photograph, taken between 1910 and 1927, shows the early effort to beautify the platform. It was policy for island platforms to place the entrance to the male toilet as far away as possible from the point of pedestrian entry to the platform. This policy was implemented at Gordon. The photograph shows the male toilet behind the privacy screen at the southern end of the building. A bit of the goods shed is visible on the left. It was relocated to a more southerly location in 1909 to allow for the construction of the ramps to the proposed footbridge, which came in 1910. **SOURCE:** K. Cook, *The Railway Came to Ku-ring-gai*, Pymble, Genlin Investments, 1991, p. 30.*

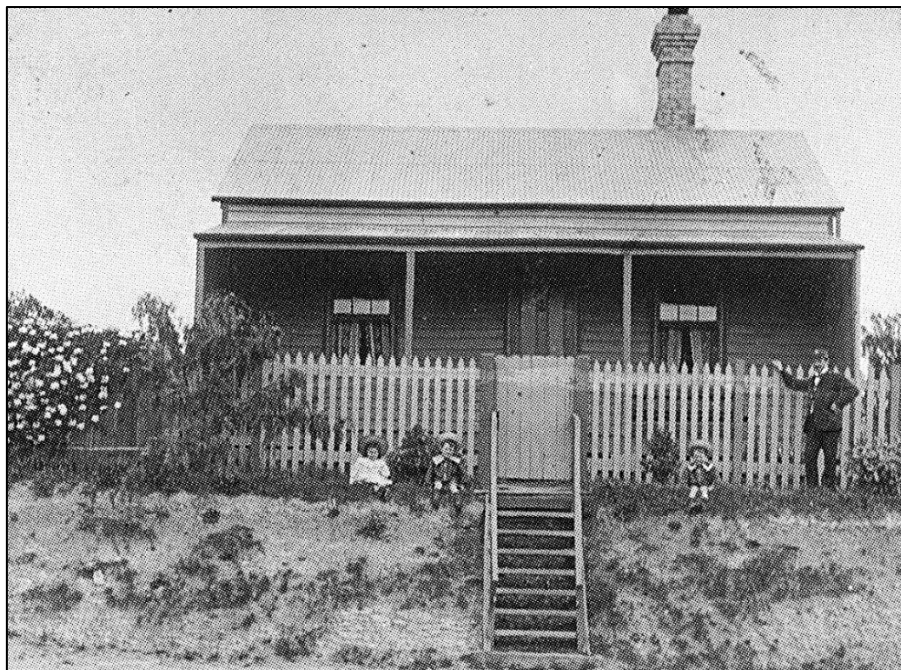
*There were several characteristics of the Station Master's cottage that oozed low cost. These were: the timber construction, the small size, the absence of decorations and the limited heating. Stepped access to residential accommodation was most unusual. While the platform fencing was formed of three horizontal timber rails, the front elevation of the station officer's house had the more attractive pickets. Six feet high hardwood palings attached to two-rail timber frames marked the side and back boundaries. SOURCE: K. Cook, The Railway Came to Ku-ring-gai, Pymble, Genlin Investments, 1991, p. 30.*

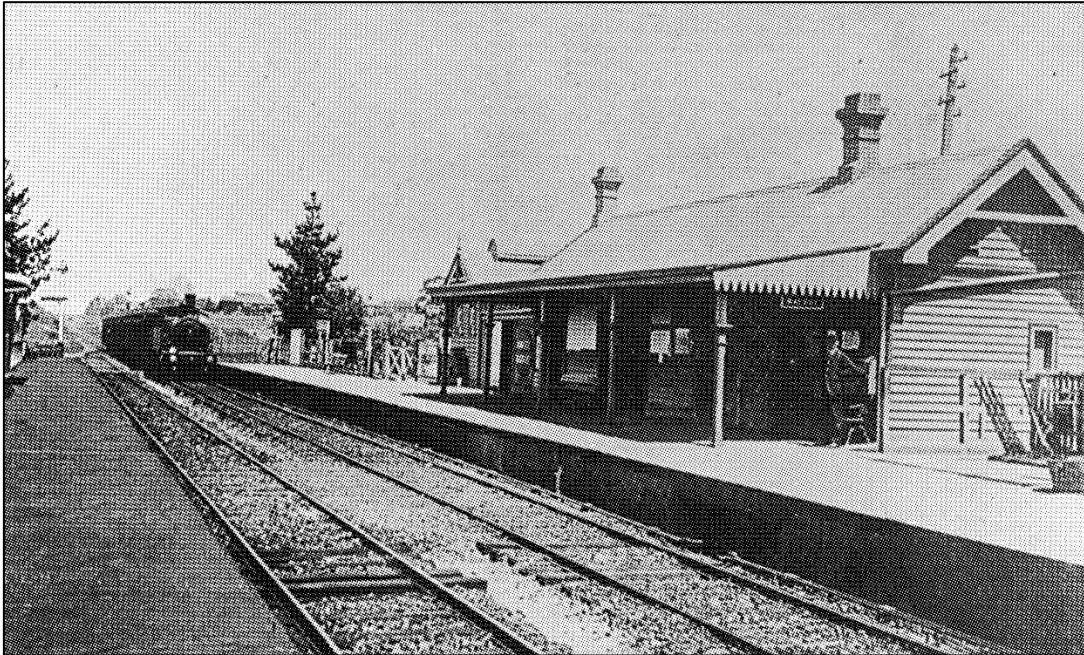
*This photograph, supposedly dated about 1905, shows the 1888-approved platform building. One interesting aspect is the difference in the colour of the two platform surfaces. The platform on the main line (on the right) shows the surface covered with crushed granite from the long-established railway quarry at Locksley whereas the surface of the platform serving the loop line (on the left) is different. It is possible and probable that, initially, the loop line platform was of timber construction with timber planks for the deck and, at a later date, rebuilt into a rammed earth platform with a brick wall. Graham Harper, signalling and safeworking historian comments about the interlocking frame seen at the end of the building on the right: "The interlocking frame contained 16 levers. Four levers have been pulled over from the vertical position into what was called the "off" position, meaning that the signals are set to allow an approaching train to enter into and proceed past the station. The lever closest to the building activated the Down Distant signal; the middle of the bunch of three levers operated the Down Home signal and the third lever in the group to have been pulled over actuated the Down Starter. Note the single pulled over lever a little way down the frame – this would be the FPL lever (i.e. Facing Point Lock) for the Sydney end loop points". Harper makes an additional comment: "I see a small window in the end of the building was inserted possibly to allow the Station Master to keep an eye on southbound trains or to oversee the lever frame to prevent unauthorised people having a fiddle with the mechanism. The window was not in the 1888 plan for the building. Another interesting aspect is the tablet (i.e. the sign outside the nearest office under the awning which, with a degree of imagination, might appear to read WAY OUT". If that were the case, the ticket office in the building would have to have been altered".*

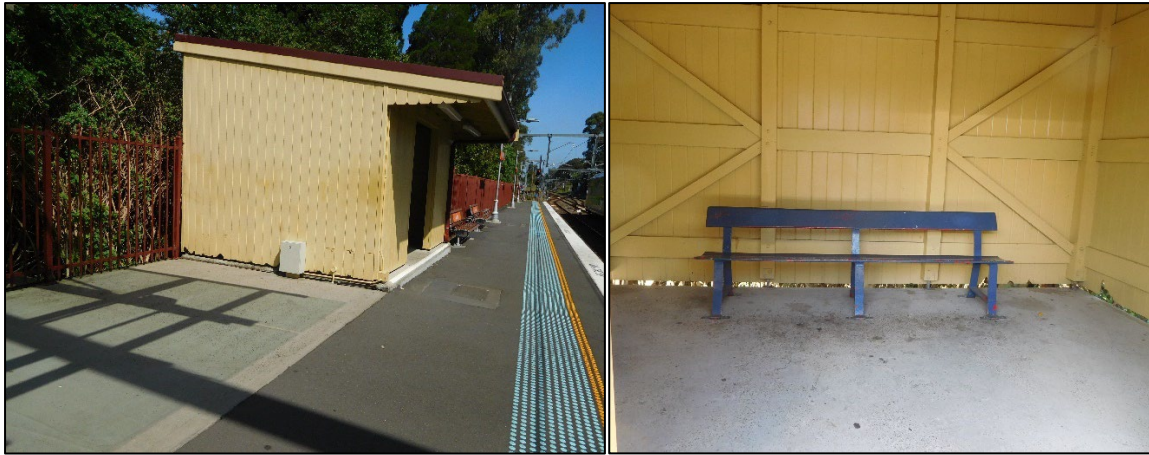
*The structure at Gordon on platform No. 1 measured approximately 14 feet six inches by 10 feet and belonged to a family of structures with the most numerous examples. The opening in the front is five feet four inches wide. In excess of 500 examples were erected between 1855 and 1957 not only as the main platform building but also as out of sheds, lamp rooms and standalone ticket offices not to mention to 226 signal boxes recorded by Dr. Bob Taaffe.<sup>29</sup> The above images were taken on 4<sup>th</sup> December 2024.*

In one of the not-surprising, frequent incidents of inconsistency, the New South Wales Railways viewed the need for a building on a third side platform at Gordon differently to the provision of a large brick building on the opposite island platform. On the Terminal Road, it provided the small timber waiting shed 14 feet six inches by 10 feet with a skillion roof. Why not replace such a tacky, inferior-quality building at Gordon? After all, the New South Wales Railways had decided not to use skillion-roofed structures in Sydney after 1897 and now, in 1909, the design policy seems to have been build-what-you-like on the evidence of what was going on at Gordon. The New South Wales Railways was always short of money and, in 1909, when the plans for the building on the island platform were proposed, the organisation did not see any reason to replace a perfectly good structure, despite its small size, despite its inconsistent and relatively primitive design and despite its inadequate shelter against inclement weather.

While the building on platform No. 1 is a simple timber shed, it is the only surviving example of the style of building that was used extensively along the North Shore line prior to the replacement of these structures with the present Federation style.

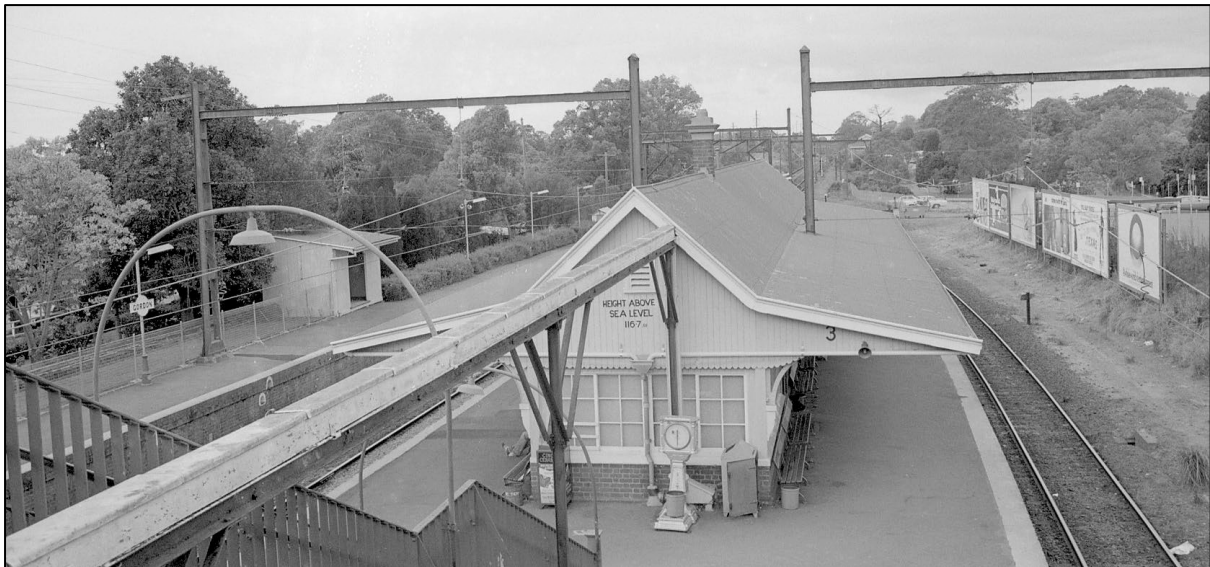
*On 8<sup>th</sup> November 1980, this was the view of the platform buildings from the footbridge. Platform Nos. 2 and 3 date from 1909. Platform No. 2 was the original platform when there was only a single main line between 1890 and 1927. The second platform is shown on the left and was erected in the 1890s. The third platform was No.3, which was erected in 1927. There were two things shown in this photograph which suggest that the Electrical Branch of the New South Wales Railways had zero interest in maintaining the aesthetics of the station – any station, in fact. Firstly, note the ugliness of the electrical conduit protruding from the footbridge to the building on platform Nos. 2 and 3. Secondly, observe the unnecessary penetration of the vertical elements of the overhead wiring structures into the platform awnings. Yes. The tops of the vertical members were capped with attractive pyramidal shaped hats but their quaintness did not make up for a total departmental disinterest in spacing the portal structures to avoid ruining the appearance of the building. Not only was the roof hurt, but the placement of the stanchion onto the platform added to the clutter that distracted from the elegance of the platform building. One chimney and the two Breaches Cows have been removed.<sup>37</sup> The advertising hoardings on the right mark the place of the post-1909 goods shed and siding. In the far distance, adjacent to the Up Main line, is the Gordon traction sub-station.*

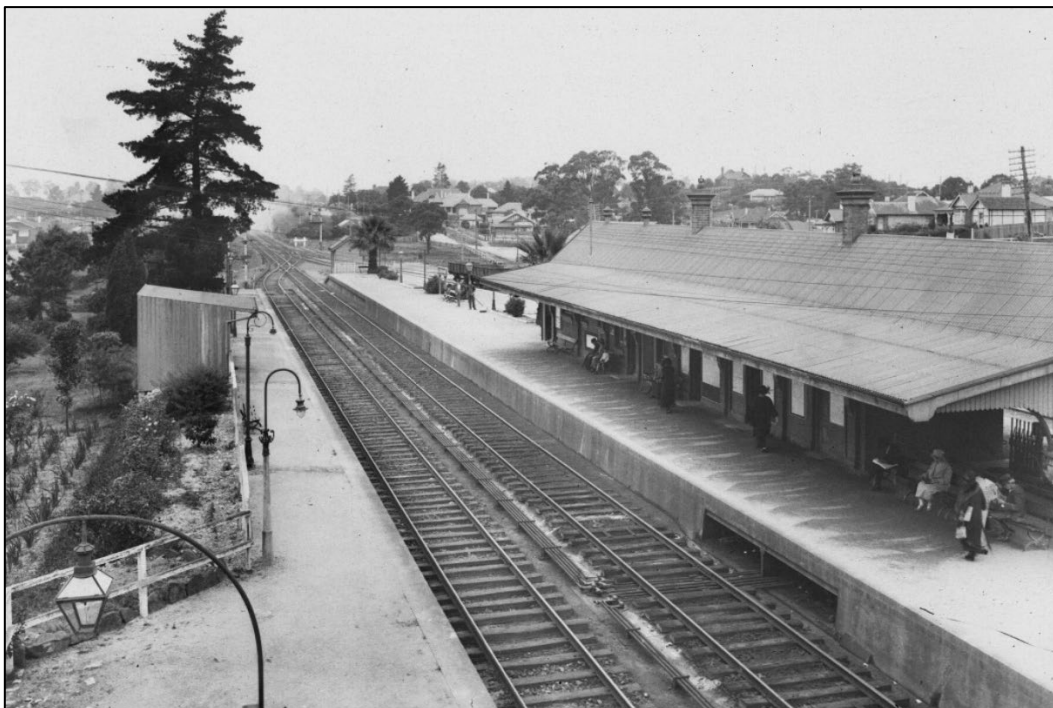
*This 1924 photograph shows the beautification works on the left. Four platform seats are located under the awning on platform No. 2 with a fifth seat beyond the building. The seat at the far right is a post-1890 product, which can be dated by the omission of armrests. On the righthand side is the interlocking frame which has yet to be enclosed with walls. The roof ridge has been penetrated by two brick chimneys. Nearest to the camera, the chimney serves fireplaces in the ticket office and in the parcels office whilst the distant chimney vents fireplaces in the general waiting room and in the ladies' waiting room. Beyond the chimneys are ventilators piercing the ridge which dissipated odours from the male and female toilets. These were officially known as Breaches Cows. **SOURCE:** Photograph No 0889607 ARHS Railway Archives.*

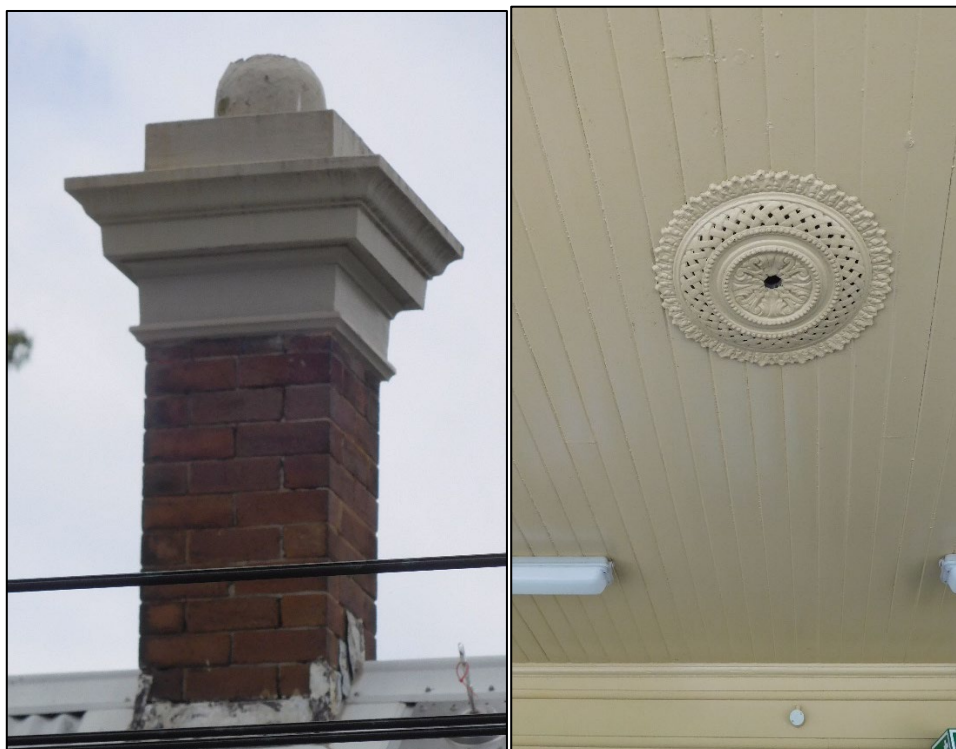
*These two images show decorative elements. On the left is the chimney with corbelling (i.e. different levels of moulding) and a remnant of the terracotta pot. On the right is the ceiling rose on the overhead booking/parcels office. Its role was to evacuate fumes from kerosene or gas lamps. Similar roses were used in the ceilings of the 1909 platform building.*

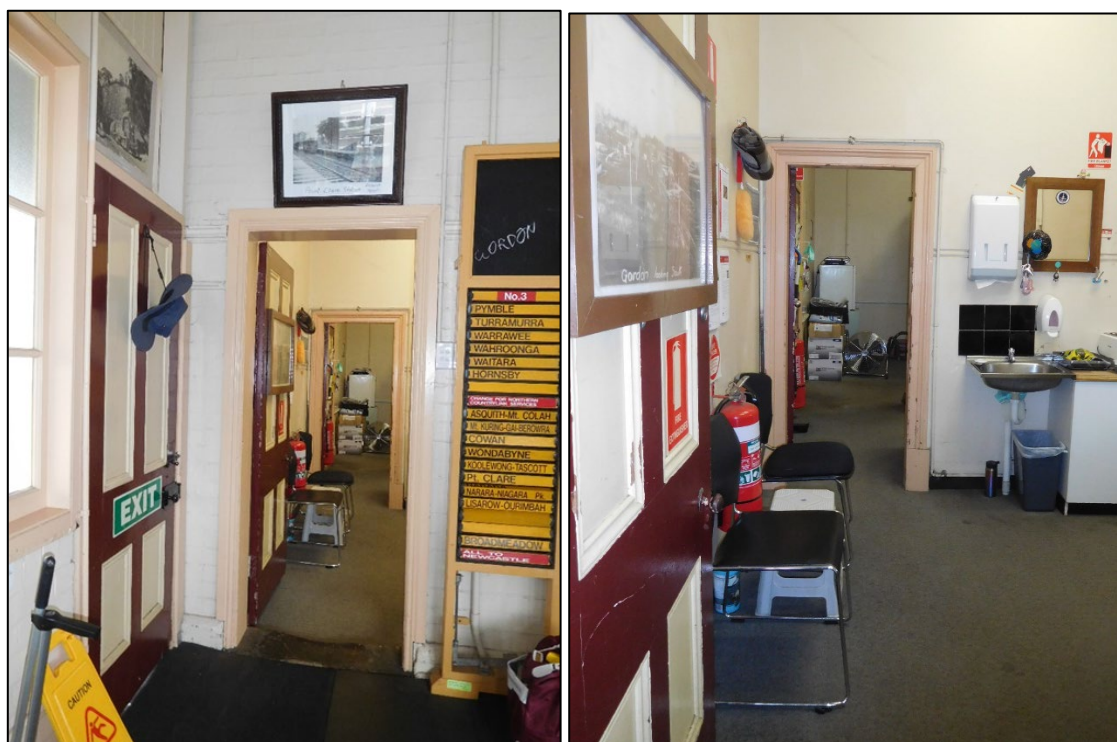
These two images show the interconnection between the rooms used by staff. On the left, the image taker is standing in the signal box looking south. The door to the left opens onto platform No. 2. When constructed, the door immediately in front of the picture man did not exist but the opening was erected sometime later to allow access to the interlocking frame. Still on the left, it is possible to denote the rendered string course that surrounded the former northern end of the structure. It is located between the two pictures on the wall. The room adjacent to the signal box was the original parcels office and, after 1910, became the Station Master's office. Beyond the parcels office was the former ticket office. On the right of the left image is one bay of the three bay train indicator board that was formerly attached to a wall of the overhead booking/parcels office. The image on the right side is taken from the staff amenities room (former parcels office) and looks into the former ticket office. The dado line is visible in the right image on the wall between the door reveal and the white-coloured paper towel dispenser. All the door frames display the authentic and traditional New South Wales Railway colour, known officially as light stone.

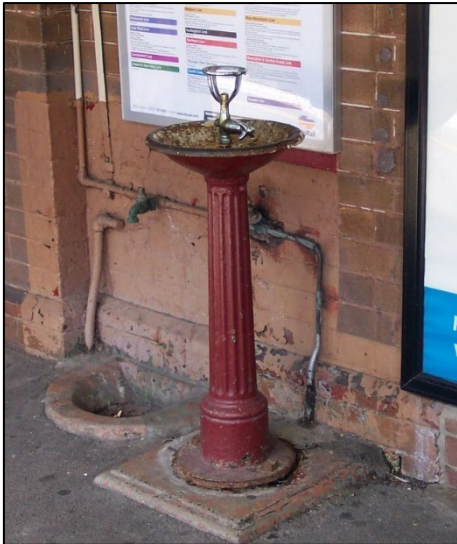
*The water bubbler was a standard fixture for most urban stations. This image on 13<sup>th</sup> March 2003 reveals two other expressions of standard station construction. These were the use of brown paint, called stone (in three shades) in Railway parlance. Here, the paint has been applied to stop water penetrating into the brick walls. As the walls had no cavity, water would continue travelling through the two skins of brickwork and damage the internal plaster on the walls. Some of the tuckpointing of the mortar is also visible.*

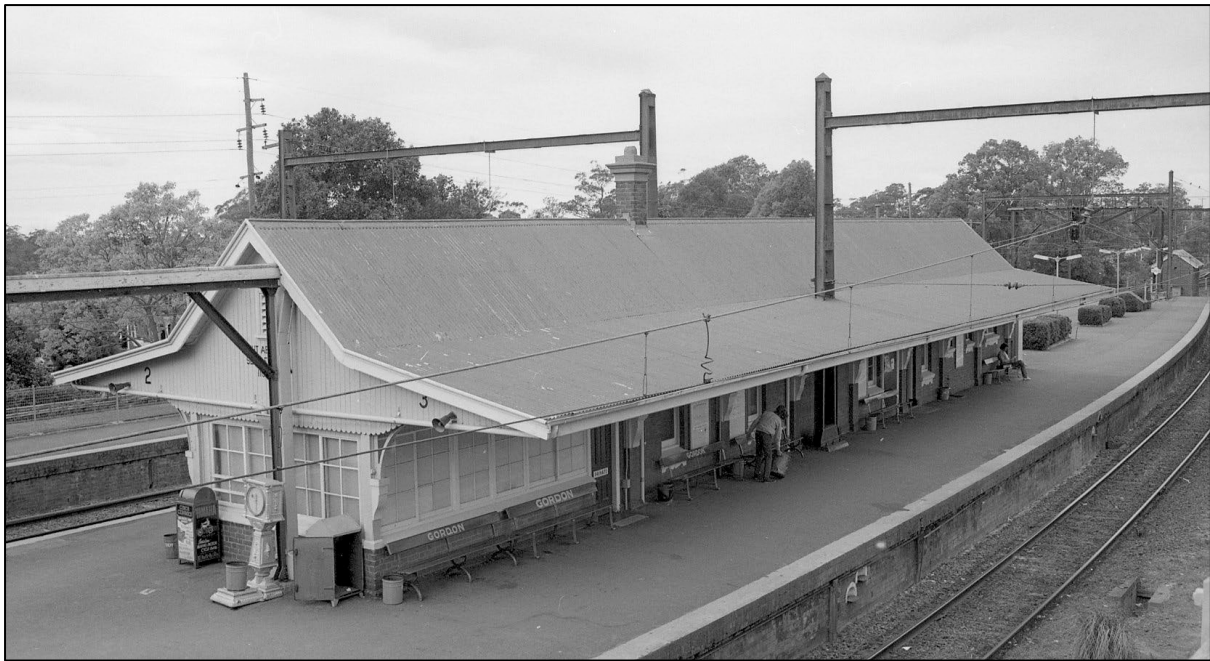
*When the island platform was built in 1909, the coping at the top of the brick wall on platform No. 3 was cantilevered beyond the face of the wall. From the centre of the building, the platform serving the Down Main line was 14 feet eight and a half inches wide and the platform for the Up Main line was 13 feet nine and a half inches wide. In other words, the building was positioned slightly off-centre. This same inconsistency occurred also at Lindfield, Pymble, Killara and Turramurra. At the time, platform No. 1 was nine feet wide. The North Shore line was electrified on 15<sup>th</sup> August 1927. Elegance was still a design virtue in 1927 and that was reflected by the placement of steel, pyramidal-shaped caps on top of the vertical elements of the portal structures for electrification. Hang on! Didn't the author say that the Electrical Branch had zero interest in aesthetics? Yes. That is correct. All the structures for electrification were designed by the staff of the Way and Works Branch – not the Electrical Branch, whose job was restricted to installation. There are several elements that gave character to the Railways. These were the round-top garbage bin with the sprung loaded lid; the small timber box where the staff kept their brooms; the silver coloured weighing machine; the green painted platform seats with the station name expressed in yellow coloured paint; the shrubs on the platform and the lamp room off the end of the platform. The photograph was taken on 8<sup>th</sup> November 1980.*

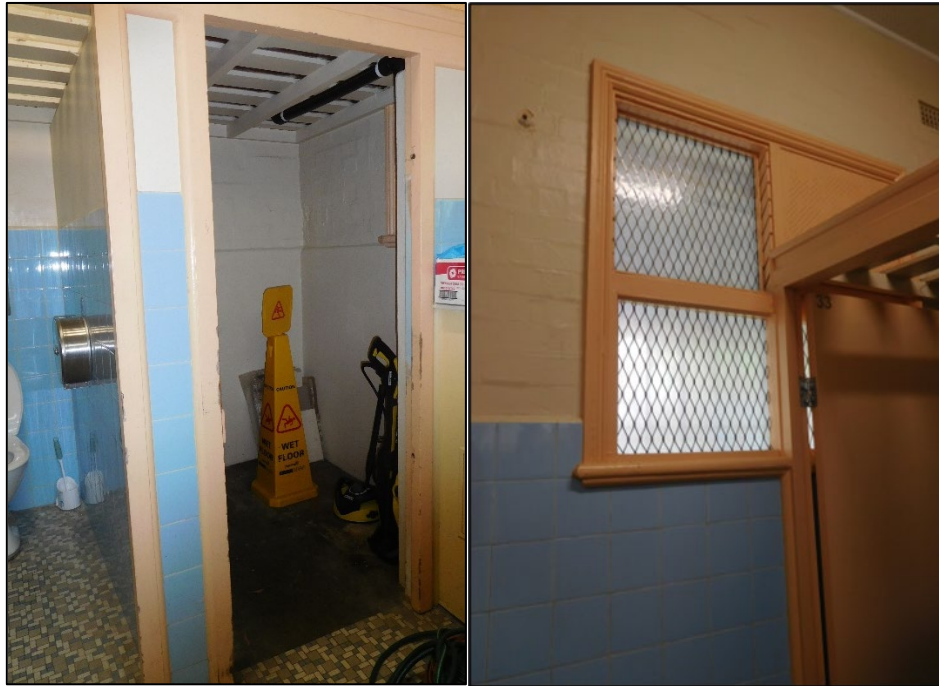
*These two 2025 images show aspects of the male toilet. There was always a hierarchy of rooms in railway buildings. At the bottom were toilets and lamp rooms. While the off-platform lamp room has been demolished, the male toilet provides the evidence of its lowly status. A false roof has been inserted in an attempt to cover the original absence of a ceiling. On the left, the picture shows part of one of the upgraded closets. The image also reveals the entrance to what was termed the 'Cleaner's Passage'. It was a transverse corridor from which pans would be removed from the male closets on one side and the female closets on the other side. In normal circumstances, the sanitary contractor to the local government authority would change the pans on a regular basis. The Railway Department paid an annual fee to the local council for the service. In rural area, the local fettling gang would carry out the work. On the right, the picture shows the inside wall, which was not rendered due to the low status of the space. Toilet closets were, up to the 1950s, raised six inches above the floor level of male toilets, possibly to facilitate washing the floor. Although that feature has not been retained in the closet area, the Cleaner's Passage does indeed show the closets being six inches above the floor level.*

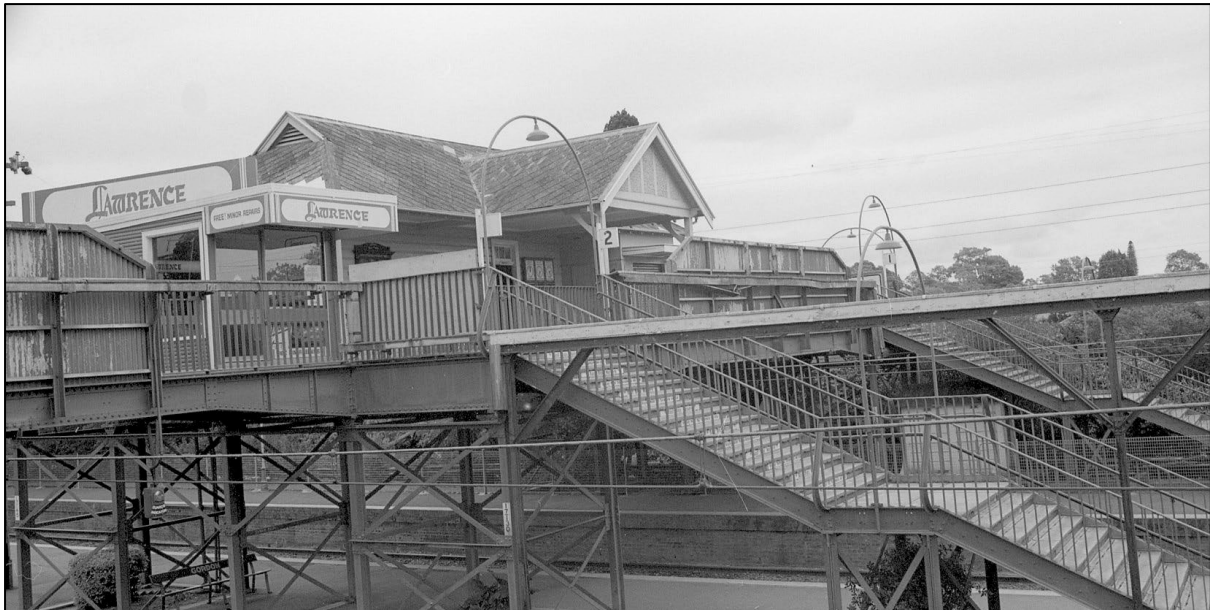
*On 8<sup>th</sup> November 1980 – 70 years after construction, it was still possible to understand the claim of disfigurement of the area by the erection of the footbridge. The picture shows what architects describe as busy. There are trestles and steel balustrades almost everywhere, making it difficult to interpret the simple elegance of the booking office or the peacefulness of the curved steel supports for the incandescent lights over the stepways. The original asbestos cement 'slates' (as the Railways called them) protect the roof of the booking office. The most colourful object in the photograph was the Lawrence Drycleaning shop at the left with its red and white paint. One wonders whether senior Railway executives witnessed the Lawrence Drycleaning colour palette, with its obvious attractiveness, and adopted it (i.e. the red and white paint) as the system-wide range of colours for CityRail, which was established in 1989.*

The deck of the footbridge was originally hardwood, which has been replaced by concrete slabs. The balustrades were originally formed by six feet high corrugated iron sheets but they have been replaced by steel balustrades. The original timber treads and risers on the stepways have been replaced by pre-cast concrete steps.

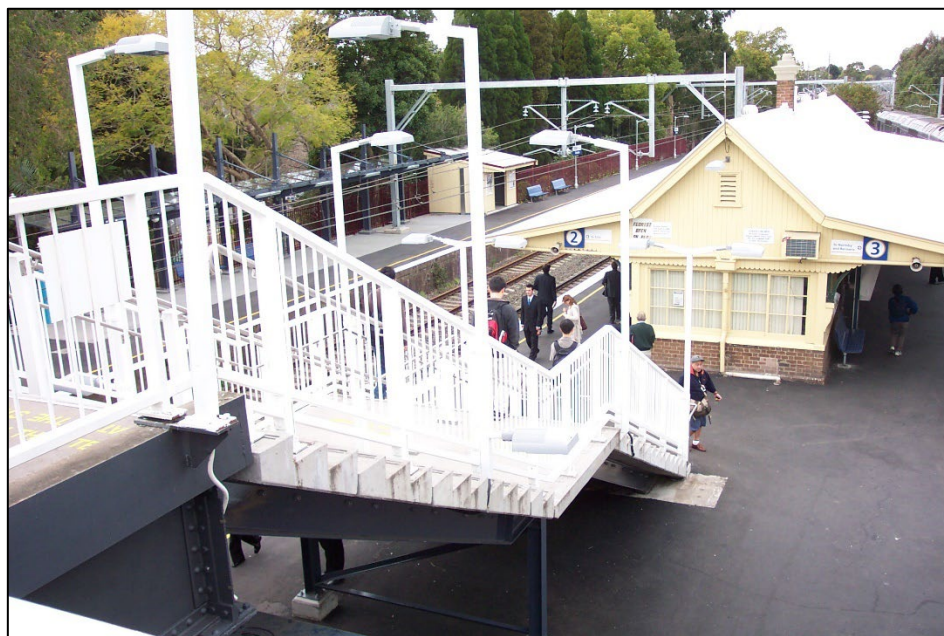
*For the first time since the footbridge was erected in 1910, the steelwork of the substructure has received a coating of other than micaceous oxide. With the creation of CityRail in 1989, every railway station in the State was upgraded, including Gordon station. The balustrades of*

*the stepways have been covered with white paint. What a difference the CityRail colour scheme made to the rusting steelwork. The date is 20<sup>th</sup> August 2005.*

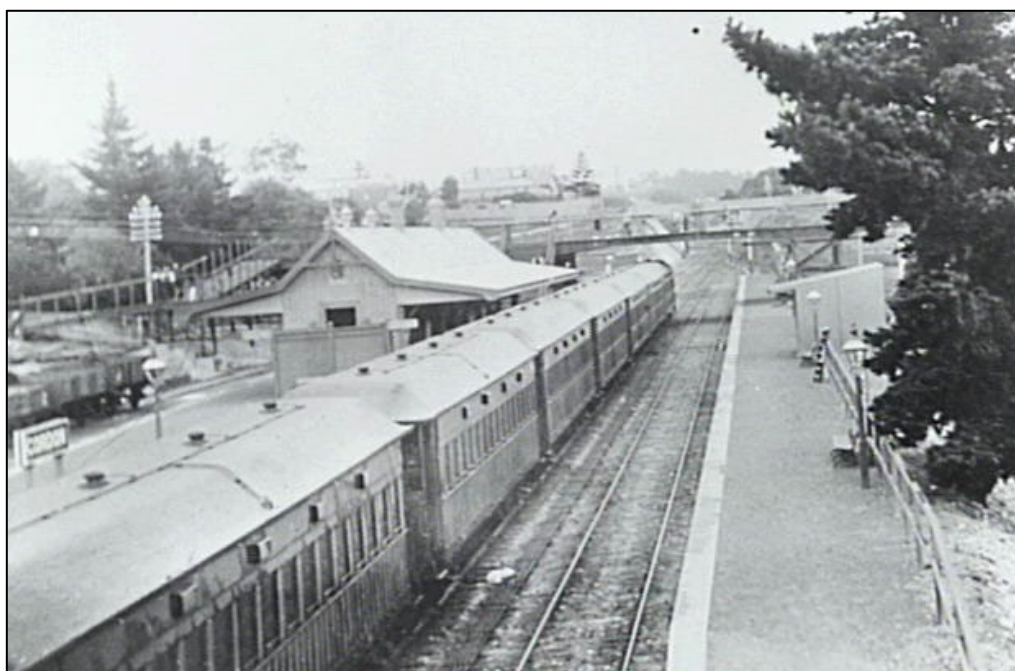
*The above photograph, taken in 1910, shows either people walking on the footbridge or, possibly, workers undertaking the first signs of construction of the overhead booking and parcels office. The original timber privacy screen covers the entrance/exit of the male toilet. The station nameboard on the extreme left displays white letters on a black background, which was the standard, pre-1914 colour arrangement. **SOURCE:** Photograph No. 439 Ku-ring-gai Library Local History Collection.*
