# A RAILWAY STATION IN A HERITAGE-MINDED AREA – GORDON

STUART SHARP

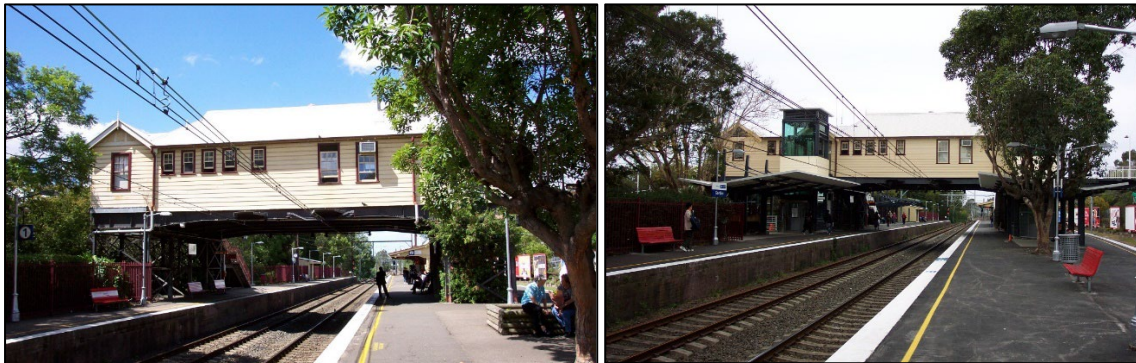
*Gordon station has had two major upgradings within a period of 12 years. In the 1970s, Lawrence Drycleaning had erected a business on the western side of the overhead booking office and CityRail added a second retail entity in the early 1990s on the eastern side of the booking office. The image on the left, taken on 13<sup>th</sup> March 2003, shows the 1992 additional concession on the left. At that time, another concession operated in the former general waiting room in the platform Nos. 2 and 3 building selling flowers. On the right is the overhead booking office showing the alterations carried out in 2005. The space occupied by the Lawrence Drycleaning business was required for the lift to platform Nos. 2 and 3 but the concession on the eastern side remained. The florist on the platform no longer operates. The right image was taken on 20<sup>th</sup> August 2005.*

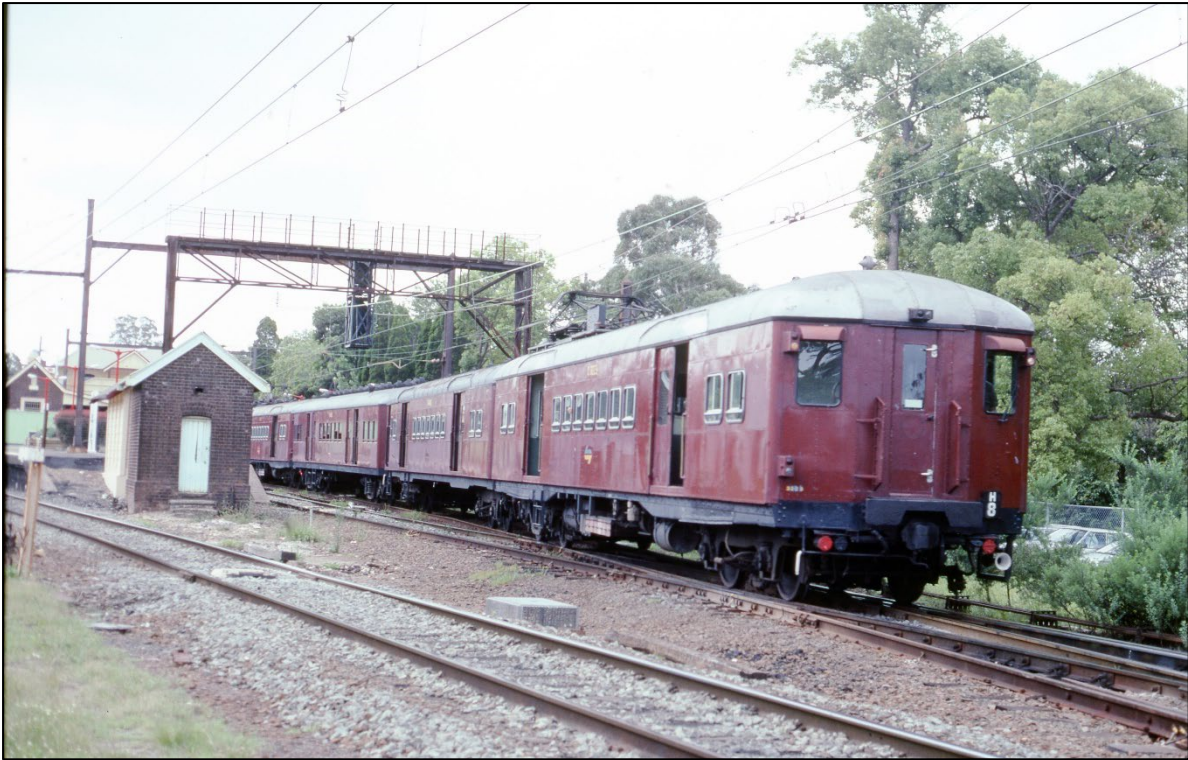
*The above photograph was taken before 1992 when the single deck suburban carriages were removed from service. On 30<sup>th</sup> June 1909, a plan was issued for a brick lamp room to be located immediately off the southern end of the platform. In this photograph, the brick lamp room is shown on the left. Behind it is a relay hut that was constructed in 1927 in conjunction with track electrification.*

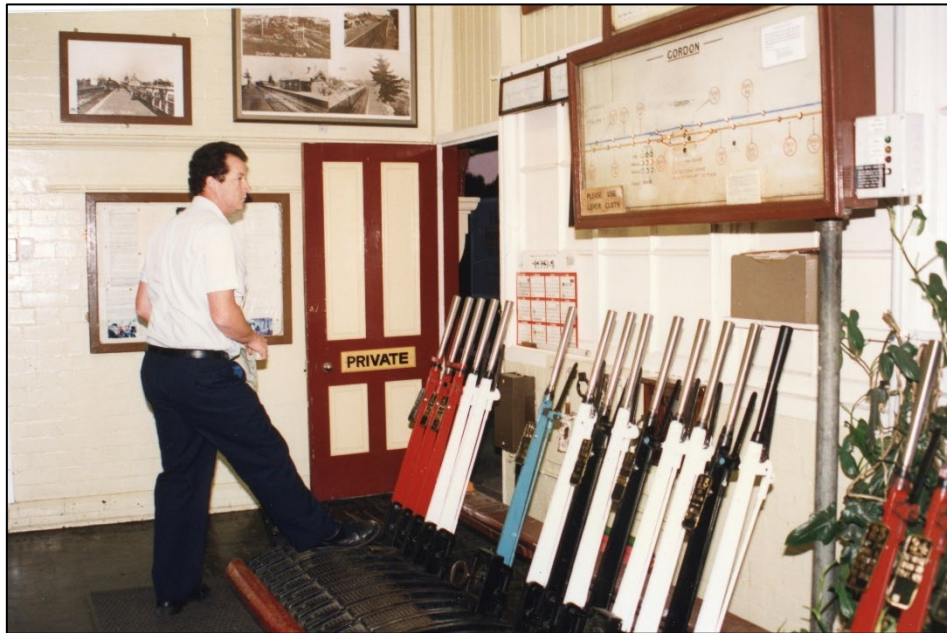
*When the above photograph was taken, the interlocking frame had 28 levers. The photograph dates from 7<sup>th</sup> October 1994 – the day before the signal box closed. All levers shown in the photograph are in the normal or ‘on’ position, meaning that all signals show a stop indication. The red levers operate signals. The black levers manipulate points and the blue lever allows the release of a key to unlock a subsidiary interlocking frame or lever or a facing point lock. The white levers indicate that the lever is spare. **SOURCE:** Photograph No. 0739762 ARHS Railway Archives*

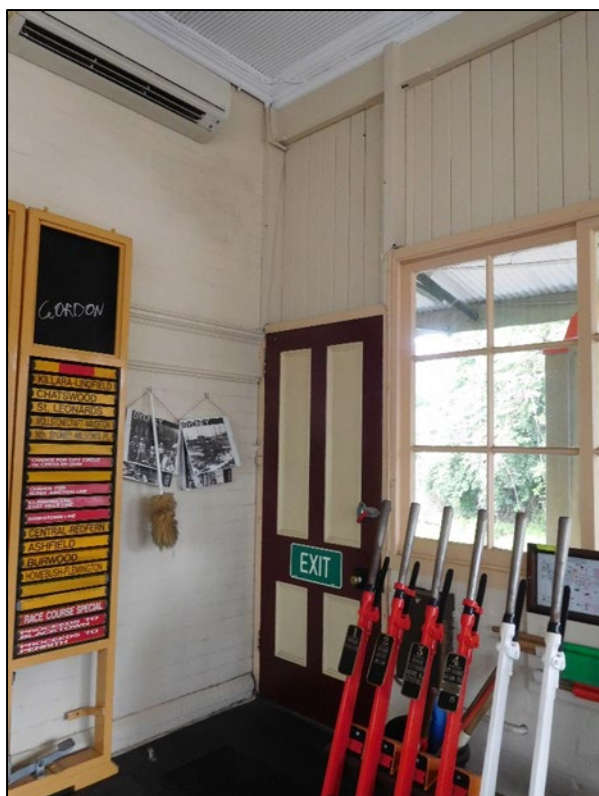
*The image taker is standing in the signal box in 2025 and is looking towards platform No. 3. The image highlights in the difference in fabric between the two parts of the structure. On the left is the end of the brick wall of 1909 building and shows the rendered string course around the end of the building. The wall itself was not rendered because it was formerly exposed, face brickwork. That was the work of the then Permanent Way Branch. When the green light was given for the interlocking frame to be enclosed, the work was performed by the staff of the Signal Engineer. He did not render the now internal end wall and enclosed the walls above the windows with vertical timber boards. The only nice feature was the use of small, corrugated iron sheets to cover the ceiling.*

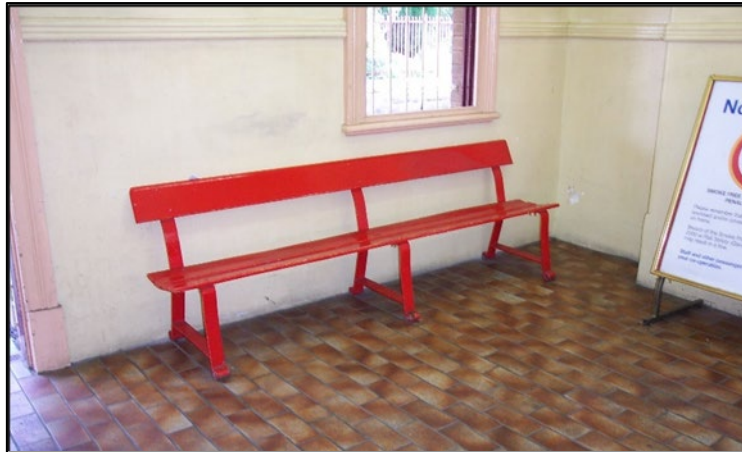
*The above image, taken on 13<sup>th</sup> March 2003, shows the selection of inappropriate, glazed floor tiles in the general waiting room at Gordon. These were installed in the 1970s at many stations in an effort to improve the environment of the station. The action backfired and the tiles act as a reminder of what not to do at a heritage-listed station. The original fixed seating installed in 1909 has been removed. While its replacement is a genuine Railway product (probably from Gordon), it was intended for use on platforms and not internal areas. The red paint was applied in the early 1990s when CityRail upgraded the station for the first time. Note the moulded dado line around the walls.*

It is not surprising that the hardwood flooring in the general waiting room had to be replaced. It sat very close to the ground with minimal ventilation. Although no plans are available to pinpoint a date, the floor product sets the timing.

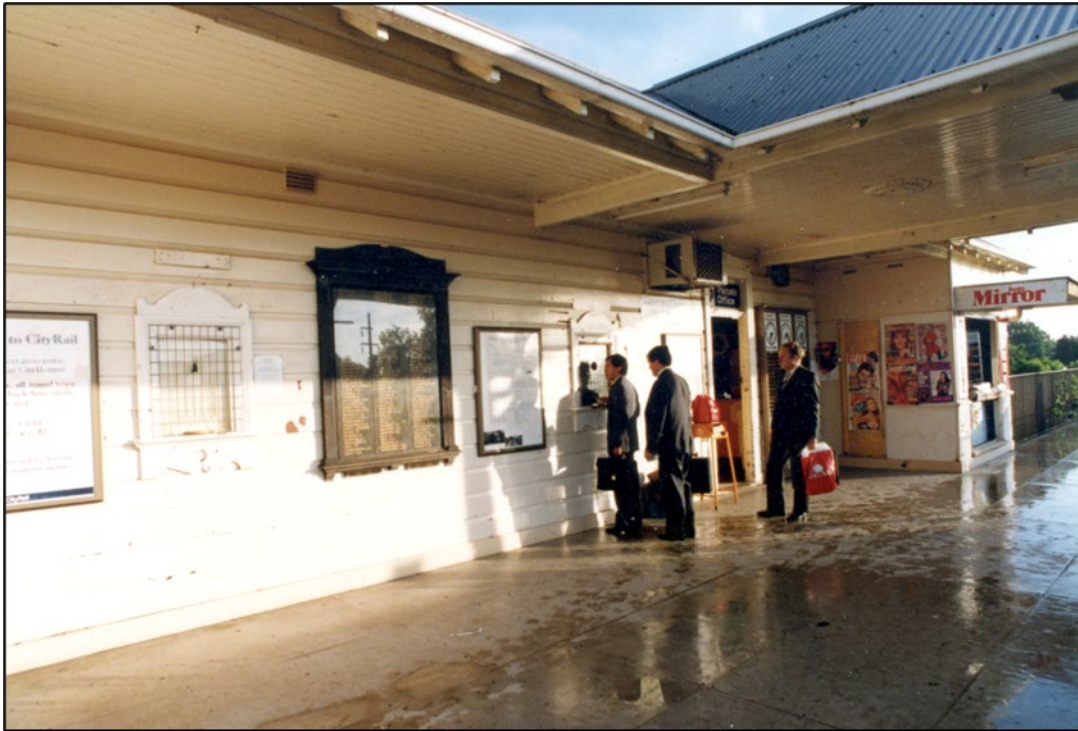
*This 1993 photograph shows the alterations at the eastern end for the establishment of a new concession (i.e. shop). At this time, CityRail was under much pressure from government to maximise retail revenue at railway stations and it was mandatory that additional shop space be provided when station upgrades were being undertaken. The manual train indicator boards are visible over the head of the man with the red bag. In front of the same person is the red public telephone. The World War 1 honour board is in its second position. Note the ornamental ends to the exposed roof rafters. Perhaps the most outstanding feature is the three travellers waiting to purchase tickets. They are all neatly attired in suits – a form of dress not seen often at stations in 2025.*

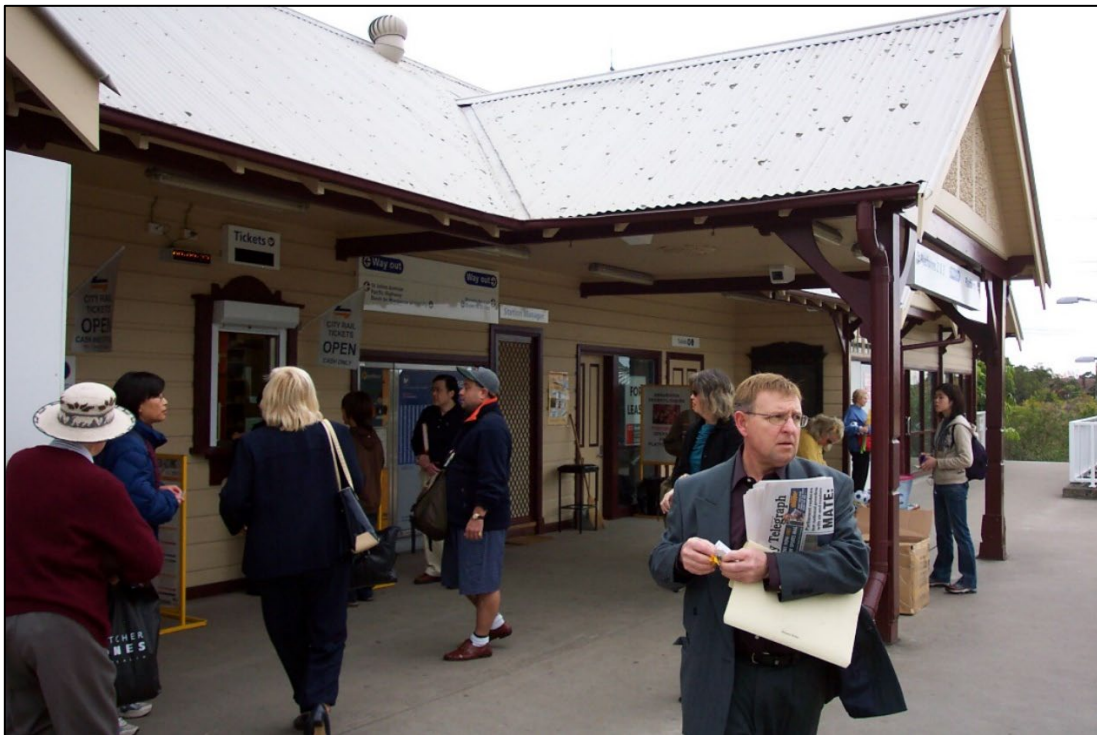
*This 20<sup>th</sup> August 2005 picture shows that the overhead ticket office had been altered. An additional concession has been built on the eastern side. A unisex toilet has been provided. Two new doors have been inserted into the wall. A recess has been fitted to allow the insertion of a ticket vending machine and a security screen fitted to the ticket window. This part of the structure was known officially as the ticket lobby and the roofing was provided to act as a shelter from weather events. Note how the transverse gable extends from the main roof and stops in line with the white painted balustrade on the left. At this time, there were three concessions on the overbridge – one at each end and one towards the centre of the structure in regard to which a “For Lease” sign can be faintly observed over the right shoulder of the man clutching the Daily Telegraph newspaper. Originally, the white painted balustrade at the extreme right side continued towards the camera, leaving only a small gap to allow the staff to collect tickets.*

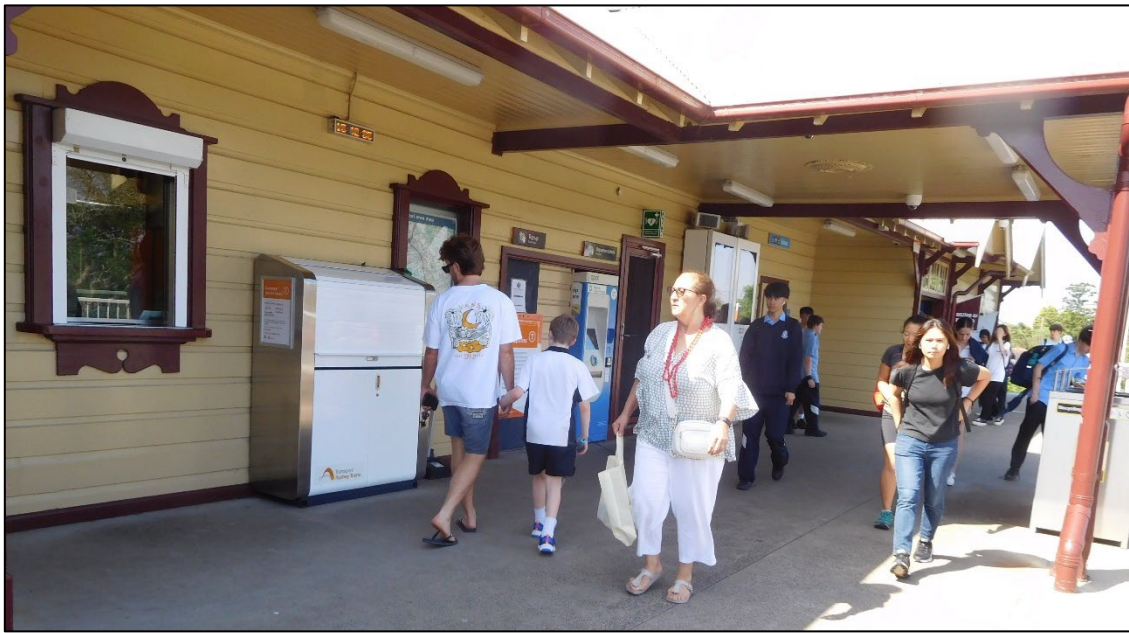
*By 4<sup>th</sup> December 2024, the station has, once again, been painted. The ticket vending machine is gone, due to the introduction of Opal cards, but the recess is still visible in the wall. A hub, which is the official name for the white coloured cabinet, has been installed. The hub houses a computer that indicates the arrival times of trains but is only accessible to staff.*

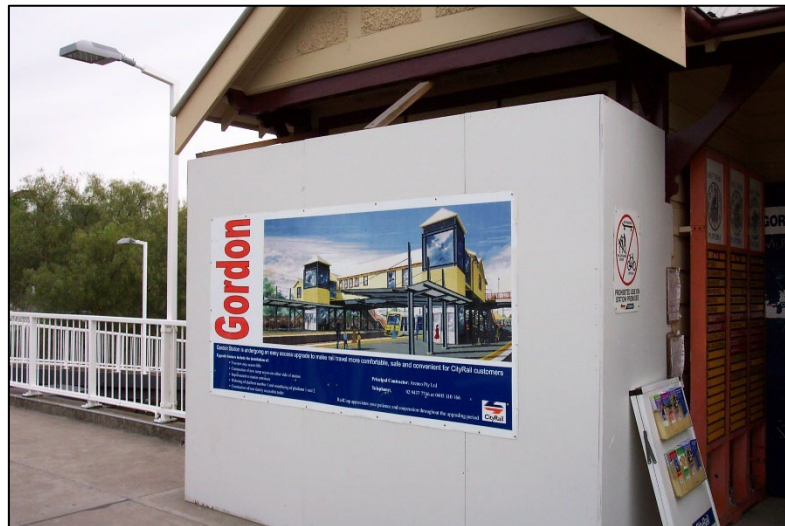
*On the 20<sup>th</sup> August 2005, CityRail had placed hoardings around the former concession at the western end of the footbridge building to allow for the construction of one lift. The image affixed to the hoarding displayed the revised location of the lift shafts on the northern side of the building, which was the site desired by the local community. A former concession had been aggressively rebuilt from the Lawrence Drycleaning shop and the image shows the gabled roof with pretend roughcast, renamed as stucco. With the work to upgrade the booking office in 1992, it was necessary to relocate the train indicator board from the eastern to the western side of the booking office. To the right is a recent item of railway history now gone forever. It is a board of brochures, including timetables, station contact details and safety information. Such paper-based documents are longer available at stations. On the extreme left side is the 1992 installed steel balustrading in white paint.*

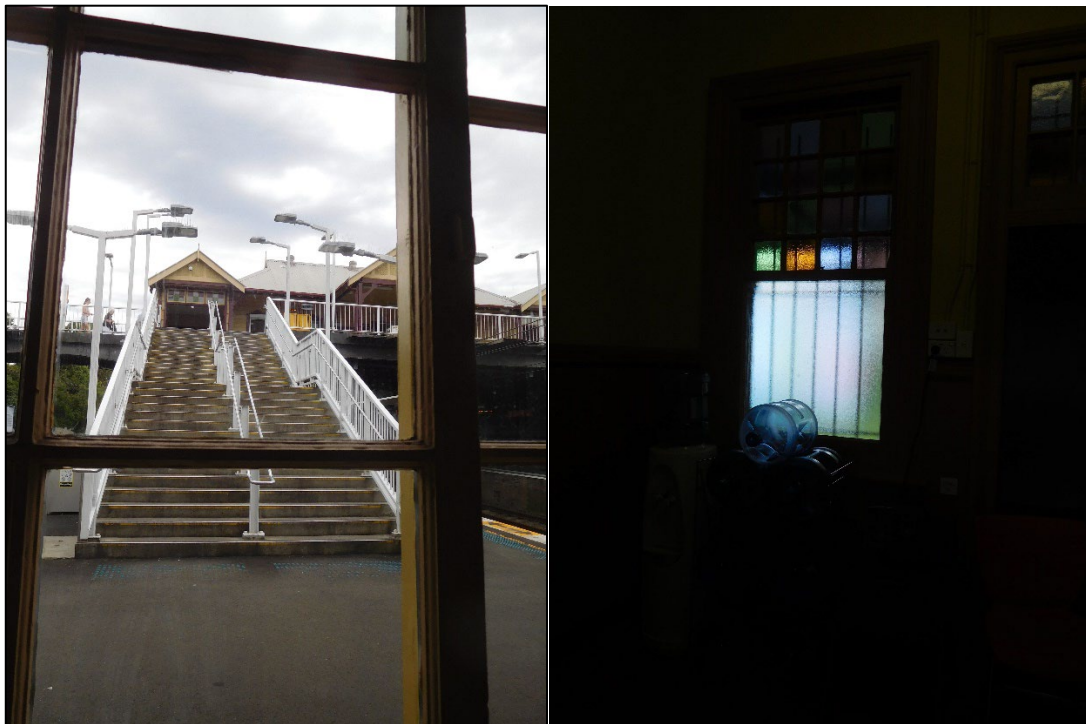
*These two images summarise what is significant at Gordon station. It was local residents who were passionate about their built heritage that enabled these images to be captured in 2025.*

*On the left, the image taker is standing in the signal box looking up the stepway to the footbridge. It was the local community who stopped the construction of lifts between the platform building and the footbridge, thereby breaking the visual link between these two important parts of the heritage precinct. They also secured the original stepways. If the CityRail initial proposal went ahead, this image would have been impossible to record. On the right, the lensman records the ambience in the Cleaner's Passage. The only light afforded to the pan man was borrowed light through a window in a transverse wall separating the Passage and the female toilet. Now, the work conditions in the early 20<sup>th</sup> century are retained for future generations to see, not visualise. Again, thanks are due to the Gordon community.*

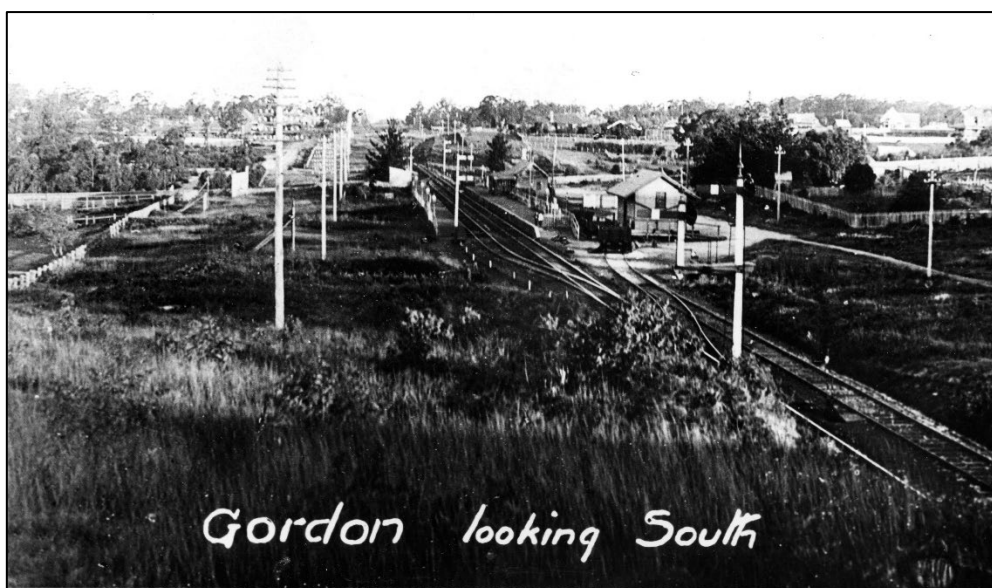
*This photograph shows the goods shed in its original position, before it was relocated further south upon track duplication. Note that the signals towards the right side and located on a bracketed post whereas the starting signals for trains proceeding in the opposite direction are located on a single post. Safeworking historian, Graham Harper, comments on the arrangement of the signals. He writes: "It's two arms for each signal post, either on a bracket or one above the other. The rule of what got what is given below. If the through route was to the left, you got the two arms one above the other as the top arm would apply to the through route. Hence, Gordon had the arms one above the other applying to the Down signals because the top arm applied to the through route under the rule of top to bottom left to right reading of signals, including shunt signals. Why it was so is a bit of a mystery, but I am aware that during the same period [1890s] some double line stations had home signals sharing the same posts as the starters for the opposite direction. One reason was apparently to save on signal posts".<sup>115</sup> Harper adds that this policy was implemented between 1884 and 1890, with possibly some later exceptions. There were a couple of instances where this rule appears to have been disregarded, but the vast majority of loops signalled in this way conformed to the rule.*

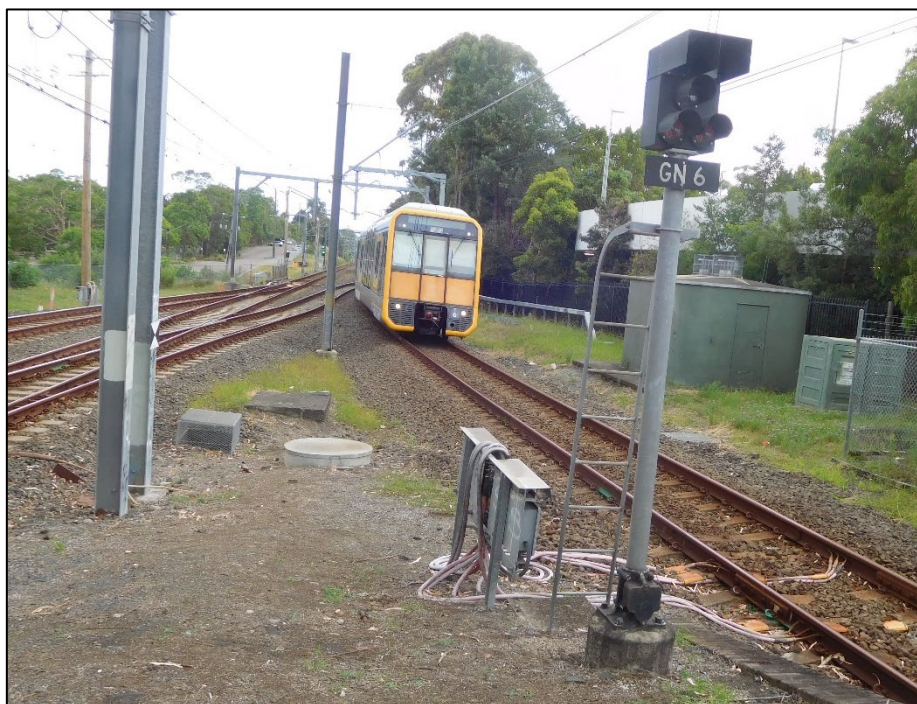
The above image shows a northbound train about to enter platform No. 3 at Gordon. The signal shown is Gordon signal GN6 – Up Shunt on Down Shore. What is the purpose of signal GN6? Why would a down train want to reverse? Would it be to proceed past, then through the crossover and stable in No. 2 platform? Graham Harper tells us: “I would assume that the flexibility is there, particularly when track work on one side of Gordon might mean that a train had to terminate in No.3 platform while No.2 platform was occupied, then shunt out and back after that train had departed. Also, the signals could be used for shunting/running around work trains. The same arrangement would apply to an Up train terminating in No.1 platform when No.2 platform was occupied.

*The normal indication, stop, is given by two red lights next to each other. When the signal is cleared, the two red lights are extinguished and a single yellow light appears above them. There is only one available route but, as this is a wrong line movement, a route indicator shows DS [Down Shore] to alert the driver that he is travelling in the 'wrong' direction. The signal allows the driver to proceed outside the home signal as far as a shunting limit board which is located between the Down Accept and Down Home signals. A similar arrangement is in place for wrong line shunts on the Up Shore towards Pymble. I would assume that there is sufficient space between the points and shunting limit boards in each direction to accommodate an eight car electric train, not just an engine.*
