AUSTRALIAN RAILWAY HISTORICAL SOCIETY

ARHS Melbourne Luncheon Outing Group, visit to Moreland Station Building & Signal Box, then the Islamic Museum of Australia Thornbury,
visit on Tuesday 9th of December 2025

Moreland Station History

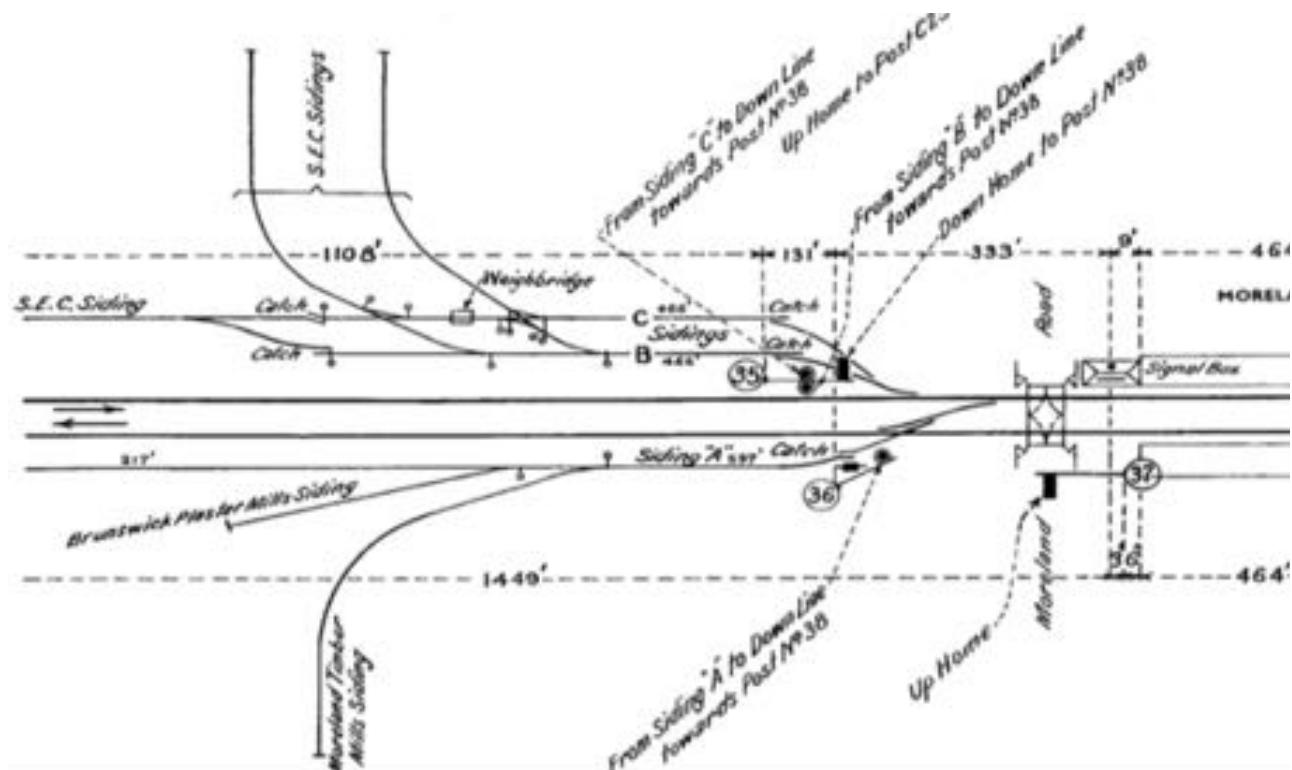
Partial Flemington Bridge to Coburg 1972-003 GWa Collection.

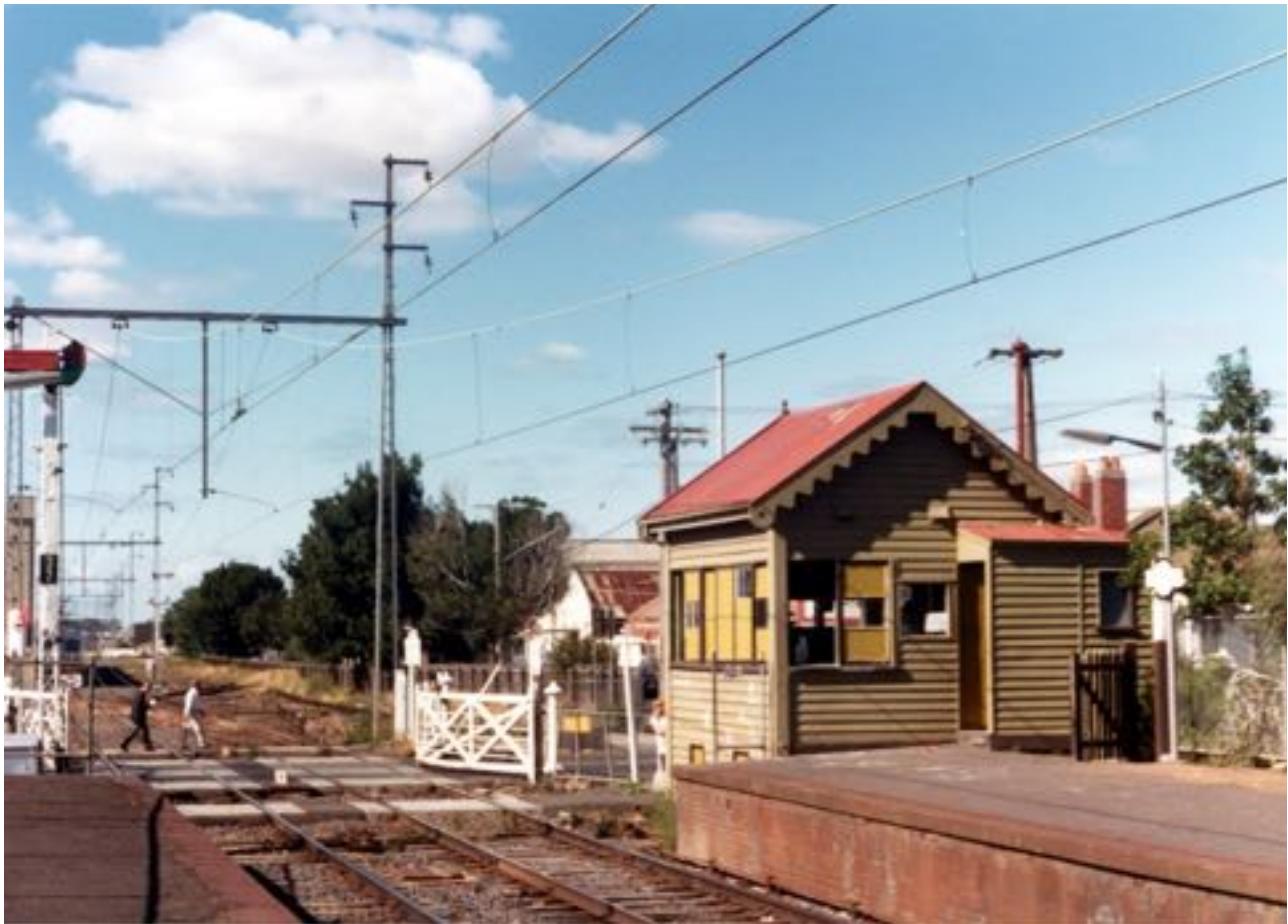
MORELAND gates & signal box in original location on Moreland Road at level Crossing 05-02-1986 Jonathan Scutt image

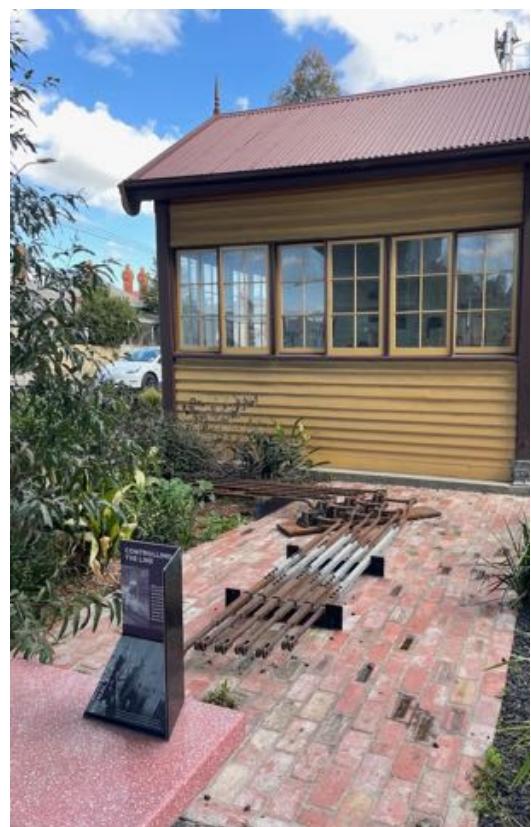
Signal Box relocated 20250905 GWa Image

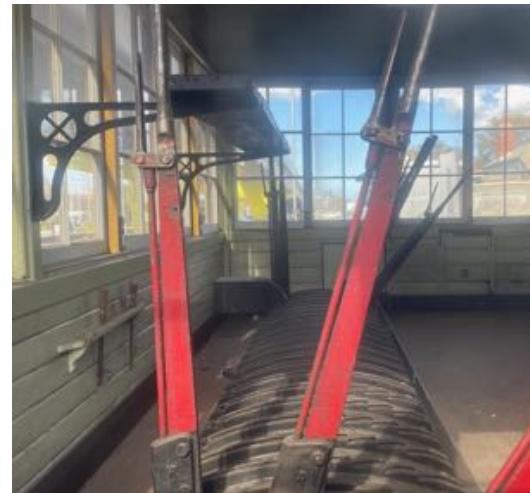
Levers in relocated Signal Box 20250905

The signal box here at Moreland Road was built to control access to sidings that connected nearby factories and warehouses with the railway line. Rail operators managed this by operating a complex series of handles and rods. The remains of the original lever system can be seen through the windows of the signal box.
